Fire risk assessment of low cost high rise residential buildings in Kuala Lumpur: A case study

Fire Risk Assessment of Low Cost High Rise Residential Buildings in Kuala Lumpur: A Case Study

Farid Wajdi Akashah*, Timothy Kurannen Baaki, and Shing Peng Lee

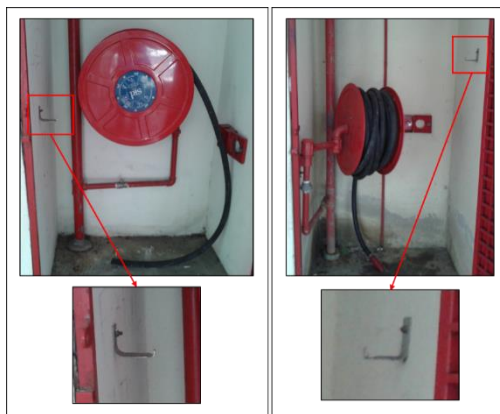
Figure 11: Missing portable fire extinguishers

It was also found that some of the hose reel locks were broken by the building users in order to get water for daily use when water supply to their units was cut off due to water crisis, maintenance of water pumps, and rents default. According to By-Law 225(2) of the Uniform Building By-Law 1984, every building must have at least one fire hydrant at a distance equal or not exceeding 45 meters from the closest location of fire hydrant. It was, however found that, the distance between two fire hydrants in PHP Q was 153.80 meters. PHP R, Block R2 did not have a fire hydrant at all, thus resulting in non-compliance with By-Law 225(2).

Secondly, the fire safety systems in all of the dwelling units of the observed PHP buildings require immediate upgrade, taking into consideration also the needs of physically challenged persons. The kitchen areas for instance need to be installed with fire blankets hence it was the location within the unit more prone to a fire occurrence. There is however, no legislation mandating the installation of fire blankets, but fire blankets are useful active fire safety equipment effective in putting out as well as containing small fires (Fire Industry Association, 2011). On the other hand, the Tenth Schedule of the UBBL 1984 requires that a minimum of one portable fire

extinguisher be installed in each dwelling unit. Strict enforcement of this By-Law would ensure that minimum fire safety requirements are achieved in this regard. Also, it is suggested that some form of automatic early fire detection and warning system e.g. self-contained devices like smoke and heat alarm be installed in areas such as the bedrooms, living rooms, dining rooms, etc. Zhang & Wong (2009) note that this system has been well implemented in residential buildings and has proven effective in reducing loss of life and property in the event of fires. And although the Fire Services Act 1988 (Act 341) exempt isolated private dwellings from having

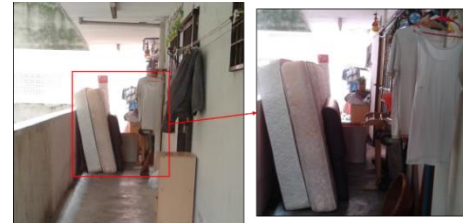
Findings show that all the case study buildings had the recommended minimum corridor width of 1,542mm, however, as shown in Figure 12 the corridors were cluttered with household items. This narrowed the width of the travel pathway and will be an obstruction in the event of emergency and mass egress.

Figure 12: Escape route blocked by mattresses and other items

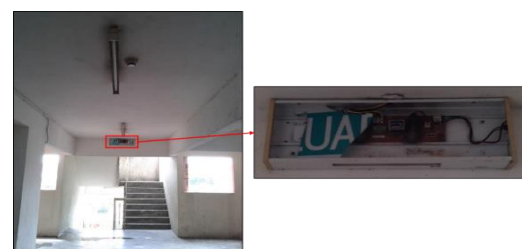
There were inadequate emergency exit signs in all the case study buildings because most of the signs were vandalized (see Figure 13). Also, none of the emergency exit signs in the case study buildings were illuminated, a non-compliance with By-Law 172(4). Also, some of the indication signs were stripped off and covered with graffiti, making them illegible as shown in Figure 14. Installed fire-fighting equipment also had no designated signage. In Figure 15, there is no signage designating fire-fighting equipment thus not complying with By-Law 248 (2) of the Uniform Building By-Law 1984 and MS 1539.

Figure 13: Vandalized emergency exit sign

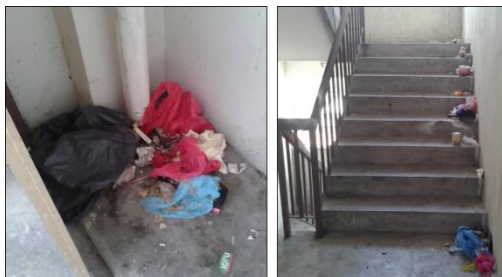
Although it was found that cleaning was performed every day, there was still garbage in common areas such as stairwells and lift lobbies at all the case study buildings (see Figure 16).

Figure 16: Garbage scattered around lift lobby and staircase

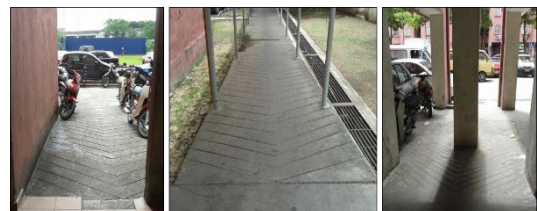
While ramps for disabled persons were provided in two of the case study buildings, none of the ramps were provided with handrails (see Figure 17).

Figure 17: Ramps without handrails
