Fragility assessment of traditional wooden houses in Madagascar subjected to extreme wind loads

<https://doi.org/10.1016/j.engstruct.2023.116220>

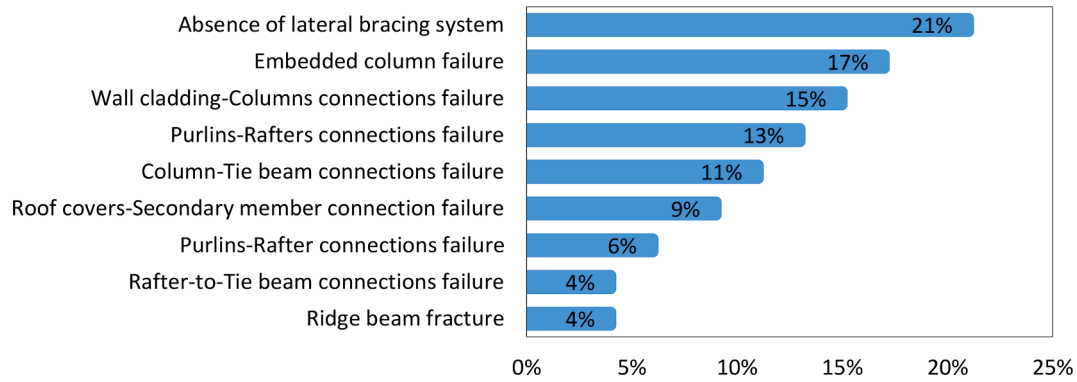
In general, the types of damage may be categorized into either secondary damage related to roofing cover and wall cladding removal without compromising the structural system or structural damage leading to the failure of structural members or their connections. Nine distinct types of damage were identified and listed according to their frequencies, as shown in Fig. 9. From these observations, it was found

Fig. 9. Damage evaluation based on photo interpretation of selected traditional houses following cyclones during the period 2004–2022.

that approximately 50% of damage due to cyclones is related to the roof system, similarly to previous findings by Ralihoana [32]. Among the types of damage related to the roof system, weak connections between secondary members and purlins were the most influential causing 18% of this type of damage. Fracture of columns' bases or failure due to weak column embedment into the ground was also a type of failure leading to extensive damage to the vertical structural system.

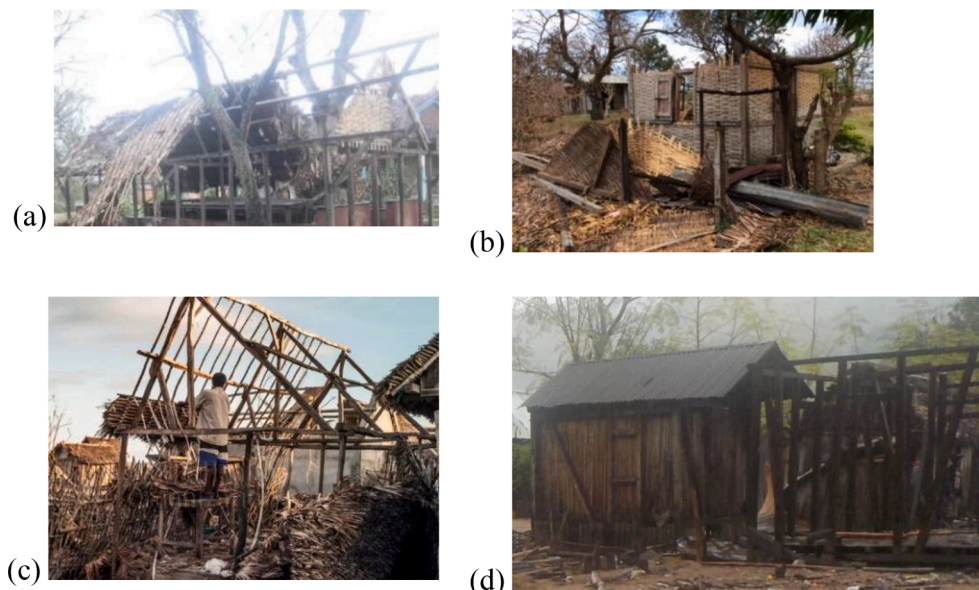
Fig. 10 shows several houses with distinct levels of damage to the roof structural system and wall cladding. The structural roof system is usually a king post truss with a ridge beam and two purlins supported at mid-span of the rafters. Secondary members that hold the roof cover are placed perpendicular to the purlins with a spacing of approximately 50 cm and connected to them by either nailed or wrapped connections. Roof cover-secondary member and secondary member-purlin connections may be qualified as a secondary type of damage (Fig. 10a, Fig. 10b), whereas purlin-rafter and rafter-tie beam connections may be recognized as primary damage to the roof system (Fig. 10c, Fig. 10d). Wall cladding is connected to the columns using wrapped connections and related damage is also categorised as secondary damage (Fig. 10d, Fig. 10b).

Fig. 10. Different damage types observed in Falafa roof systems and wall cladding. (Copyright (a) & (b) Macolline Madagascar, (c) WHO Photo Library, (d) R. Ntsiva N. Andriatsitohaina).

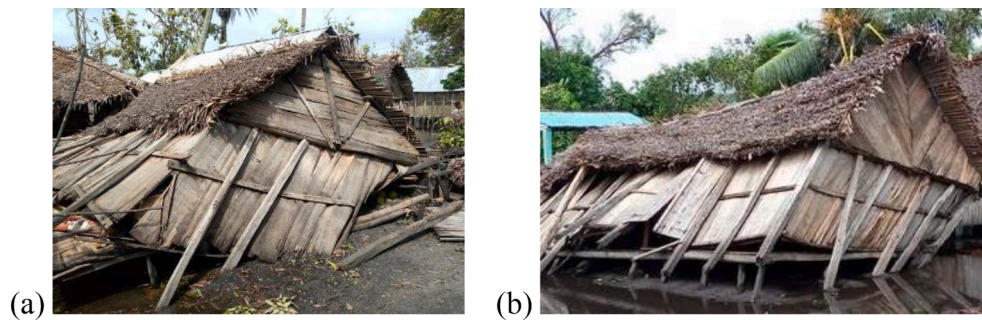
The collected photographs show that structural damage is, in many cases, associated with an extensive leaning of the structural system (Fig. 11), which is due to either the inclination of the embedded columns, because of insufficient soil reaction, or fracture at the column base. Fracture of columns at their base may be attributed to the strength of the wooden column but, more importantly, to the degree of rot at the base of the columns, resulting in reduced strength or even loss of ground connection and structural integrity.

These types of damage usually lead to an extensive damage situation due to the large inclination of the structural system or even its total failure. These types of structural damages would also be associated in many cases with the absence of diagonal bracing in the frame that provide lateral stiffness. Surveys in the study sites confirmed that, although required by the construction guidelines for traditional wooden houses, construction without lateral bracing system is a widespread practice.

Fig. 11. Traditional wood houses with total failure of the structural system. (Copyright AIC-Madagascar).

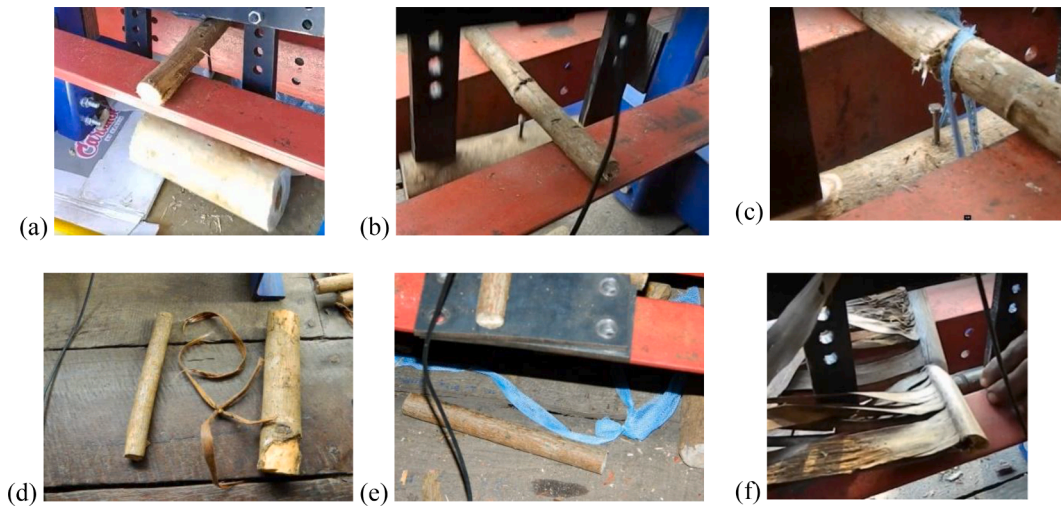
The different observed failure modes are shown in Fig. 18. Table 2 and Fig. 19 give the mean and standard deviation of the load capacity of each type of specimens. All single-nailed specimens failed due to pull out of the nail from either the purlin or the secondary member, while wrapped connections failed due to tension failure of the wrapping material. Those three types of connection showed the lowest strength. On the other hand, failure of Zavy and mosquito net wrapped connections showed two different failure modes due to either the tension failure of the wrapping material or the failure of the secondary member at mid span. For roof cover-secondary member connections, all specimens failed was due to the failure of the petioles. The mean and standard deviation for the strength were found to be 0.22 kN and 0.09 kN, respectively.

Fig. 18. Observed failure modes for (a-e) member-member connections failed by rupture of wrapping materials, and for (f) for secondary member-roof-cover connections with petiole failure.

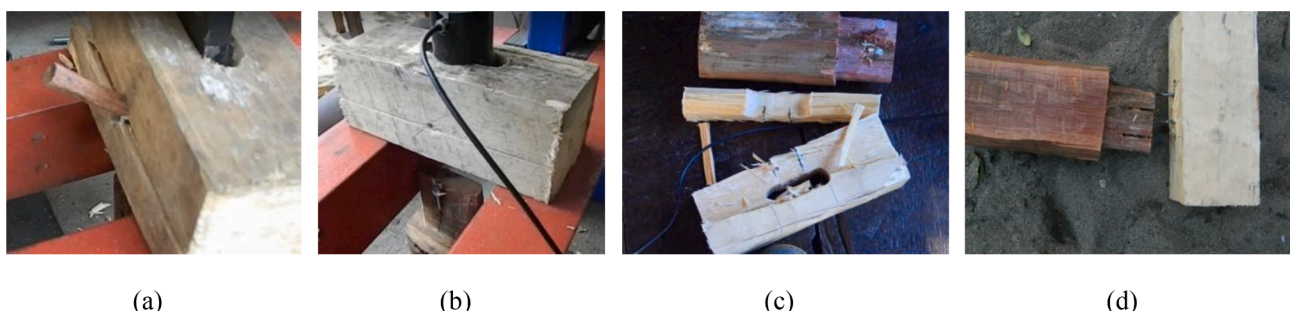
Two types of failure modes were observed for axially loaded MT joints. The first category of failure was due to grain tension splitting of the mortise, observed for pegged MT joints. The second was observed for single nailed MT joints and was due to the splitting failure of the tenon member driven by the bending deformation of the nails. For double nailed MT joints, both failure modes due to splitting of the mortise member and the tenon were observed (Fig. 20). Table 3 and Fig. 21 gives

Fig. 20. MT joints failure modes under axial load for (a) pegged (b) nailed and (c, d) Double nailed with rectangular tenon specimens.

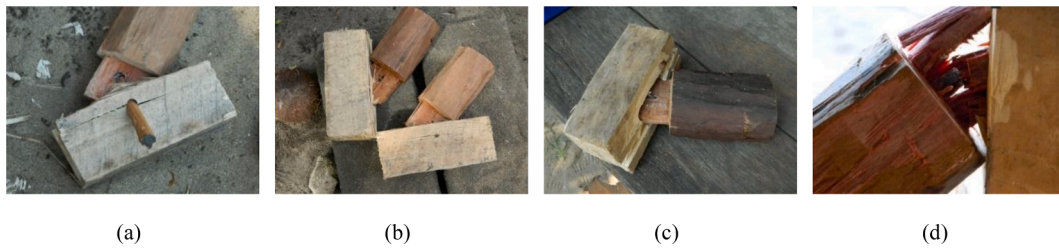
Table 4 and Fig. 22 gives the mean and the standard deviation of the load capacity for each test configuration. Three categories of failure mode were observed for laterally loaded MT joints. The first was due to grain tension splitting of the mortise member (observed for pegged MT joints, which were similar to failures observed for axially loaded pegged MT joints), and the second was due to the splitting failure of the tenon at the contact line with the nail, driven by the bending deformation of the nails (Fig. 23). The third category of failure mode was observed for double nailed MT joints and was due to the tension splitting of the tenon.

Fig. 23. Mortise-Tenon joints failure modes under lateral load for (a) pegged (b, c) nailed and (d) double nailed with rectangular tenon specimens.
