**Performance-based methods for masonry building rehabilitation using innovative leaching and hygrothermal risk analyses**

# Performance-based methods for masonry building rehabilitation using innovative leaching and hygrothermal risk analyses

This paper analyses the conservation and rehabilitation approaches for the Convent of Madre de Deus (Mother of God) of Verderena in the city of Barreiro, Portugal, built in the sixteenth century by the Capuchin Franciscans. Nowadays the convent is partially used as a public library and will be used also by the University for the Third Age. In order to upgrade the building, interventions were carried out during the 1970's and 1990's. However, such interventions were insufficient and unsuitable given the degradation level of the building. The degradation occurred mainly in the external and internal envelopes (walls and roofs) of the convent [1], due to the inadequate indoor environment quality, high levels of relative humidity and leaching phenomenon of the mortar joints between bricks masonry.

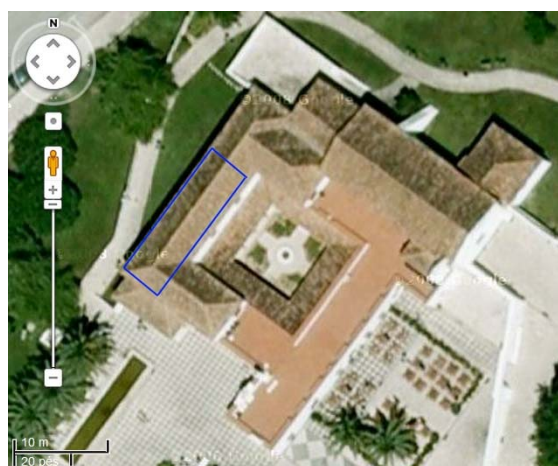
Figure 4 - General view of the convent and its orientation. The blue rectangle shows the main area where is the library (1<sup>st</sup> floor) and where the U3A (ground floor) will be implemented [28].

The historical investigation previously made to the Convent enabled to understand the adopted techniques used in oldest interventions and the characteristics of materials used on those restoration works (in particular concerning the use of new materials) and their compatibility with existing materials [1]. Figure 4 presents the general view of the convent and its orientation.

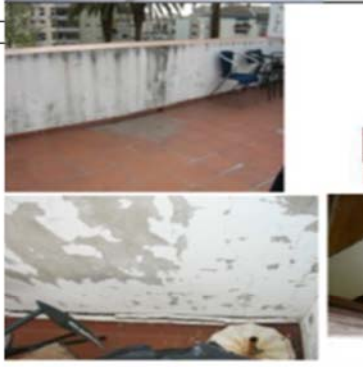
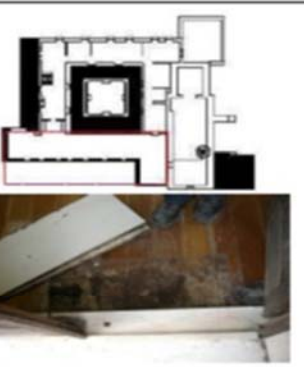
<p><b>D</b></p> <p>Terrace above library access</p> <p><b>Observed damage</b></p> <p>Dysfunctional water flow system at the terrace</p> <p>Water accumulation due to small inclinations of the floor</p> <p>Problems in the water roofing system below ceramic tiles and near the door</p> <p>Inexistence of expansion joints at the ceramic tiles floor</p>

<p><b>E</b></p> <p>Masonry wall</p> <p><b>Observed damage</b></p> <p>The main structural damage exhibited by the masonry consists of diagonal cracks. Those cracks intercept the cross section of the plaband above hidden masonry arch</p>

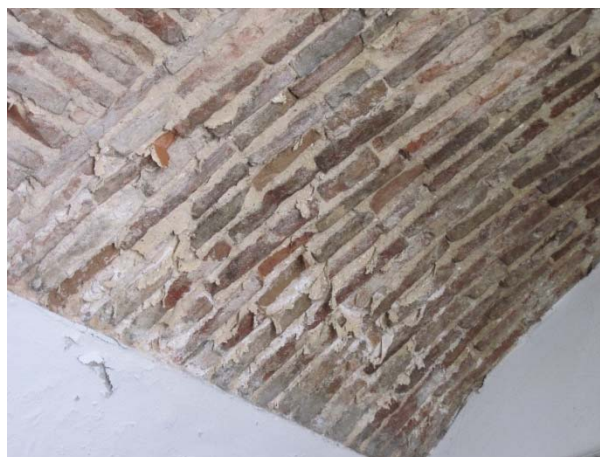
Originally the vaults of the convent were covered. Currently some of them are unplastered, showing their structure, namely the one presented in situation C – Table 1. In this situation, some salt crystallization and leaching phenomena of the mortar joints between brick masonry could be observed (Figure 5).

**Figure 5** - Presence of salts and leaching phenomena of the mortar joints of the brick masonry vault confirms the migration of binder from the original lime mortar.

Leaching phenomena presented in this convent probably occurs not only due to the extended water presence and infiltration from the terrace above the vault (situation D - Table 1), but also due to the lack of protection of the vault structure enabling the ceramic elements and the lime mortar from the joints to be directly affected by indoor hygrothermal conditions. This exposure to several cycles of different relative humidity (RH) could affect the lime mortars microstructure, leading to a decrease of adhesion and mechanical strength with time [24, 31, 33, 34].

The major benefit achieved by covering a vault with a plaster is the reduction of moisture present inside the masonry structure and particularly to stabilize the moisture content in the masonry even with different indoor cycles of relative humidity [29; 30]. The presence of water and its movement inside the pore network of mortars are among the biggest causes of their degradation [29, 31, 32]. In fact, depending on the conditions of temperature and humidity, water in both vapour and liquid state can allow freezing-thawing phenomena (in cold climates) and can favour the entry and the transport of salts which crystallize and dissolve inside the material matrix, namely the joint mortars. Therefore, it will cause the reduction of mortar mechanical strengths and adhesion to the masonry, whenever the RH decreases or increases from the salt hygric equilibrium level (what happens cyclically and very frequently with time).

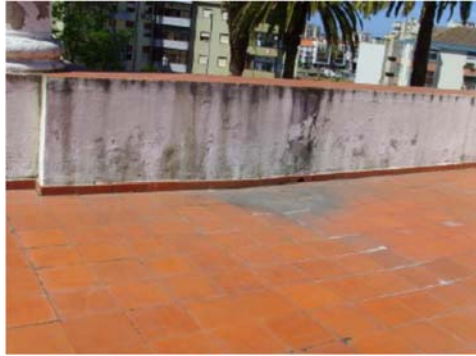
Problems in the terrace flat roof water proofing system of the convent and on its own positioning under ceramic floor tiles lead to water infiltration and damage of masonry walls and vault (situation D - Table 1). The lack of pending at the terrace able to drain rainwater for collection devices has serious consequences on the building functioning, namely in the structural performance of the vault mentioned in Situation C - Table 1, where water infiltration occurs leading to leaching phenomena of the mortar joints of the brick masonry vault.

**Figure 6** - Terrace covering with ceramic roof tiles. Water accumulation due to insufficient slope of the terrace floor.

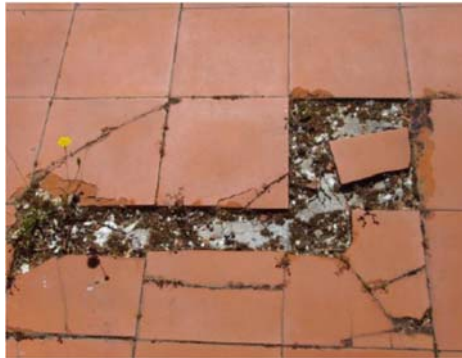
Besides that, the previous construction works made in the 90's at the terrace, with the construction of a new cement based mortar layer and placement of the ceramic floor tiles (Figures 6 and 7) at the top of the hidden masonry arch increased the weight above this structural masonry, leading to crack evolution. This set of cracks could represent significant danger and a pre-collapse situation (situation E – Table 1) [1, 24].

**Figure 7** - The inexistence of expansion joints at the ceramic tiled floor leads to its fracture and to the cracking of cement based mortar layer under tiles, contributing for inefficient roof water proof and therefore leading to leaching of the mortar joints between brick masonry vault.

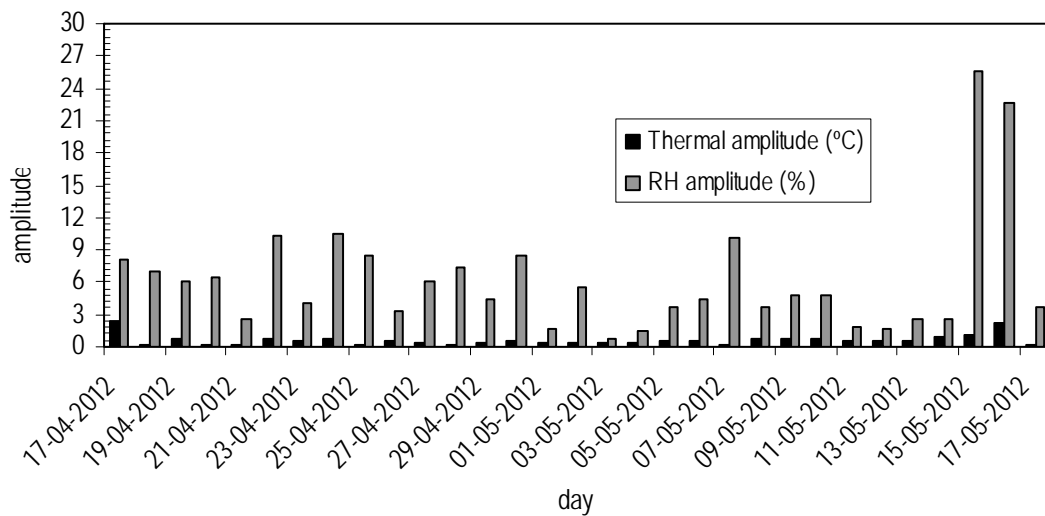
The indoor thermal daily amplitude is not higher than 3°C (which is associated with a good thermal inertia of the building) and the daily variation of RH in the U3A zone presents values between 6% and 25% (except in two days of May) (Figure 13).

**Figure 13** - Daily amplitude variation of indoor temperature and RH at the convent zone U3A (from April 2012 to May 2012).

Based on the results presented in Figures 11 -13, the use of bio based earth plasters (formulated with clayish earth, sand and vegetal fibres) can be a solution to implement inside the U3A area, due to their hygroscopic characteristics. In order to maintain a healthy indoor air quality inside the class rooms, the use of these type of bio-based materials should be promoted since they contribute to the stabilisation of fluctuations in relative humidity [44 - 46]. Nevertheless, susceptibility to biological development with the indoor conditions should also be studied and, if needed, controlled.

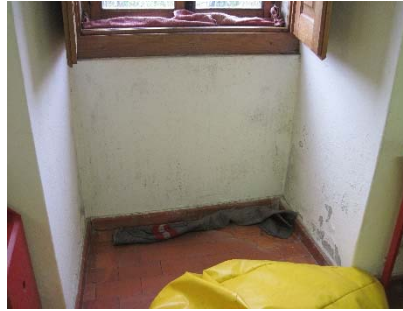
Historic buildings like this convent are usually made of solid masonry walls and single glazed wooden windows (Figure 14). The rehabilitation of this kind of old buildings requires an upgrading of the shell so that comfortable temperatures and relative humidity can be maintained to keep up with modern life requirements.

Figure 14 - Detail view from the interior showing the wood window and the thickness of exterior walls.

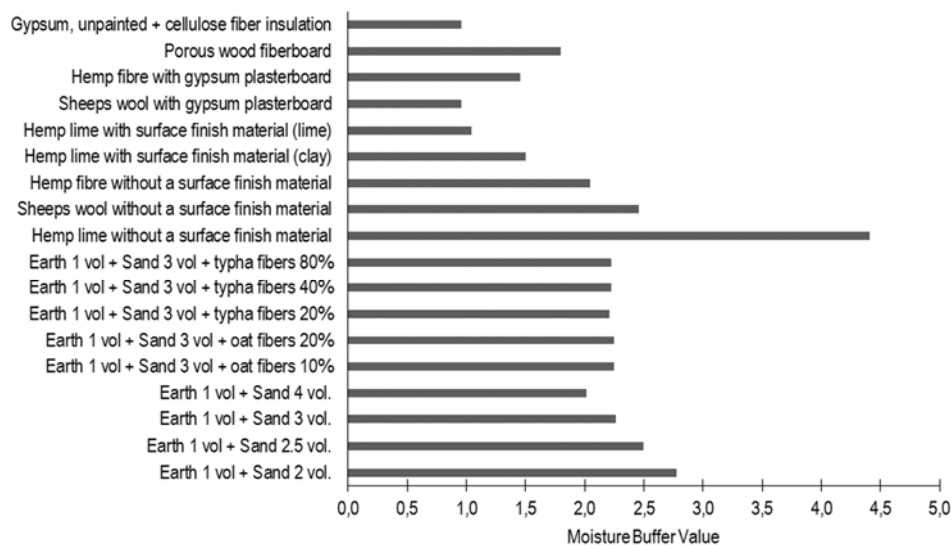
Figure 15 presents several Moisture Buffer Value collected from the existing state of the art regarding bio-based materials [46; 48-50]. Taking into consideration the previous range, those MBV are in general good or excellent.

Figure 15 - Several Moisture Buffer Value collected from the existing state of the art regarding bio-based materials [46; 48-50].

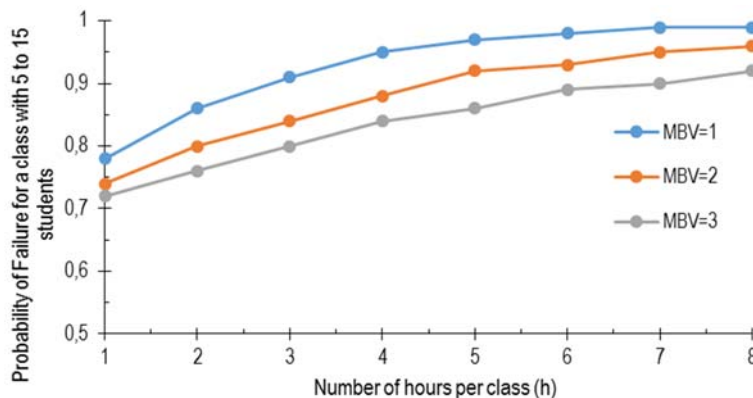
Once again, no explicit target performance measures are available to help to select the best retrofitting solution. Therefore, it was decided to carry out the analysis for the number of hours inside a non-ventilated classroom as a function of the number of people inside the U3A for different types of rendering applied in the surface (MBV=1, 2 and 3) (Figure 16).

Figure 16 – Probability of reaching a relative humidity level higher than 70% for a classroom with 5 to 15 students, if the surface is retrofitted with materials with MBV=1, 2 or 3.

The previous results show that by increasing the MBV of the retrofitting solution, the Pf decreases 10% (from MBV=1 to 3) if the number of hours per class is not higher than 4-5 h. However, this is not enough and some natural ventilation recommendation must be implemented. Therefore it is suggested that the number of hours per class with closed door and windows should not be higher than 2h, so that the air could circulate after that period.

Since the highest RH values at the U3A zone do not satisfy the minimum values to promote a healthy environment, the authors suggest a careful scheduling of operation of heating and dehumidification systems devices.
