Does a micro-grooved trunnion stem surface finish improve fixation and reduce fretting wear at the taper junction of total hip replacements? A finite element evaluation

Ariyan Ashkanfar, David J. Langton, Thomas J. Joyce

To appear in: *Journal of Biomechanics*

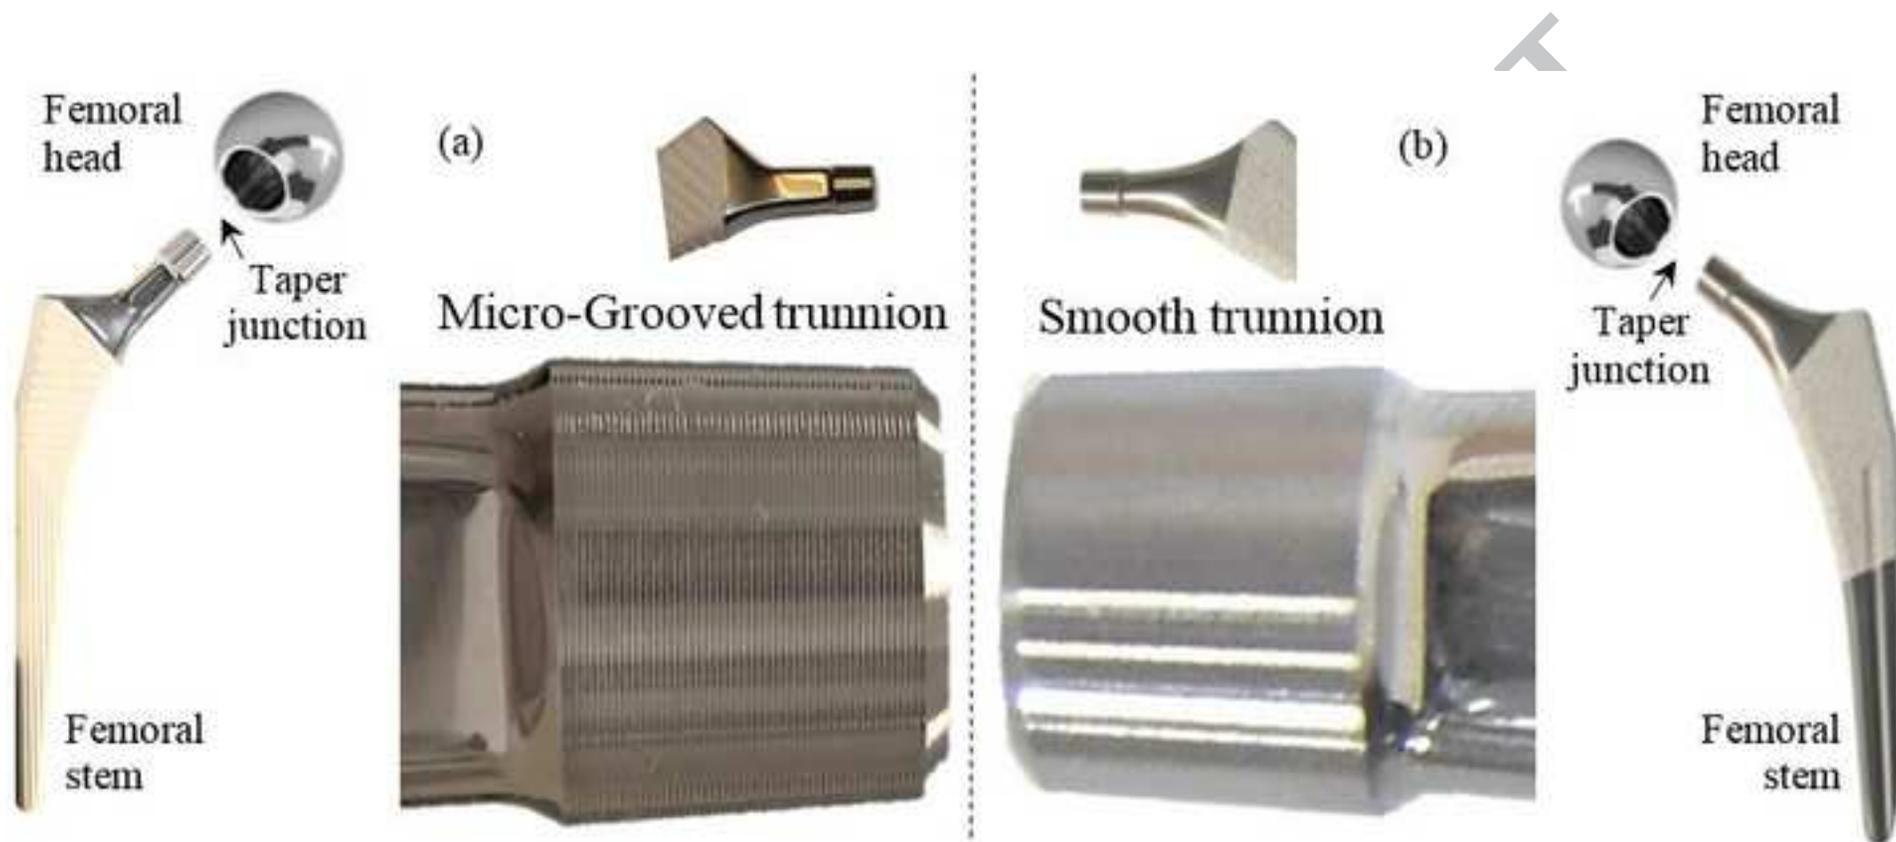
Figure 1: CoCr femoral head and Ti femoral stem of THRs; 36mm femoral head with smooth taper surface finish mated with femoral stems with (a) micro-grooved trunnion stem and (b) smooth surface finish.

The use of separate components (modularity) in total hip replacements (THR) is very common, allowing flexibility intra-operatively to facilitate optimum prosthetic functionality and anatomical fit for individual patients. In addition, modularity allows the use of different materials for different components – e.g. cobalt-chromium (CoCr) for femoral heads due to good wear properties, and titanium (Ti) for femoral stems in order to encourage bone ingrowth. On the femoral side of a THR, the modular connection involves a taper junction between the femoral stem (trunnion) and the internal taper of the femoral head (see Figure 1).

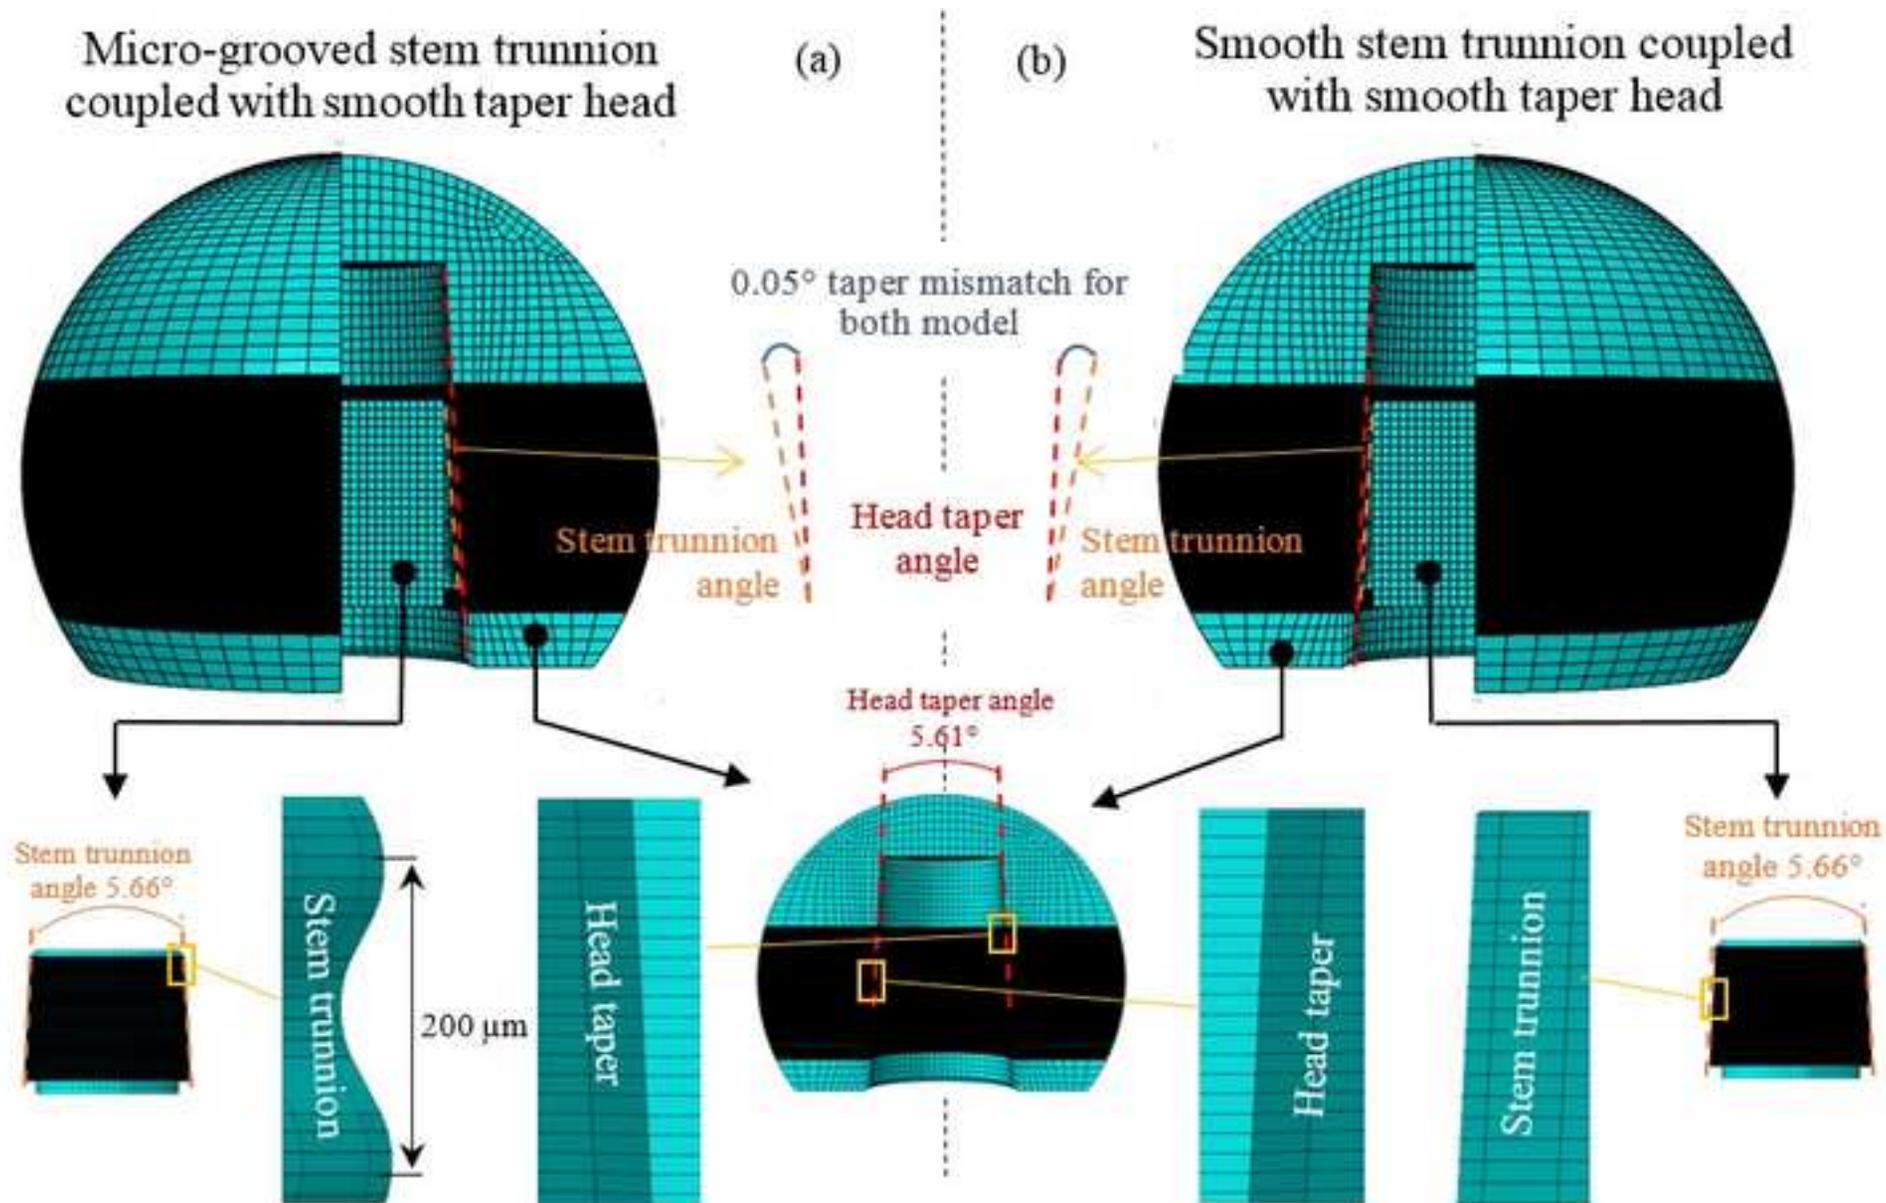
Figure 2: FE model and mesh distribution of the head and stem of THRs; smooth femoral head taper mated (a) with micro-grooved trunnion stem with 200 μ m spacing (Munir et al., 2015) and (b) with smooth trunnion stem; 5°36' head taper angle (in red) and 5°39' stem trunnion angle (in orange) (Brock et al., 2015) produced 3' base-locked taper mismatches for both models.

Two femoral stem FE models, one with machined micro-grooves and the other with a smooth trunnion surface finish, both coupled with a 36 mm diameter CoCr femoral head with a smooth taper surface finish, were modelled in ABAQUS (6.14-3 ABAQUS Inc) (see Figure 2). A base-locked taper mismatch – where the taper and trunnion surfaces engaged at the base of the interface – of 3' between taper and trunnion was selected (see Figure 2) (Ashkanfar et al., 2017). The key difference between the models was the trunnion surface roughness as shown in

Figure 2.

Both models were meshed with highly refined mesh at the taper interface, using eight-node bilinear hexahedral reduced integration elements (C3D8R). The elements at the contact interface were carefully matched and this was followed by a mesh study. The procedure of the mesh study is comprehensively explained in a previous paper (English et al., 2015). The approximate element size at the interaction for both models, although it was not necessary for the smooth coupling, was reduced down to 0.012 mm in order to model the micro-grooves accurately.

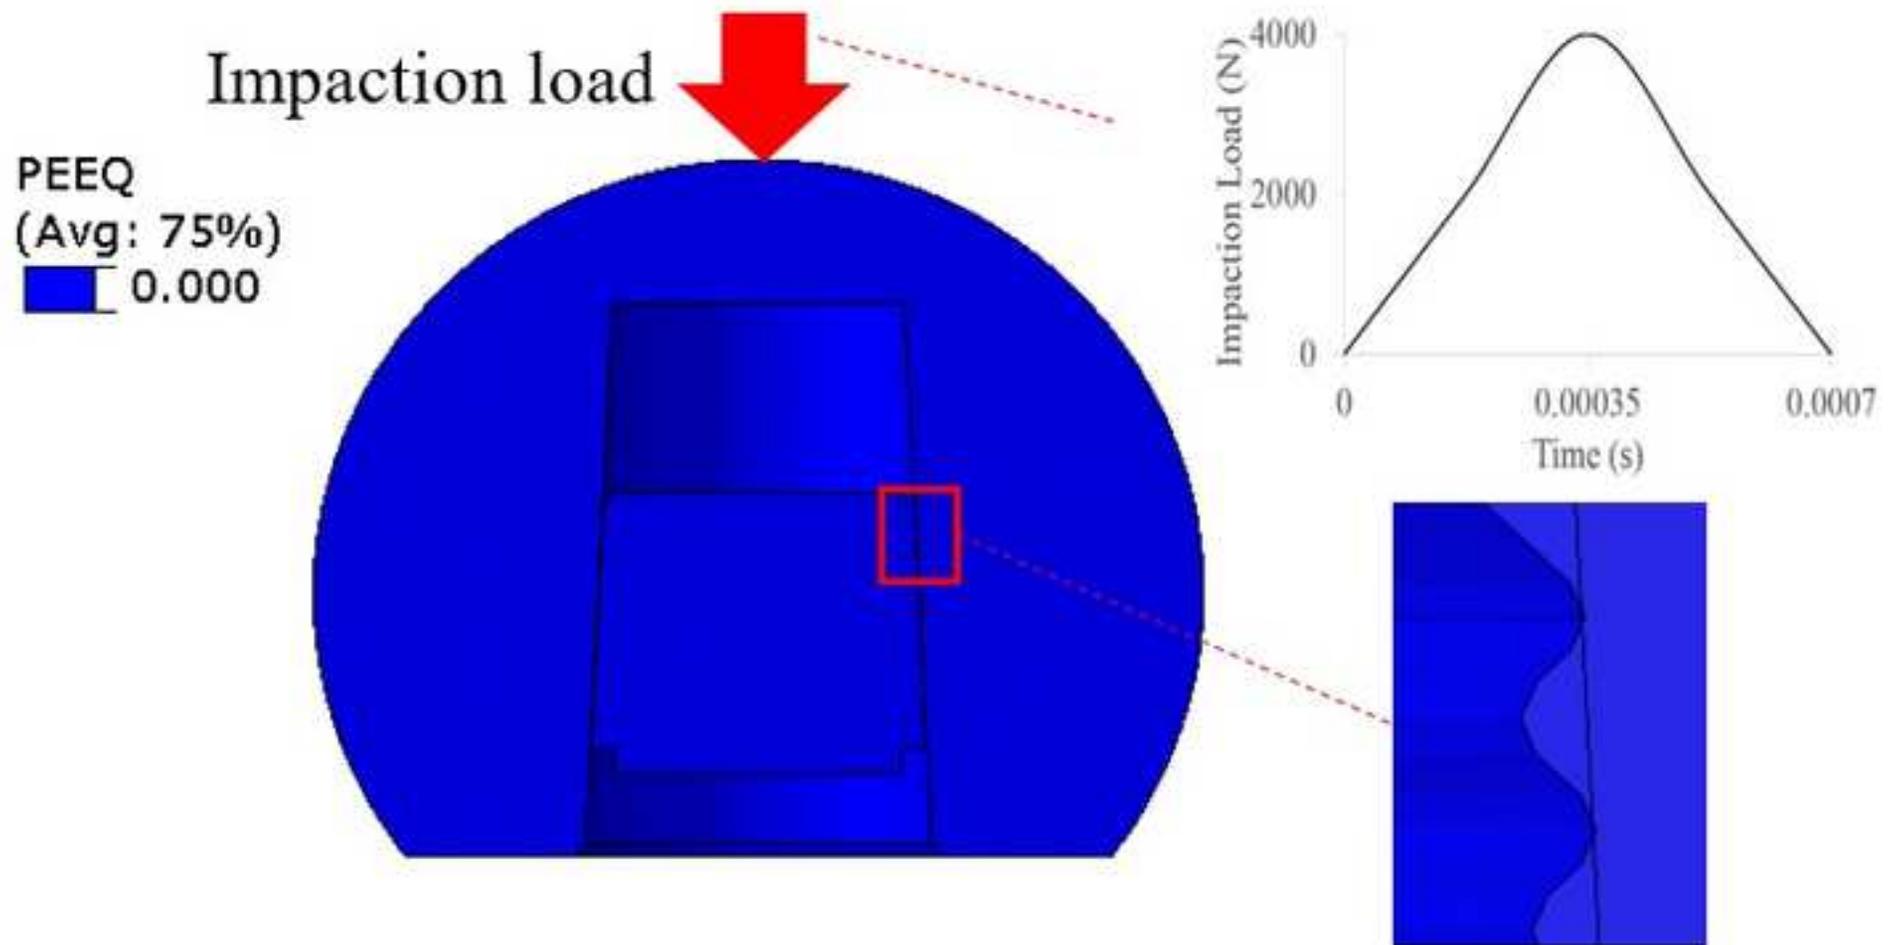
Figure 3: Equivalent Plastic Strain (PEEQ) showed no plastic deformation at the grooves of the femoral trunnion stem associated with FE initial impaction Elastic-Perfectly Plastic analysis

The impaction analysis was executed as a dynamic implicit analysis (see (English et al., 2016) and Figure 3 for full details). Furthermore, in this study, the plasticity included in the FE impaction analysis and simulated as an FE Elastic-Perfectly Plastic analysis, was undertaken to investigate whether any plastic deformation of the micro-grooves would occur due to the initial assembly force.

During the impact analysis, 4kN impact load with the load time history as shown in Figure 3 was applied on the top of the femoral head. The overall aim of machining grooves onto the stem trunnion stem is said to be that the grooves enhance the fixation at the taper junction (Munir et al., 2015). However, in this study, the result showed no Equivalent Plastic Strain (PEEQ, ABAQUS field output) as illustrated in Figure 3. Figure 6 details the contact pressure distributions along the trunnion surfaces. As expected, the maximum contact pressure was localised at the distal edge of the models due to the base-locked taper mismatches. The maximum contact pressures were approximately 196 and 385 MPa for smooth and micro-grooved trunnion surfaces respectively. These stresses illustrate that no plastic deformation could possibly occur based on the initial impact assembly load for CoCr/Ti material combination.

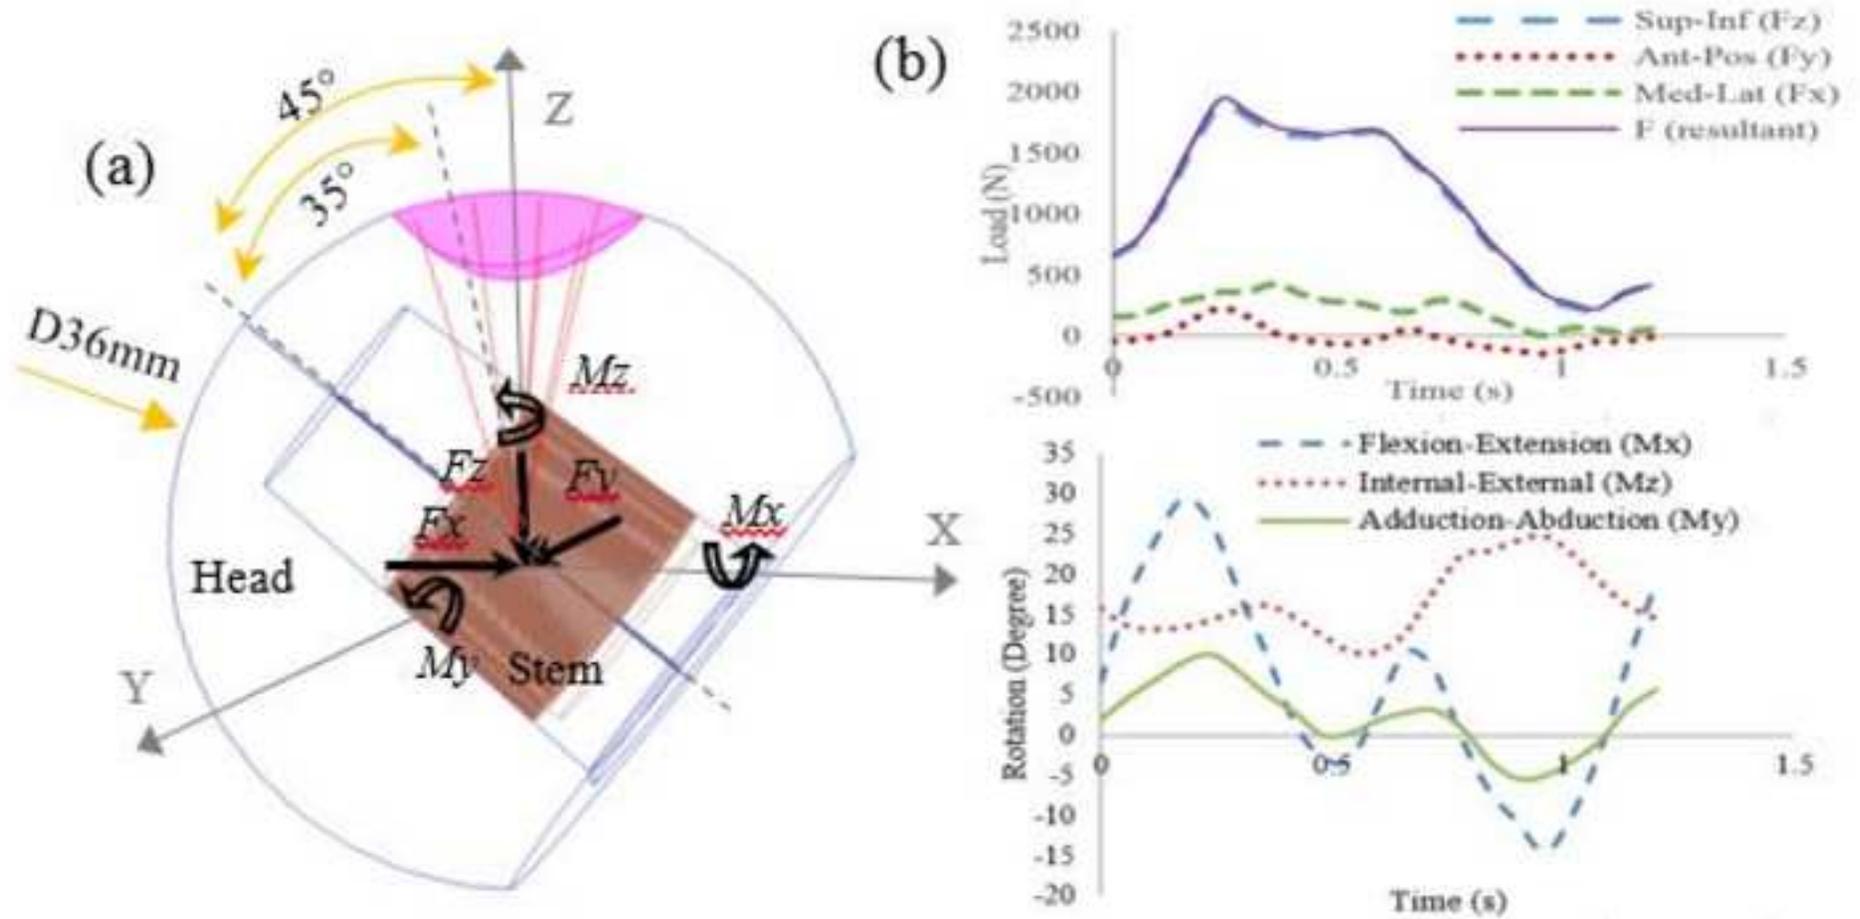
Figure 4: Schematic presentation of the finite element loading

The loads and rotations of a walking step were assigned on the models as shown in Figure 4 and described earlier in detail in (Ashkanfar et al., 2017). These loading and boundary conditions create an efficient and realistic walking simulation which was applied to a dynamic implicit analysis step discretised into 10 equal time intervals over a 1.2 s period.

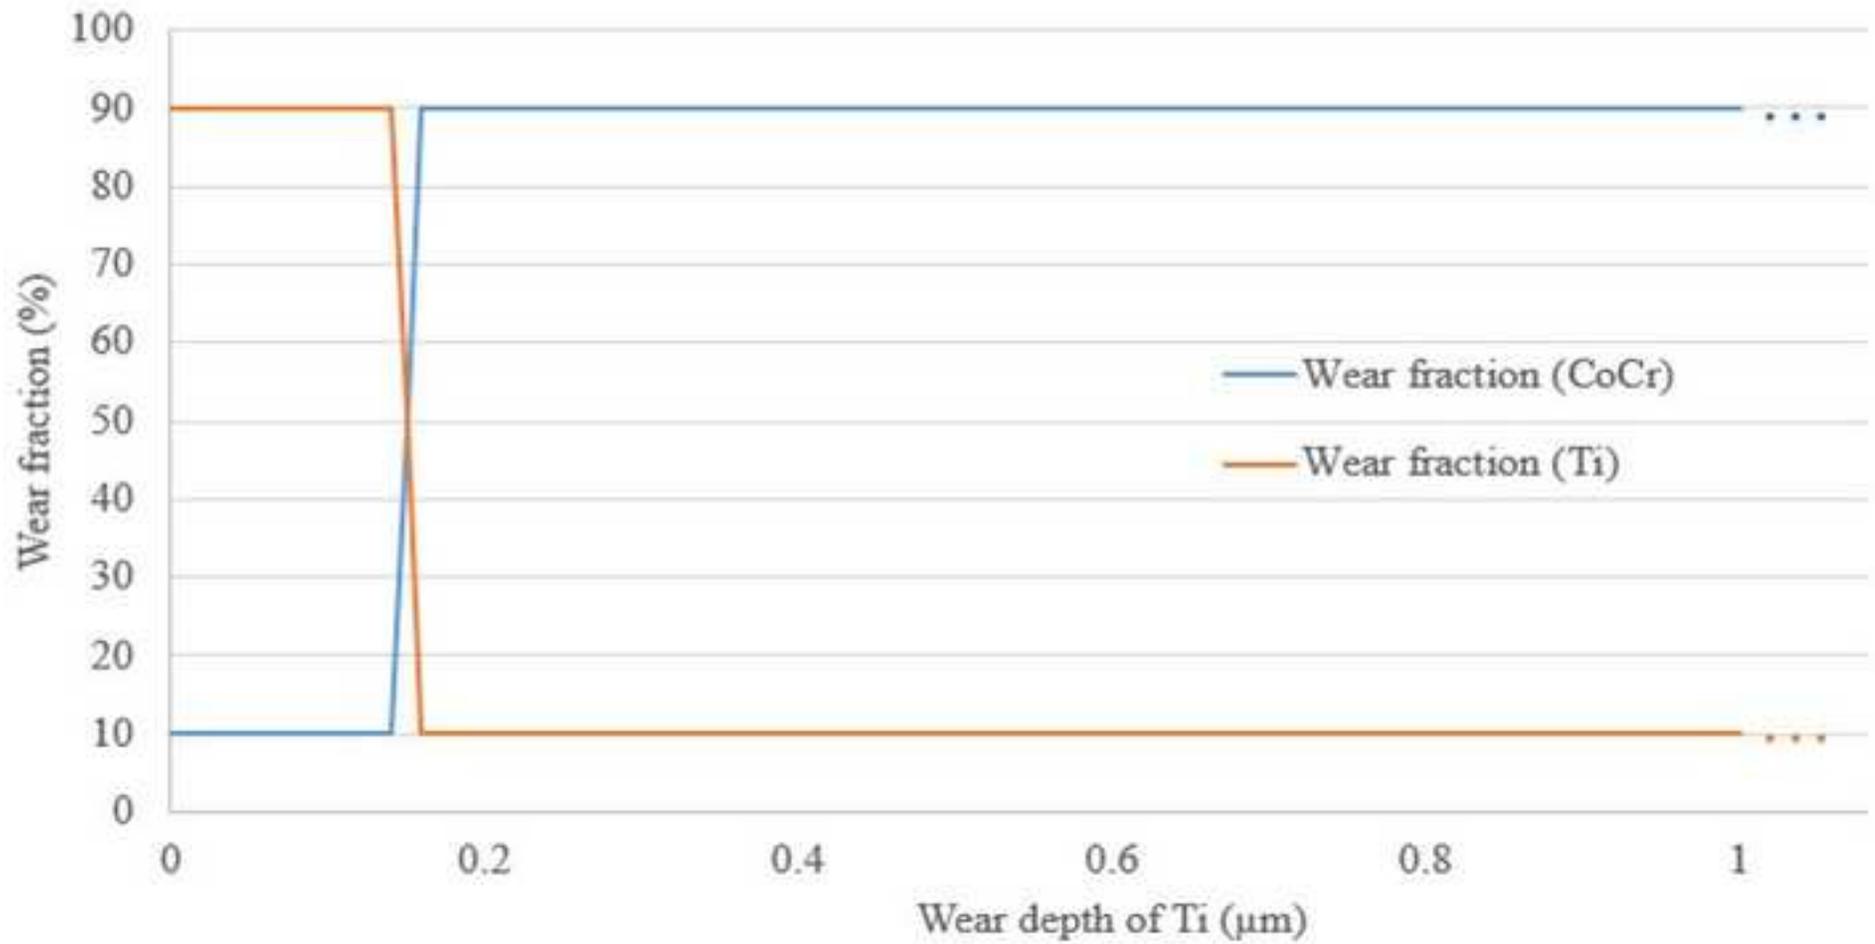
Figure 5: wear fraction between CoCr and Ti material combination over developed wear depths during the wearing procedure

“wear fraction” (English et al., 2015), depends on the specific materials being considered. The wear fraction for a CoCr femoral head and Ti trunnion material combination is mainly based on the theory of Ti hardening in-vivo (Moharrami et al., 2013). Put simply, at first, the Ti trunnion is worn by the harder CoCr head. However, over time an increasingly thick Ti oxide layer builds up. Once it reaches around 150 microns in depth, it has sufficient hardness at sufficient depth to begin to wear the CoCr alloy. This change in hardness, and thus wear, has been modelled computationally by varying the wear fraction during the wearing analysis as shown in Figure 5. While the concept of an apparently softer material wearing a harder material may seem counterintuitive, under fretting conditions (as would be the case in a taper-trunnion junction) such an effect has been seen in multiple tribological studies (Elleuch and Fouvry, 2005; Kayaba and Iwabuchi, 1981; Lemm et al., 2015; Varenberg et al., 2002). In such cases the differential wear has been attributed to “the formation of oxide debris which then became trapped in the contact area and embedded in the softer surface; the hard, embedded particles then abraded the harder” material (Lemm et al., 2015).

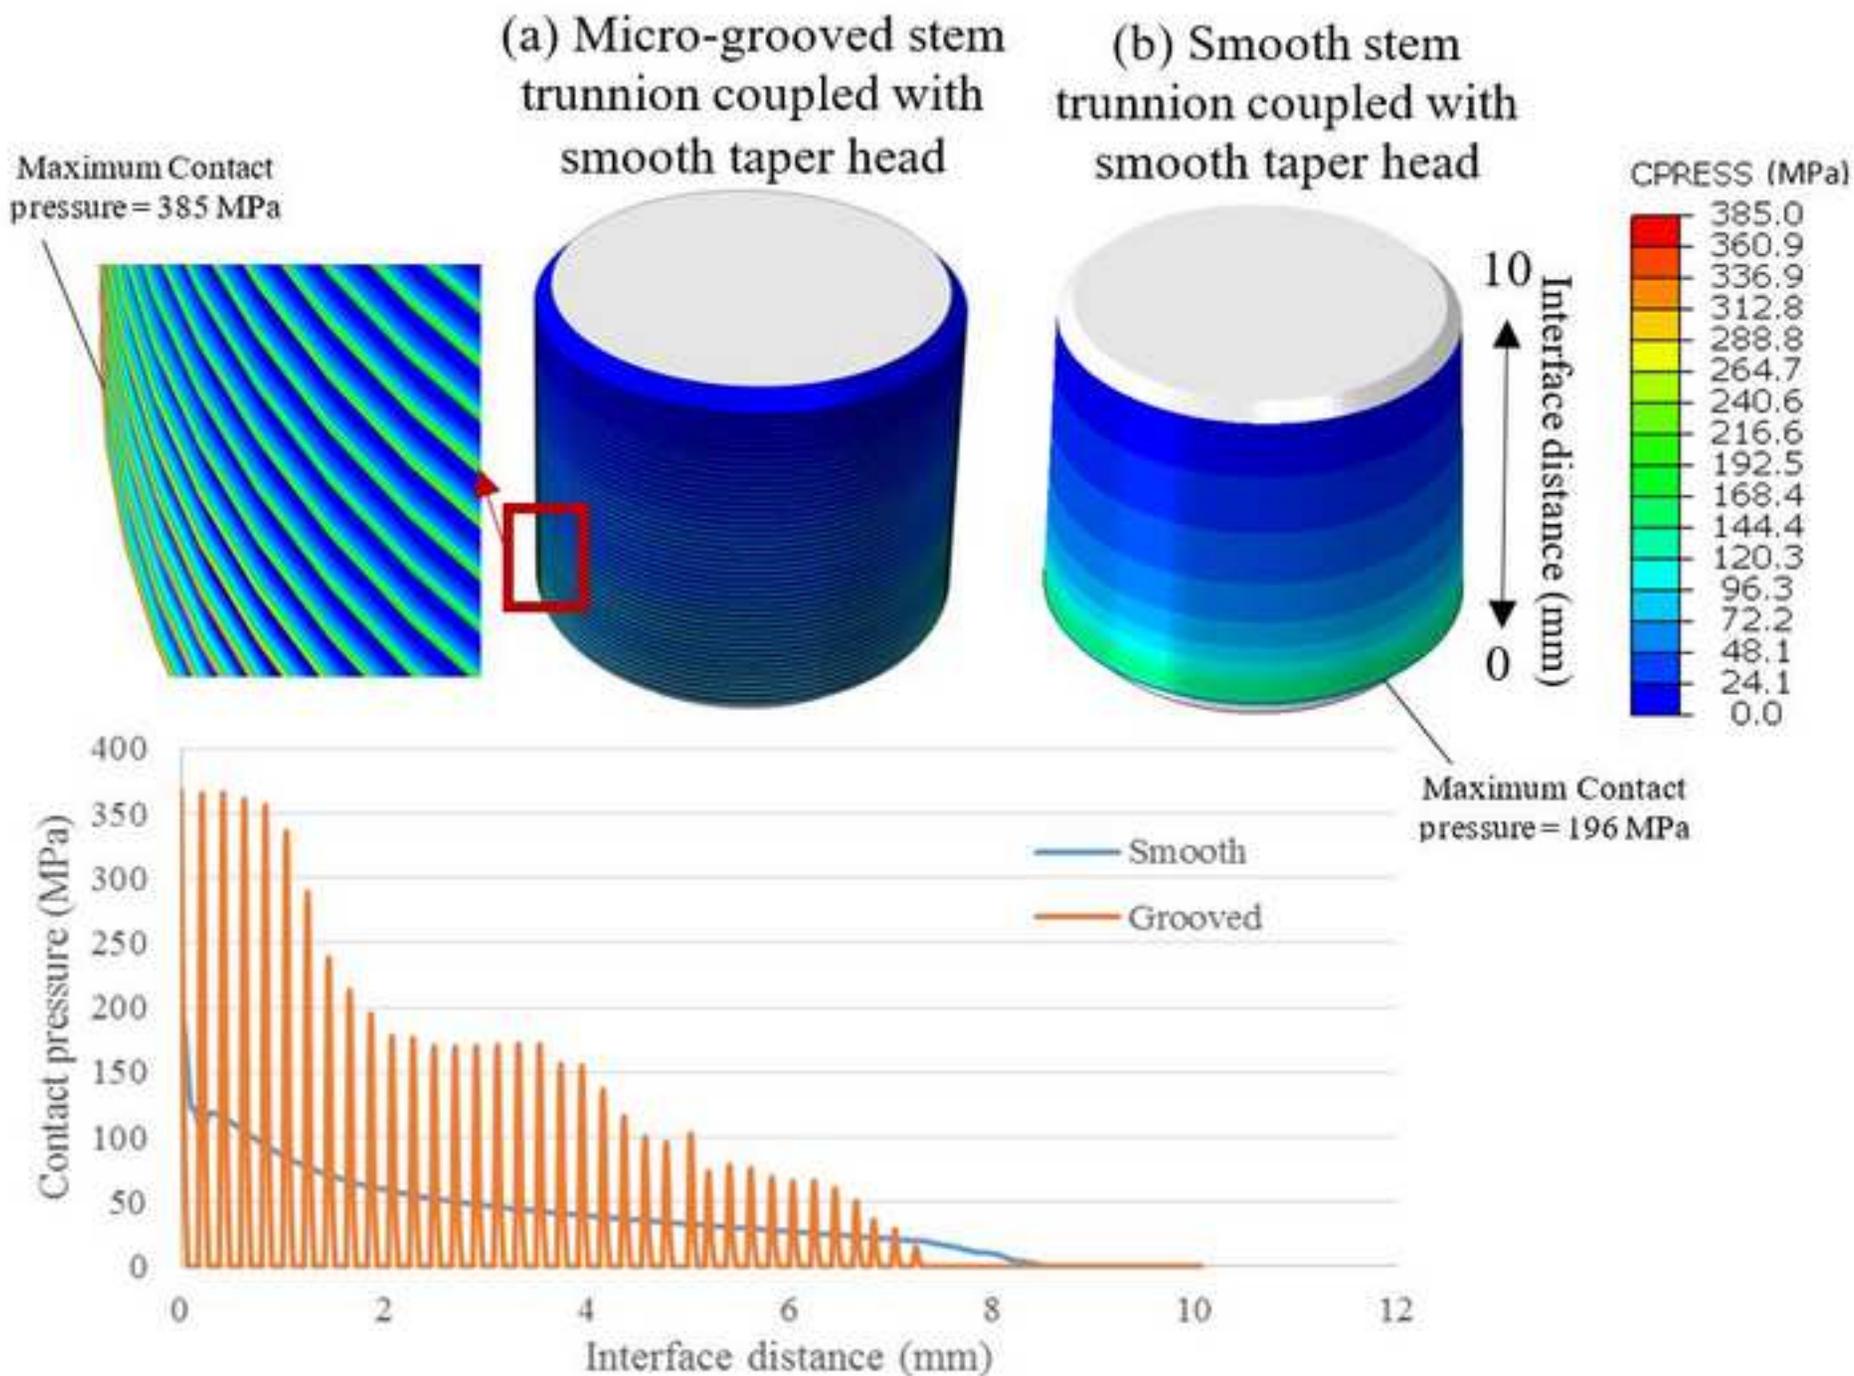
Figure 6: Contact pressure (CPRESS) distribution over the interface of the trunnion stem associated with the initial assembly impaction (4kN) for (a) micro-grooved and (b) smooth trunnion surfaces

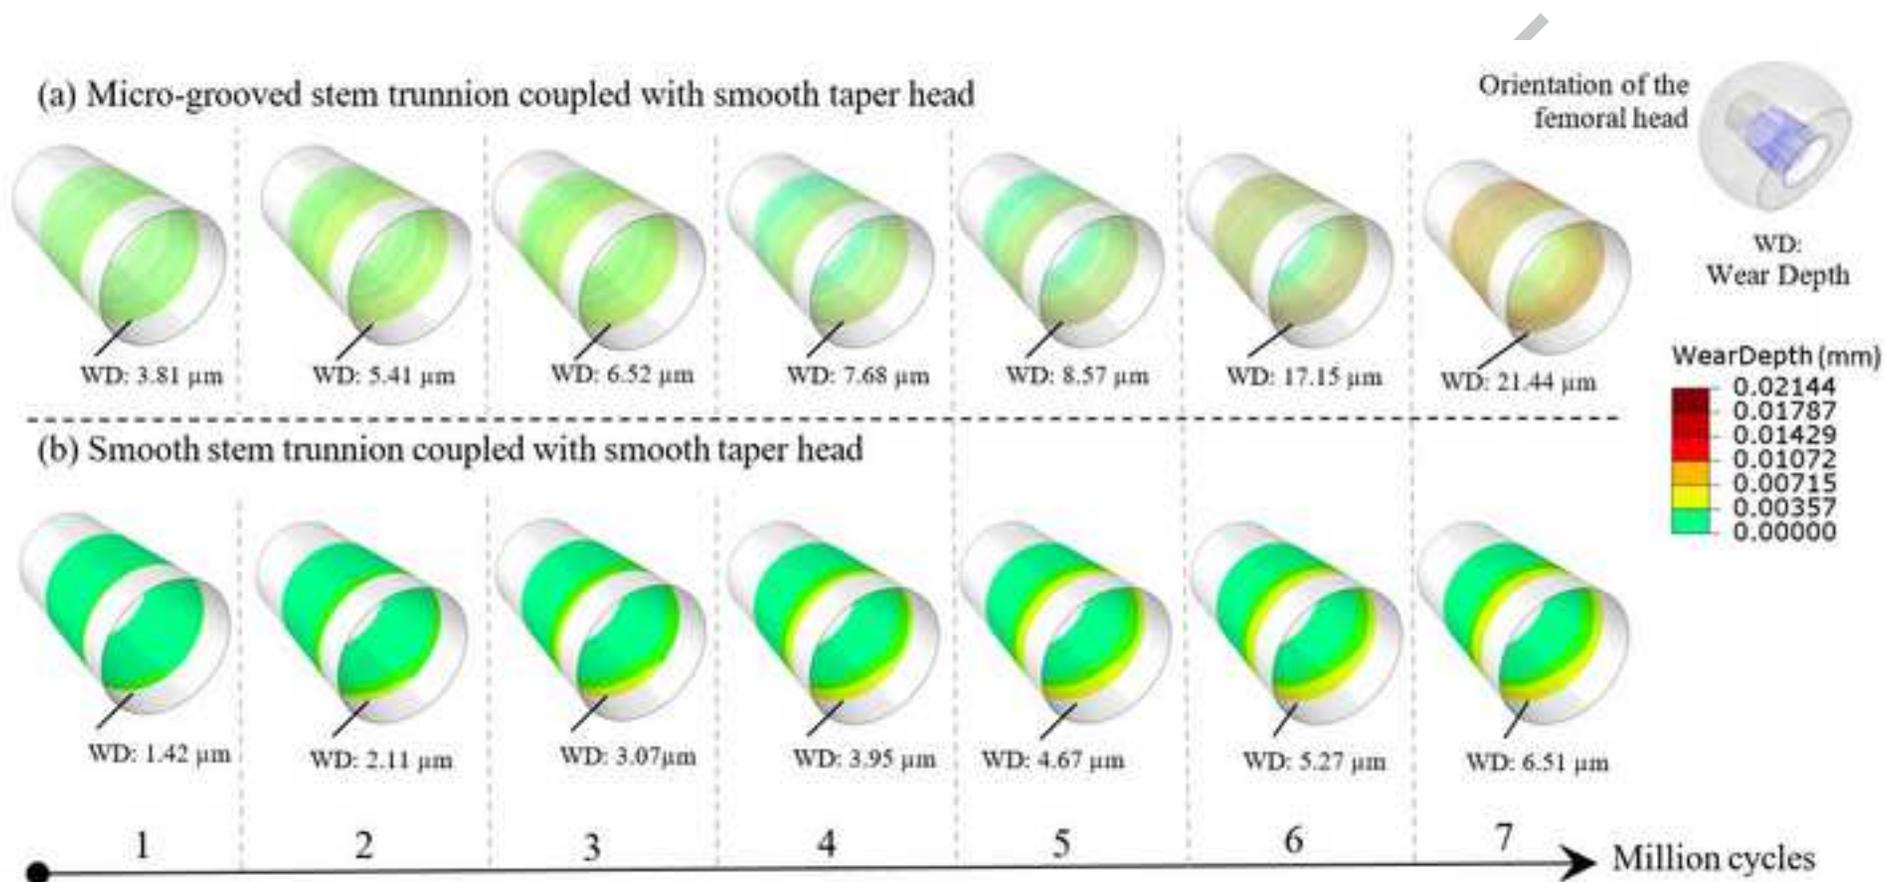
Figure 7: Evaluation of the wear pattern on the smooth head taper surfaces mated (a) with a micro-grooved and (b) with the smooth trunnion surface finish. Note that the specific wear depth (WD) values on the figure show the maximum wear depth at each stage of the analysis.

The evaluation of the wear damage over a 7 million load cycle period is shown in Figure 7, comparing the smooth femoral head taper surface coupled with micro-grooved (Figure 7a) and smooth (Figure 7b) trunnions. As expected the wear depth evolves for both cases as the wear analysis progresses.

Accelerated increases in the wear depth can be seen for the femoral head taper which was coupled with a micro-grooved trunnion after 5 million load cycles where the relative micromotion at the interface starts increasing rapidly. This increase in the micromotion continues until the femoral head starts rotating on the femoral stem with a much larger scale than fretting relative micromotion at 6.8 million load cycles. The maximum wear depth increases from a value around $8.57 \mu\text{m}$ at 5 million load cycles to $21.44 \mu\text{m}$ at 7 million load cycles (see Figure 7a). It should be noted that, as the sophisticated FEA model focussed on wear at the micro grooves with a resolution of 0.012 mm , so when the entire taper (approximately 10 mm long) is shown as an image, as in Figure 7, areas of red (maximum wear depth) become difficult to discern on this macro scale. For the femoral head coupled with a smooth trunnion (Figure 7b), however, the wear depth increases at the distal edge of the contact interface to approximately $6.51 \mu\text{m}$ at 7 million load cycles. The wear damage at the interface is distributed more uniformly and circumferentially at the femoral head taper (see Figure 7b). This lower wear depth, compared with the femoral head coupled with micro-grooved trunnion stem, is mainly due to having more area in contact and subsequently a larger interface. The larger interface allows better fixation which could maintain the relatively small amounts of micromotion for a larger number of load cycles.

As discussed, due to the Ti hardening *in-vivo*, which increases its hardness over the CoCr alloy, the CoCr alloy wears significantly more (Moharrami et al., 2013). In this study, the algorithm is able to consider the hardening of the Ti during the wearing analysis. As such, the harder micro-grooved trunnion stem imprints into the femoral surface as shown in Figure 7. Although this hardening happens for the smooth Ti trunnion stem as well, the surface damage is less extensive (see Figure 7).

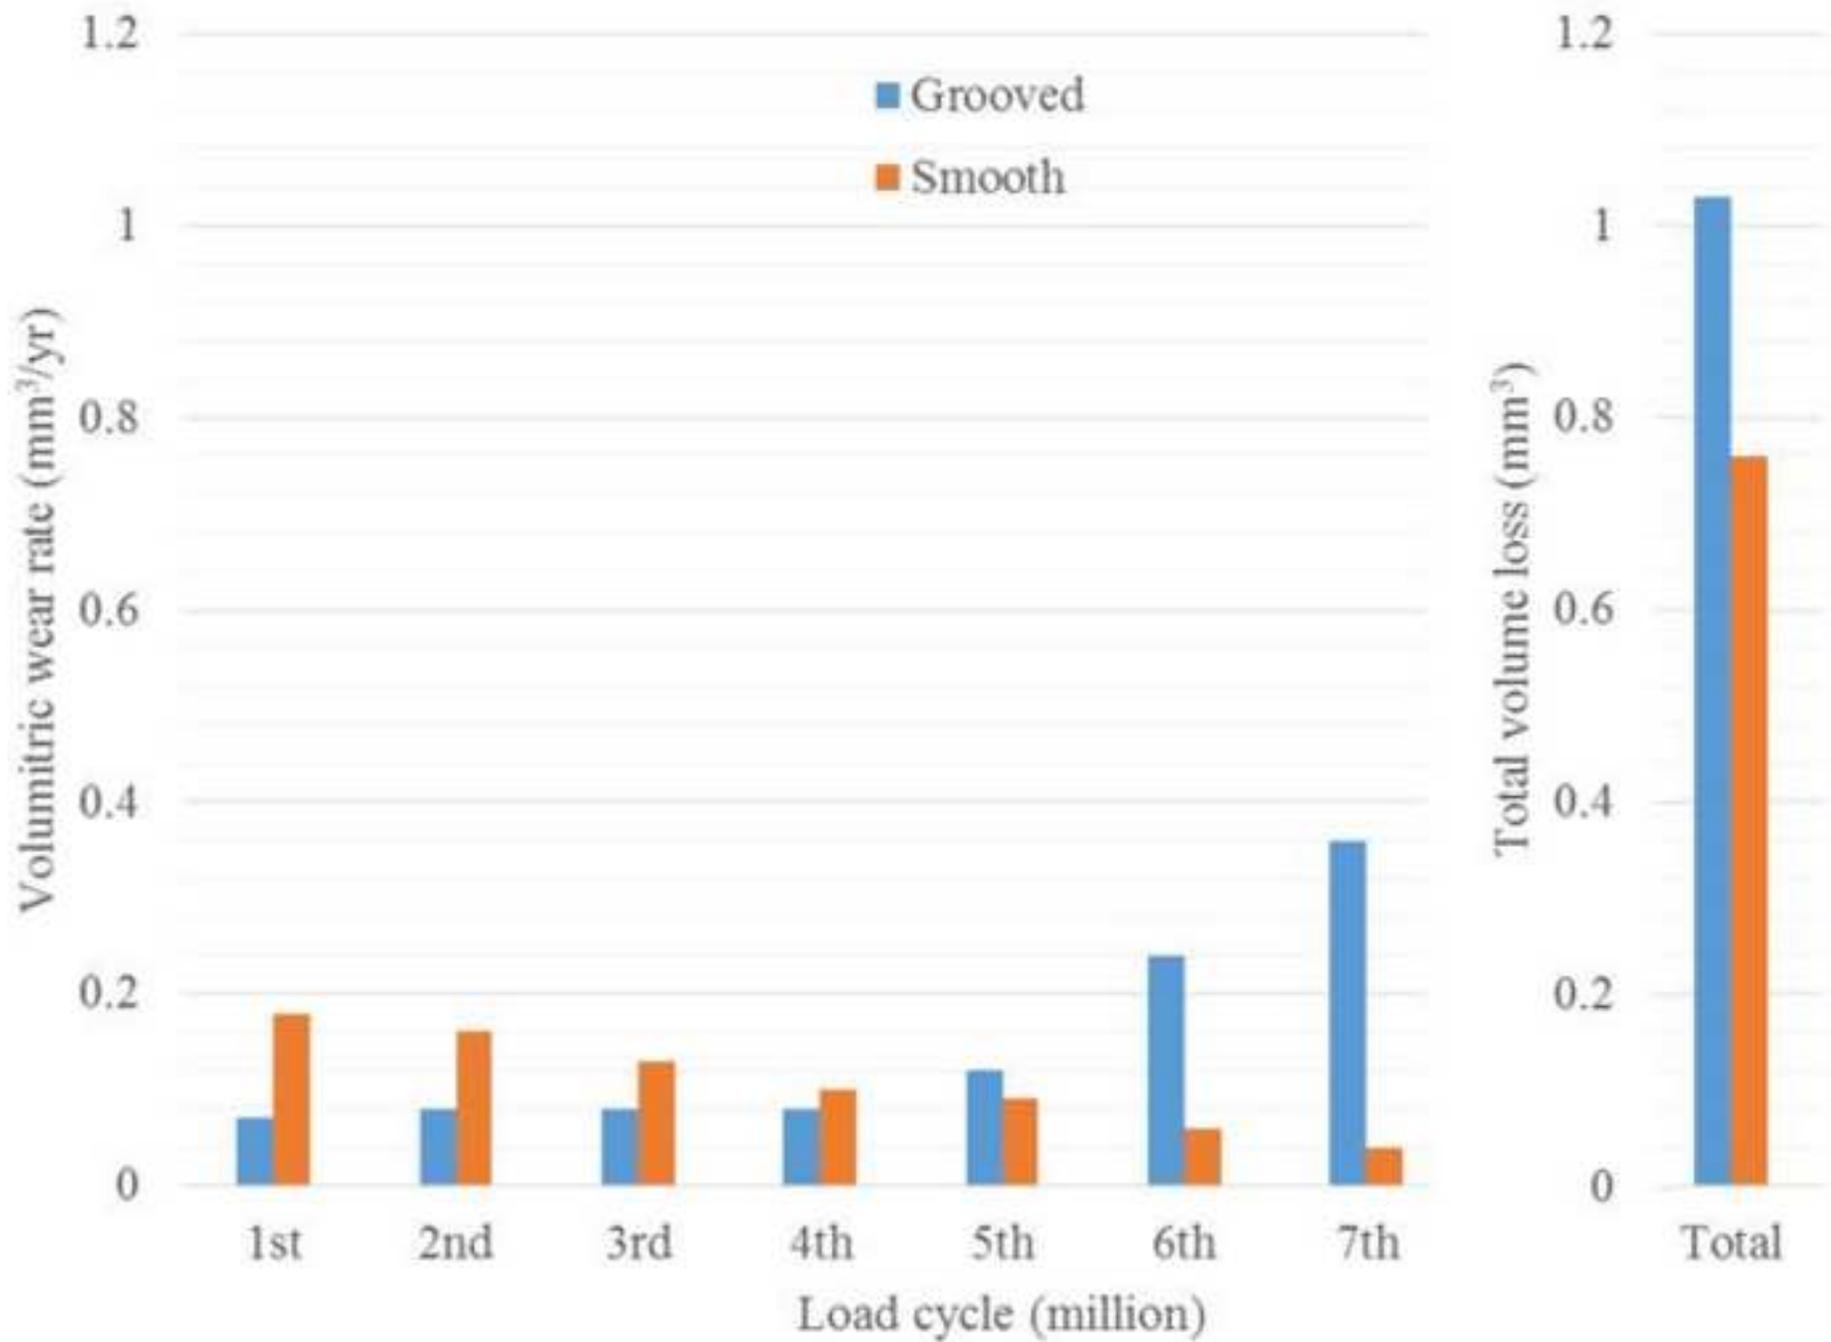
Figure 8: Volumetric wear rates and total volume loss over and after 7 million load cycles respectively

The volumetric wear rate over 7 million load cycles and the total volume loss are compared for both cases and are shown in Figure 8. For the head coupled with a micro-grooved stem trunnion, the volumetric wear rate is relatively constant over 4 million load cycles (approximately $0.08 \text{ mm}^3/\text{yr}$) and then rapidly increases to 0.12 , 0.24 and $0.36 \text{ mm}^3/\text{yr}$ over years 5, 6 and 7 respectively. This increase in the volumetric wear rate is due to the effect of loss of fixation which leads to a rapid increase in the relative micromotion and thus the material loss. The total volume loss is around 1.03 mm^3 over 7 million load cycles. It can be seen in Figure 8 that the initial wear rates for the head coupled with a smooth trunnion surface are slightly higher than the head coupled with a micro-grooved trunnion surface ($0.19 \text{ mm}^3/\text{yr}$) as a smooth taper-trunnion coupling provides a greater surface contact area. Although these initial wear rates are higher, the fixation is better maintained over time at the

taper junction. As the micromotion is maintained at its lower extent over a longer period of time the contact stress at the interface reduces slightly and this causes a reduction in the wear rates gradually over time (to around $0.04 \text{ mm}^3/\text{yr}$ at 7 million load cycle). The total volume loss over 7 million load cycle is 0.76 mm^3 .

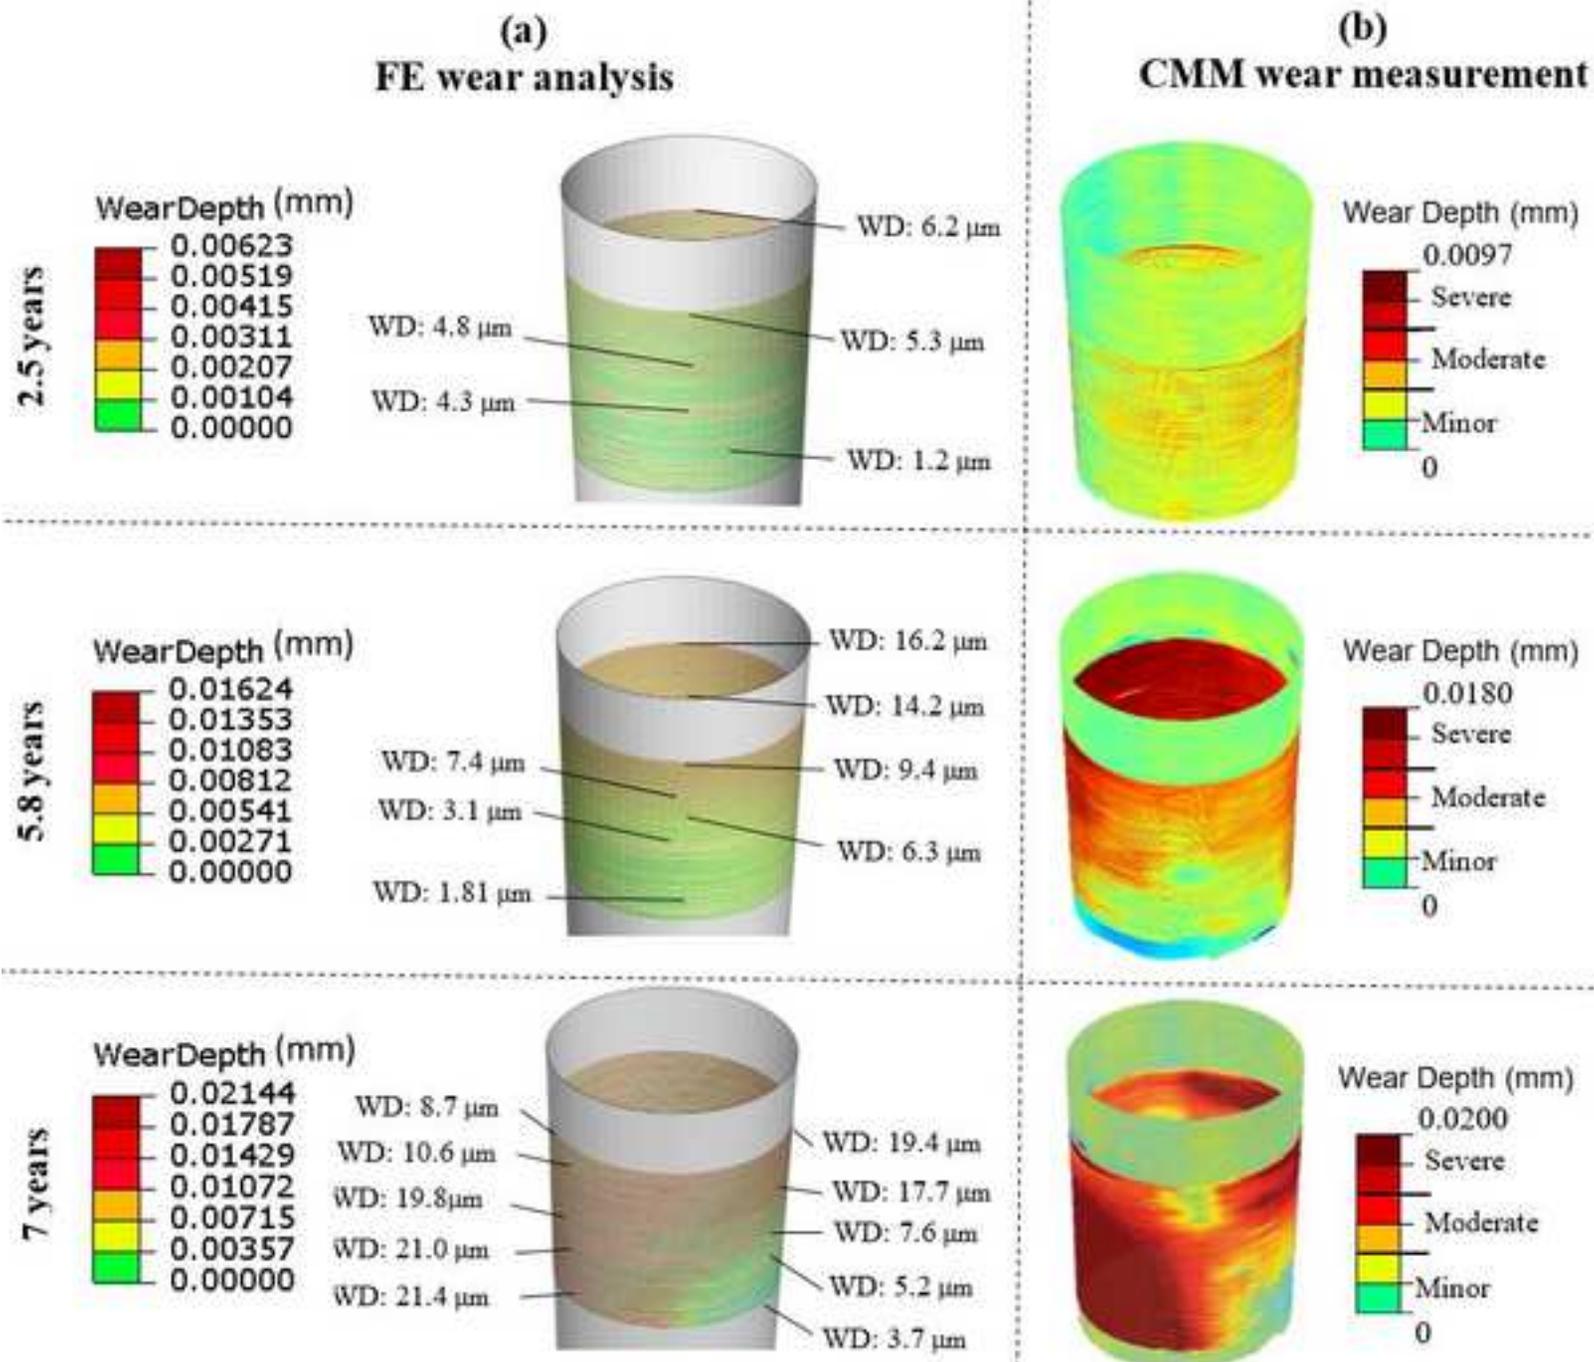
Figure 9: 36mm CoCr femoral head taper mated with Corail micro-grooved stem trunnion; (a) Finite Element analysis and (b) CMM wear measurement. Note that, the specific wear depth (WD) values have been added to help show the similarity in wear results between the FEA and CMM analyses.

Figure 9 compares the computational FE wear pattern damage obtained in this study with CMM measurements of wear damage at the retrieved femoral taper surfaces. The FE wear model could be analysed at specific points (i.e. 2.5 million cycles) to allow a direct comparison with a specific hip implant's time *in vivo* (i.e. 2.5 years). It can be seen in Figure 9 that the wear depths obtained computationally compare favourably with the CMM measurements for explants retrieved at 2.5, 5.8 and 7.0 years. Once again, note that due to the fine mesh size (0.012mm) of the FEA model, and the localised material removal from microgrooves, once the image is scaled up to show an entire taper, so areas of red (maximum wear depth) become difficult to discern on the FEA image. The average volumetric wear rate for the hip explants obtained from the CMM was $0.28 \text{ mm}^3/\text{yr}$, (range 0.04 to $1.67 \text{ mm}^3/\text{yr}$), while that from the FEA model was $0.26 \text{ mm}^3/\text{million cycles}$ (figure 8). The close similarities shown between the numerical analysis and measured wear damage of retrieved prostheses

demonstrates the effectiveness of the 3D FE wear model, the chosen loading and boundary conditions, and the wear algorithm; therefore, the computational analysis is validated.
