Preliminary approach to bio-based surface healing of structural repair cement mortars

Van Der Bergh, JM, Miljević, B, Šovljanski, O, Vučetić, S, Markov, S, Ranogajec, J and Armada Bras, AM (2020) Preliminary approach to bio-based surface healing of structural repair cement mortars. Construction and Building Materials. 248. ISSN 0950-0618

Bio-based surface healing of structural repair cement mortars

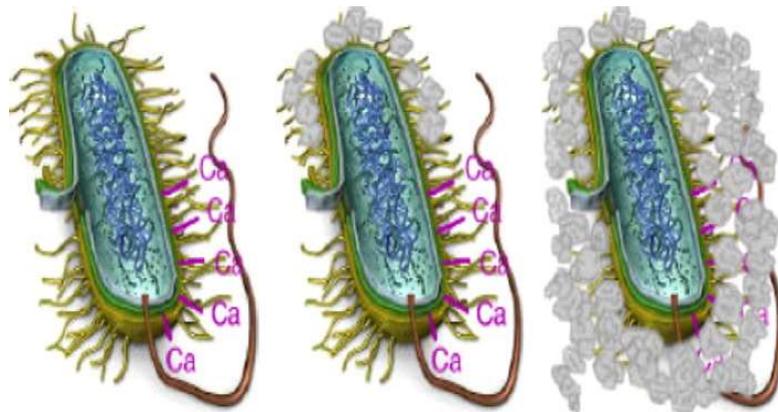
Figure 1 - Bacteria as nucleation sites for calcium-carbonate precipitation [30].

Apart from metabolic production of carbonate ions and consequential CaCO_3 formation, bacteria can also induce the precipitation of the calcite by acting as nucleation sites. Namely, the bacterial cell wall contains negatively charged groups due to which calcium cations can bond to it. Afterwards this bonded calcium reacts with carbonate to form CaCO_3 [29] (Fig. 1).

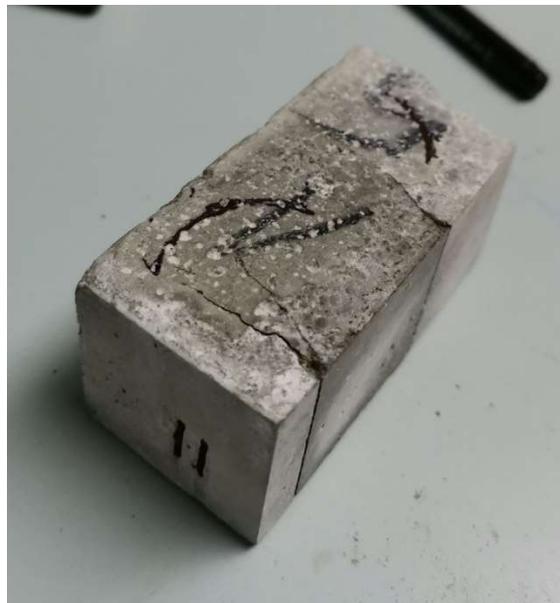
Figure 2 – Cement mortar beam with developed cracks after flexural testing.

In total, 11 Portland cement mortar CEM I 42.5 beams (with standard dimensions: 4 cm x 4 cm x 16 cm) were prepared according to standard EN 196-1 (Methods of testing cement – Part 1: Determination of strength [33]) and cured for 28 days. Table 1 shows the composition of mortar beams. The beams were then subjected to flexural strength test in accordance with the same standard during which 2 cracks were developed at the sites of point loading on each mortar beam. These cracks were the subject of external healing repair (in 6 out of 11 mortars) as described in 2.2. It should be noted that the samples investigated were actually the remaining parts of the original beams, which had various dimensions after the beams were broken by the flexural testing. Figure 2 shows an example of mortar following exposure to the flexural test.

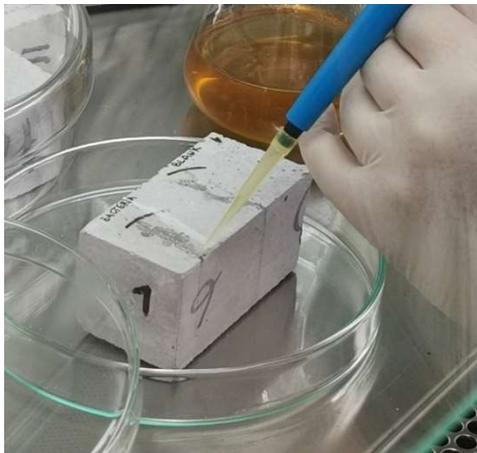
Figure 3 - Application of bio-agent to the 'bacteria' crack ('blank' crack can be seen to the right).

Every mortar beam sample selected for external healing testing had 2 relatively prominent cracks on the lateral sides in regard to the side that was in contact with the flexural strength measuring device (points of loading). On both of these cracks 100 µL of nutrient solution was applied by dropping, using a sterile micropipette. Then, on one of the cracks (marked 'bacteria', Fig. 3) 100 µL of bacterial suspension was dropped, and on the other (marked 'blank', Fig. 3) 100 µL of sterile distilled water was dropped and the process was repeated for all 6 samples. This was done in order to visually compare the differences in carbonate precipitation with and without bacterial culture on the exact same sample. After the application of bio-agent and blank suspensions, the beams were put in a dish filled with distilled water up to 1/3 of the beams' height (the side with the treated cracks being on top) and incubated at 30 °C for 21 days. The non-bio samples were kept in the same conditions as the bio samples.

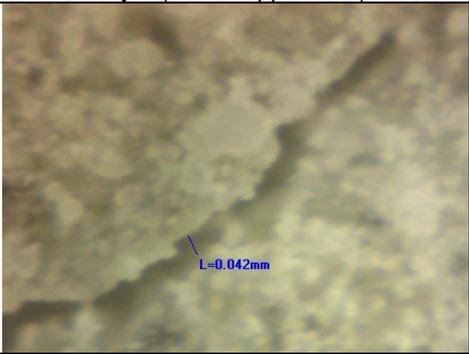
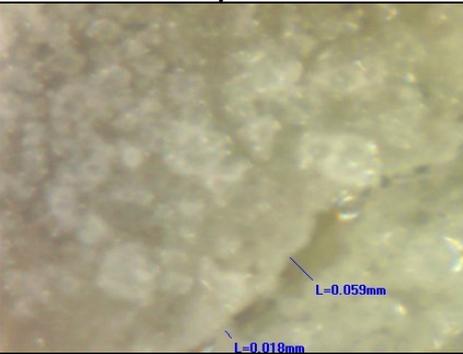
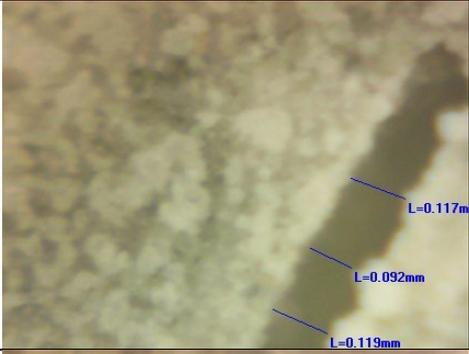
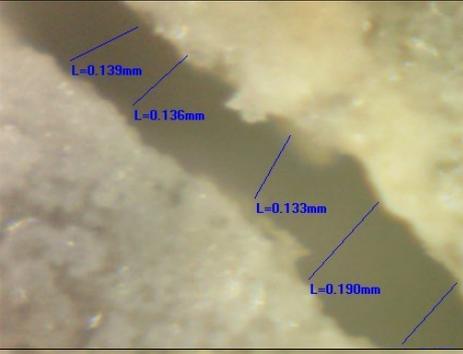
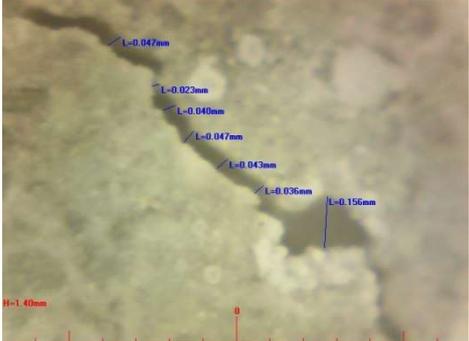
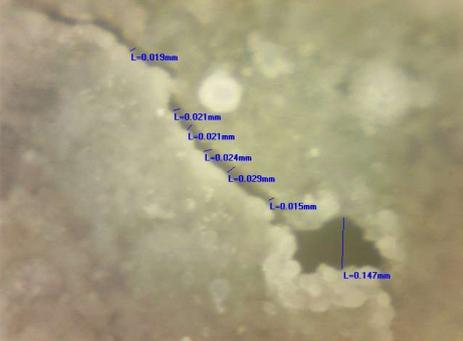
Table 2 - Images of cracks on bio and non-bio samples.

Table 2 shows selected images of cracks before application of the repair bio-agent – day 0 – ('bacteria' cracks) and 21 days after the application. 'Blank' cracks are also shown for comparison.

Images of 'bacteria' cracks show what seems to be the initial stage of microbiologically induced calcite precipitation. This preliminary evaluation is based on noticed morphology of the cracks before and after the treatment and on measurements of the crack widths. Although microscope and software used had technical limitations in regard to precision of the measurements, it can be noticed that the crack widths reduced in size between 20 and 40%. On the other hand, in most of the 'blank' cracks there are no observable reduction of widths, and there is even some increase of widths, probably due to sample handling.

Non-bio samples showed various phenomena regarding the cracks. It can be noticed that autogenous healing took place on some of the cracks, but it is non-systematic. Some of the cracks almost completely filled up and

some were almost unaffected. It could be concluded that the autogenous healing depended on the locally developed micro-conditions.

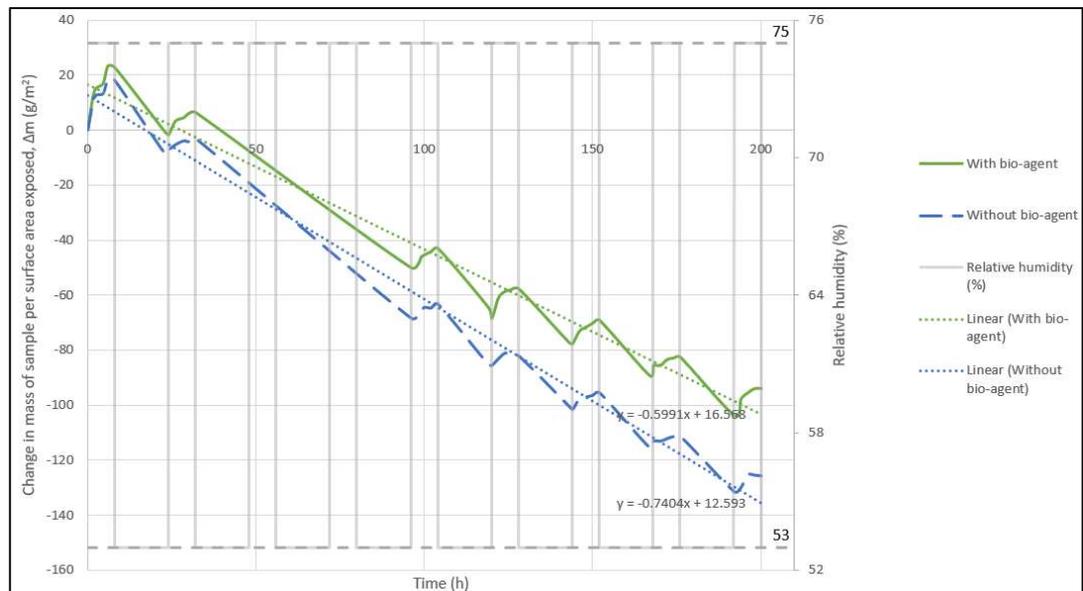
Figure 4 - Adsorption/desorption graphs for samples with and without bio-agent applied, after 1 month.

The Fig. 4 shows that the change of mass of material follows change of humidity in the testing chamber. After 18 h of experiment non-bio mortar's mass change went into negative. Same thing happened only after 40 h in case of bio mortar which indicates different porous structure of the two materials. It took longer time for bio mortar to lose mass (i.e. the trapped water) due to desorption phenomena, which can be explained by a more complex internal porous structure developed by the bio-agent. Different behaviour is also evident from the slope values of respective trend lines for each graph (-0.599 and -0.740 for bio and non-bio mortar, respectively). The results show that there is a decrease of the impact of moisture cyclic change by 20% for the bio mortars in comparison with the conventional ones. Desorption phenomena are clearly the more dominant factor in the mass change of both materials, as can be seen from the graphs which have general downward trend. However, cement mortar with bio agent is less affected by the change of environmental humidity in respect to the non-bio mortar – the adsorption and desorption phenomena (shown as change of mass per surface area) are generally less expressed. Further study should prolong the experiment to determine the final mass change and the behaviour differences of respective materials after final stabilisation.

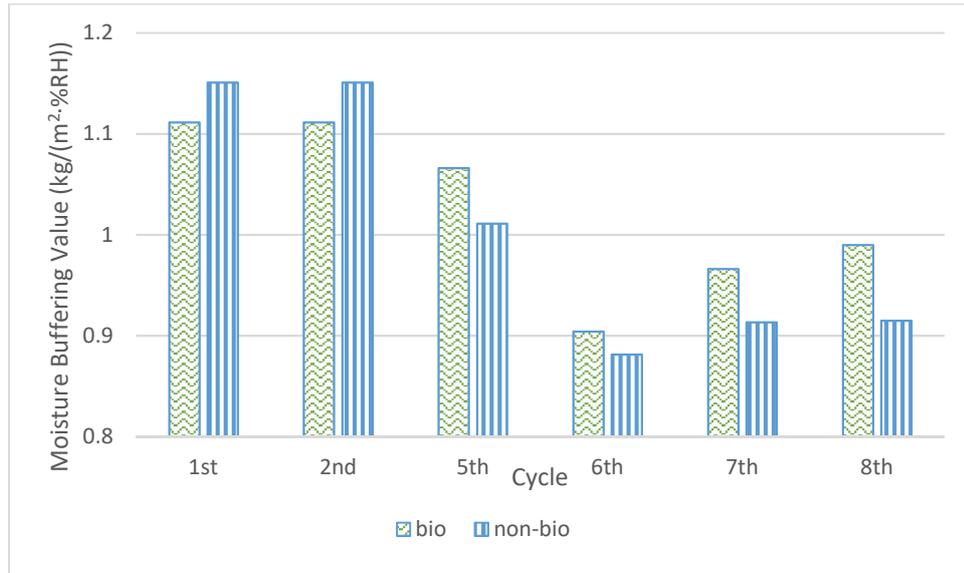
Figure 5 - Moisture buffering values of bio and non-bio cement mortars, after 1 month.

Moisture buffering value (MBV) is a quantitative representation of a material’s ability to absorb and desorb water vapour from the air when the air humidity is high and low, respectively. It is generally a desirable property for a material to have high MBV. Fig. 5 shows that MBVs for both types of mortars are at least 15% higher in the first 2 days of cycles. After the 2nd cycle, there is a switch in the MBVs, where MBVs for bio mortars tend to be 3% to 7% bigger than for non-bio mortars. This could be associated with the time needed for bacterial precipitation. It is also noticed that there is a general rising trend of MB values for bio samples from the 6th cycle onwards, while the values for non-bio samples are comparatively lower and stagnating. Based on classification given by Rode *et al.* [36] the tested samples can be categorised as ‘Good’ (MBV 0.8 to 1.0). Further study should encompass longer exposure of samples to the humidity cycles in the testing chamber in order to determine the final MBV improvement of the bio samples.

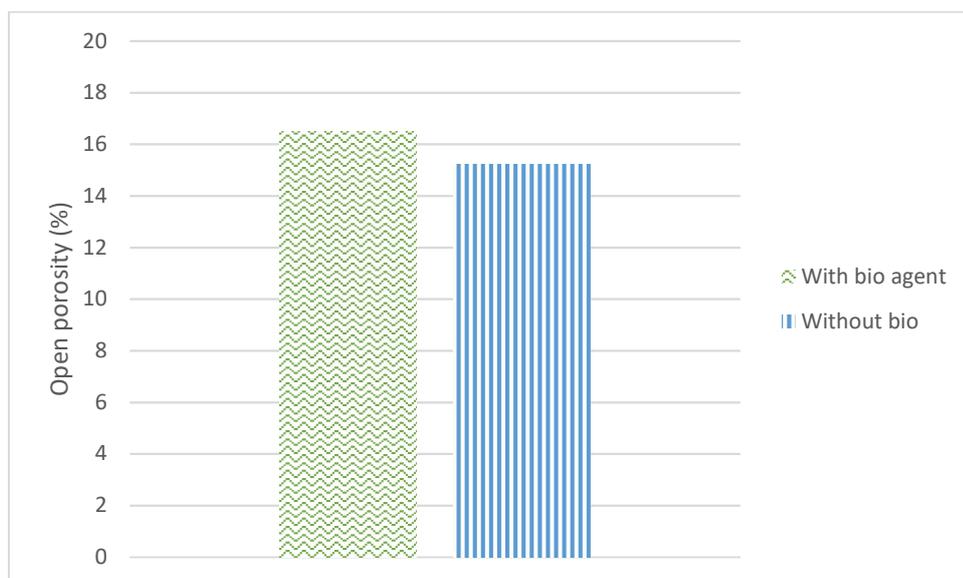
Figure 6 - Average open porosity of the selected samples with and without bioagent, after 2 months (coefficient of variation obtained for the bio mortars was 2% and for the non-bio mortar was 1.5%).

Fig. 6 shows that open porosity of the bio-samples is somewhat larger than samples without bioagent applied. However, the results are quite similar (16% and 15%) indicating that this test is not adequate, at least for the first 2 months after mortar preparation. Probably, the newly formed carbonate bridges were not yet sufficiently stable relative to the surrounding cement matrix and were washed out with the water used as a measuring fluid.

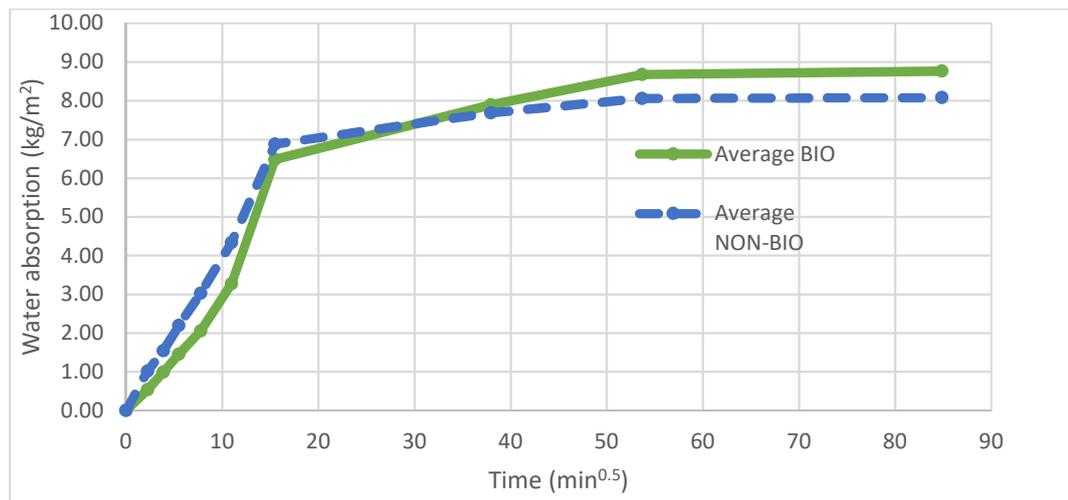
Figure 7 - Capillary action curve for bio and non-bio cement mortar samples, after 2 months.

Fig. 7 shows the average values of capillary action curves for bio and non-bio samples. Initial water absorption is generally lower for the bio samples than the non-bio samples, which is a desirable result. Only after 900 min of testing does the water absorption of the bio samples become somewhat higher than non-bio samples. This presents an interesting result as it is obvious that the bio-agent affected the initial stage of the capillary absorption in a positive way (i.e. preventing water migration) but had little effect afterwards, when the samples tend to become saturated. From practical point of view, the behaviour presented in the first part of the capillary curve (water absorption in a non-saturated medium) is associated with the behaviour of a maritime structure area exposed to the tidal-splash. The second region of the curve is related to a saturated medium as it happens in structures under water. Therefore, it seems that this bioproduct presents benefits to minimise migration of water-soluble ions in tidal-splash zones.

It is known that *S. pasteurii* favours oxygen, so it can be presumed that the highest activity was at the surface, which may be related with the obtained results – capillary action was impeded by the microstructure formed near the surface. To completely explain this phenomenon further study is required.

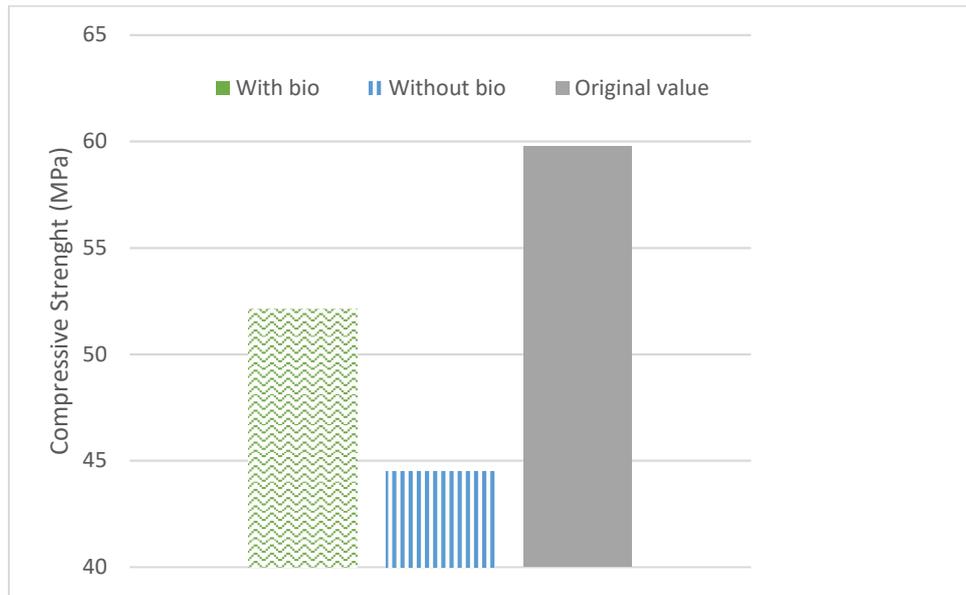
Figure 8 - Compressive strength values of bio (waving lines) and non-bio cement mortar (vertical lines) samples after 2 months, and original value of the samples after 1 month.

The 'original value' of the samples seen on Fig. 8 represents the compressive strength value of the cement mortar samples obtained after 28 days of curing. It represents the average value for all samples, to some of which the bio-agent was added afterwards (as described in 2. Materials and Methods). The bio mortar samples showed remarkable recovery of compressive strength of over 87% (52.14 MPa out of original 59.77 MPa), while the non-bio samples presented only 74% of the original value (44.50 MPa). Coefficient of variation was well within tolerated values for building materials (4% for bio and 9% for non-bio).

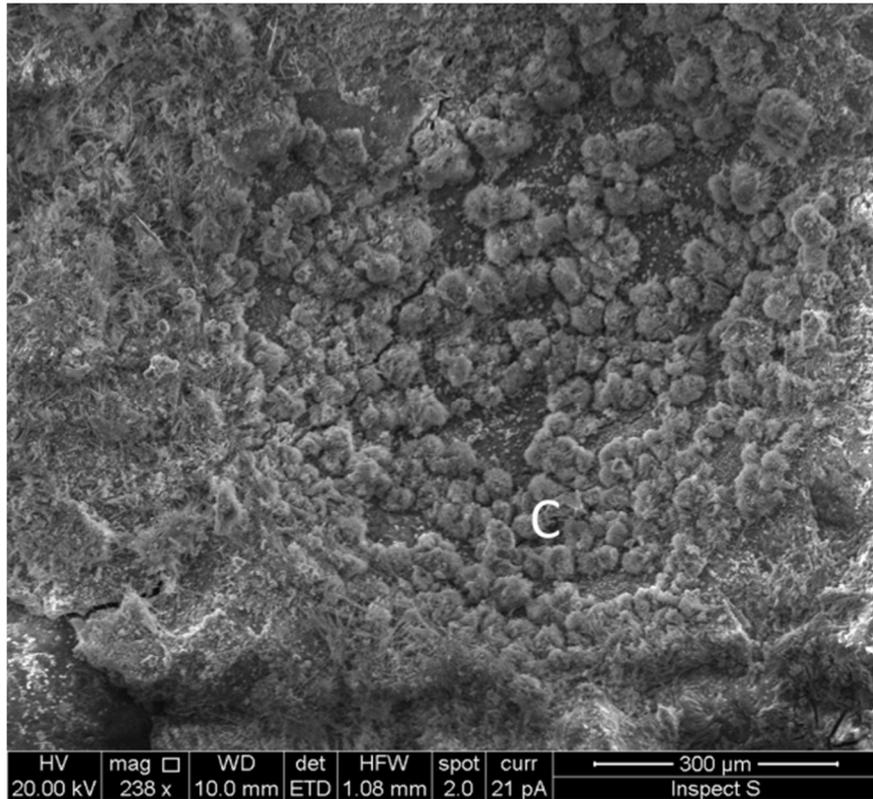
Figure 9 - SEM image of 'bacteria' crack cross-section, magnification 238 x.

Fig. 9 ('bacteria' crack sample) shows typical morphology ascribed to calcite – grainy crystals, which are absent from 'blank' and 'non-bio' samples. Fig. 10 ('bacteria' crack sample) shows what appear to be bacterial spores (marked with purple circles and letter S). As it is hard to claim that these are in fact spores (Without new-born CaCO_3 crystals in surrounding, these spherical forms can be bacterial spores which were not metabolically active during incubation time), a good indication toward that statement is the fact that there were no similar morphologies detected inside the cracks where no bio-agent was applied. The same micrograph also show forms typical for ettringite (blue marker and letter E) and calcium silicate hydrates (red marker and letters CSH) [37]. It should be noted that the hydration products are much more prominent inside the 'bacteria' crack sample than in other samples, which could be a positive side-effect of bio-agent application and explains the better mechanical characteristics of the bio samples. Furthermore, calcite crystal and an amorphous film, most likely bacterial biofilm, can be seen in Fig. 11 (marked with white marker and letter C, and green arrow and letter B respectively). Figures 12 and 13 show 'blank' and 'non-bio' samples, where absence of calcite phase is obvious. Observed morphologies of these samples are remarkably similar to control samples of cement mortar found in literature (e.g. [38]).

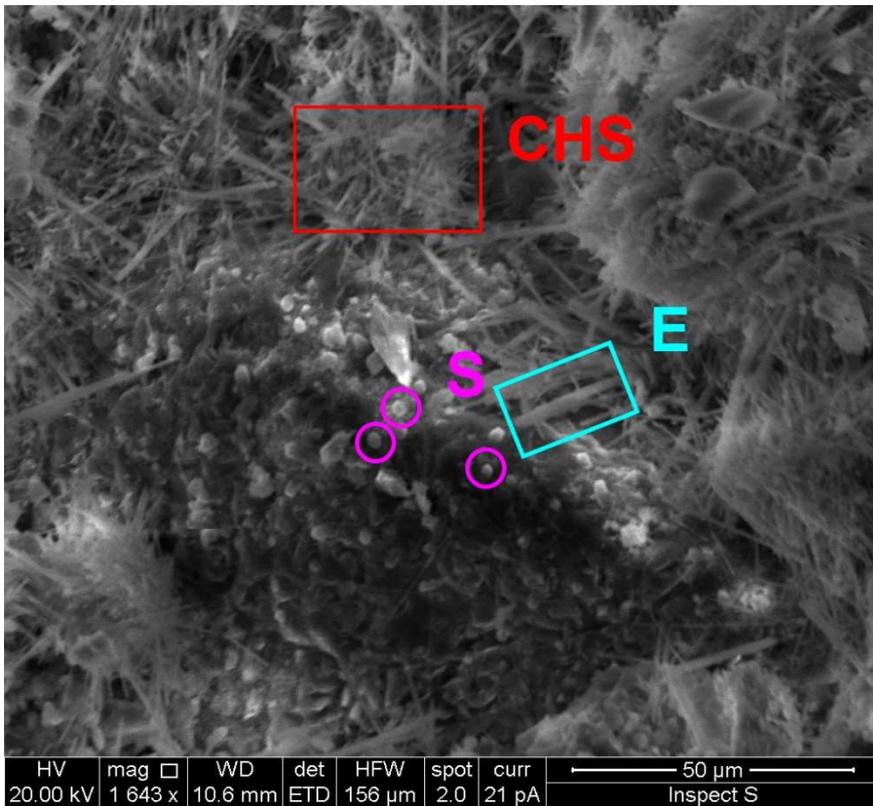
Figure 10 - SEM image of 'bacteria' crack cross-section, magnification 1643 x.

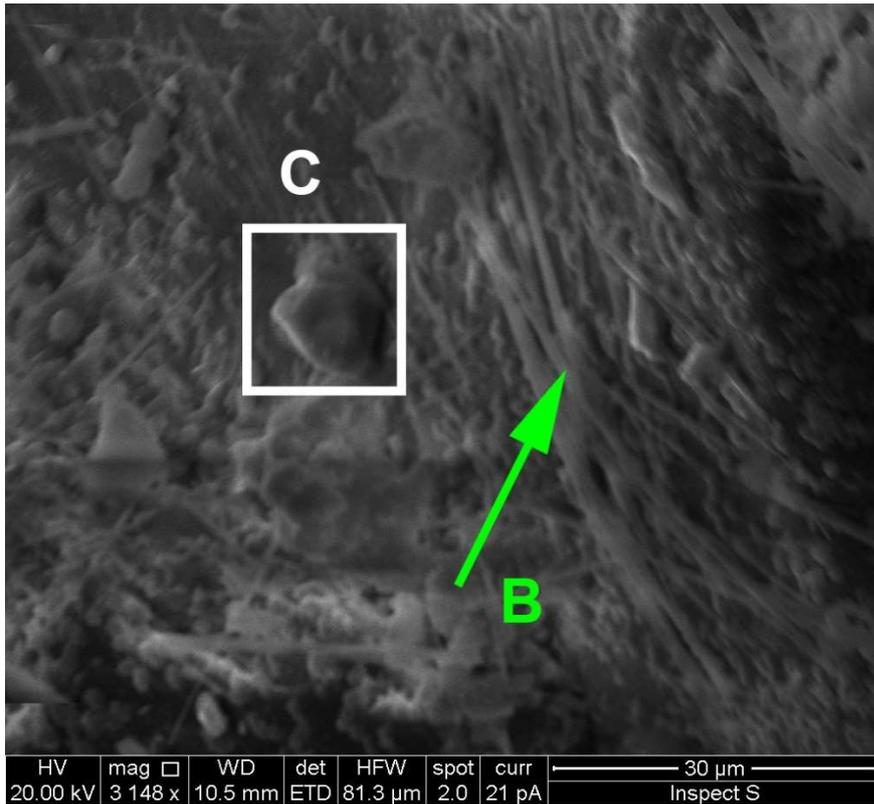
Figure 11 - SEM image of 'bacteria' crack cross-section, magnification 3148 x

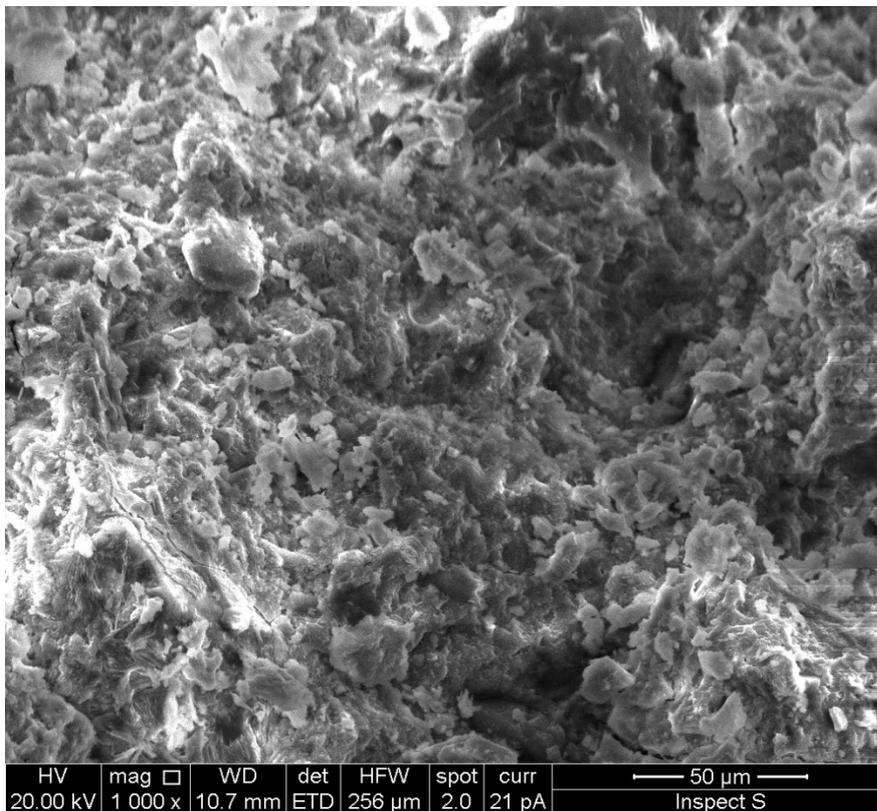
Figure 12 - SEM image of 'blank' crack cross-section, magnification 1000 x.

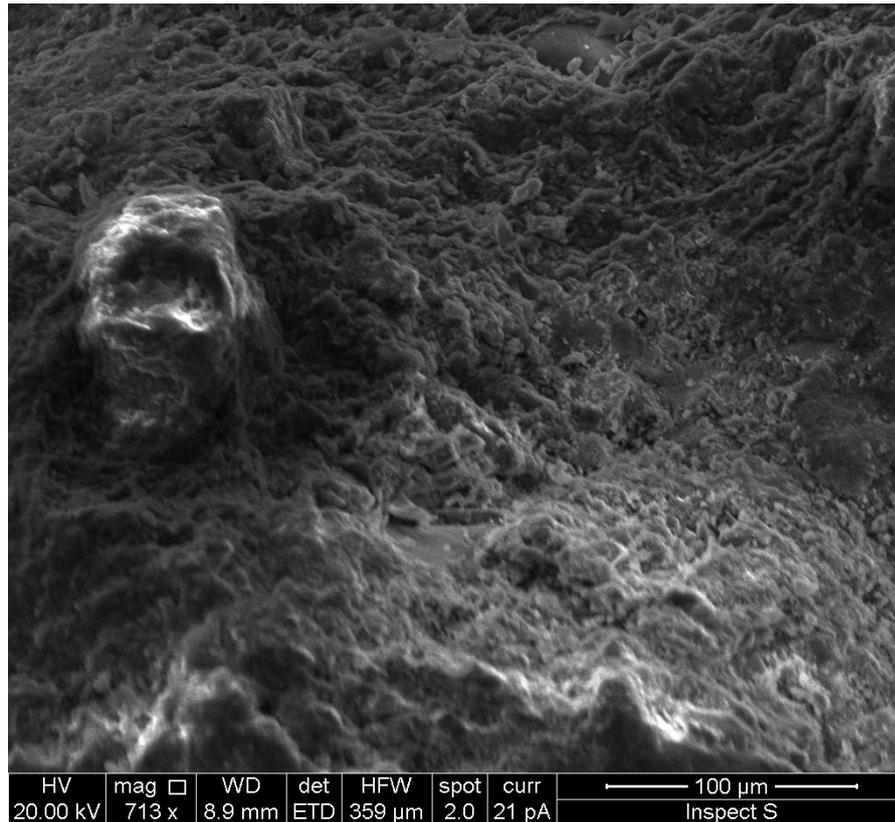
Figure 13 - SEM image of 'non-bio' crack cross-section, magnification 713 x.
