**Non-Destructive System for In-Wall Moisture Assessment of Cultural Heritage Buildings**

**Muradov, M, Kot, P, Markiewicz, J, Łapiński, S, Tobiasz, A, Onisk, K, Shaw, A, Hashim, KS, Zawieska, D and Mohi-Ud-din, G (2022) Non-Destructive System for In-Wall Moisture Assessment of Cultural Heritage Buildings. Measurement. 203. ISSN 0263-2241**

## Non-destructive system for in-wall moisture assessment of cultural heritage buildings

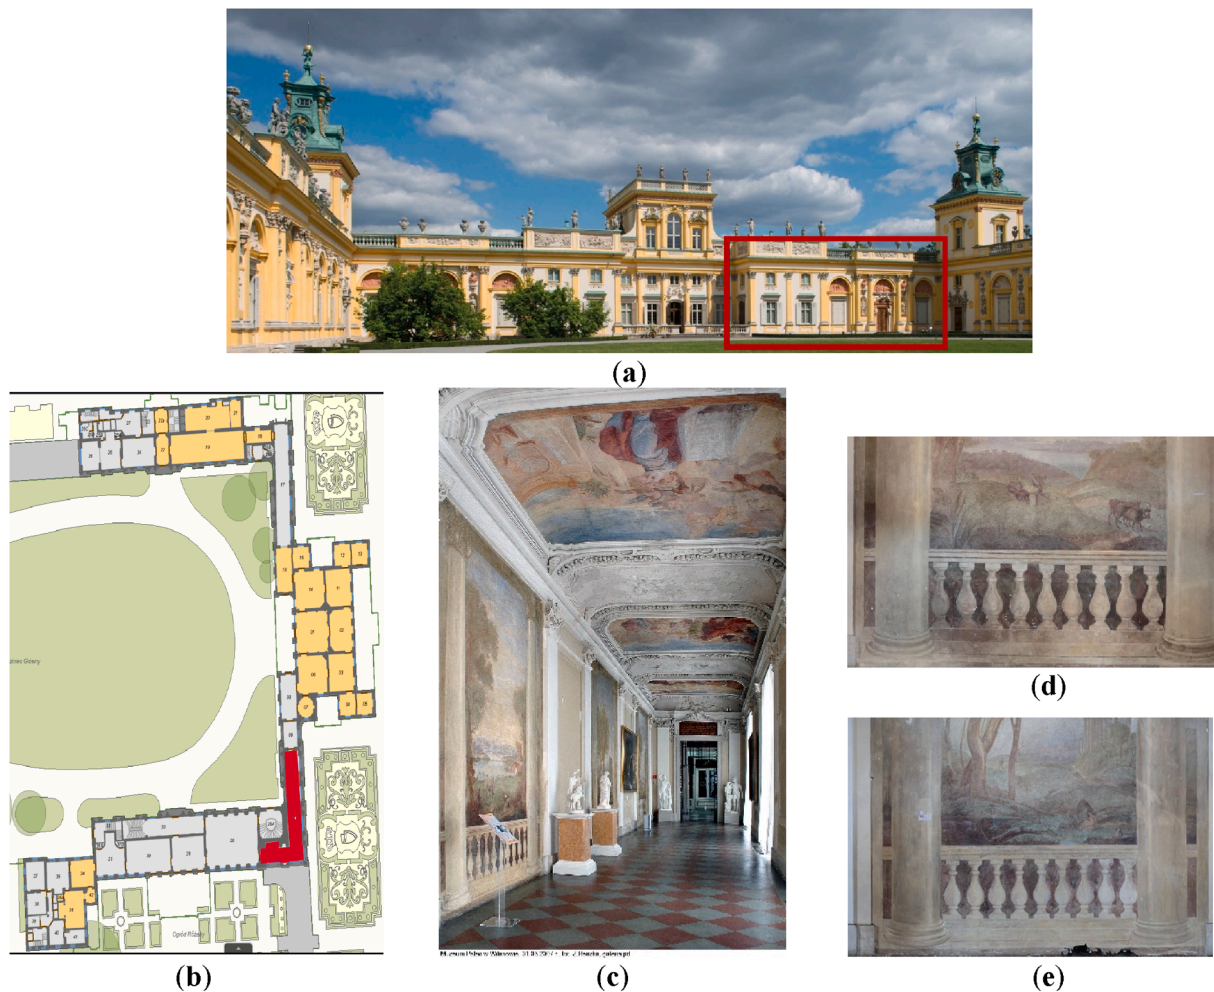
Fig. 1. Museum of King Jan III's Palace at Wilanów. (a) Front of the Palace with the marked south gallery, (b) The map of the Palace with the marked south gallery, (c) the photo of the gallery interior, (d-e) Fragments of the orthoimages of the tested walls.

The initial stage of this study was undertaken in the Museum of King Jan III's Palace at Wilanów (Fig. 1), particularly in the Open Gallery/Transparent Garden Gallery, which was added during the extension of the chateau in 1681–1683. The south gallery originally had 4 bays and was extended by 2 more bays in the first third of the 18th century to close the tower from the south. There are eighteenth-century landscape frescoes on the gallery walls and ceiling. The gallery walls' moisture content is monitored weekly using a Gann Hydromette UNI 2 moisture meter with the B50 active electrode. However, the penetration depth of the measurement is limited to the surface of the wall and a single-point measurement; therefore, the meter does not provide adequate moisture measurements of the walls.

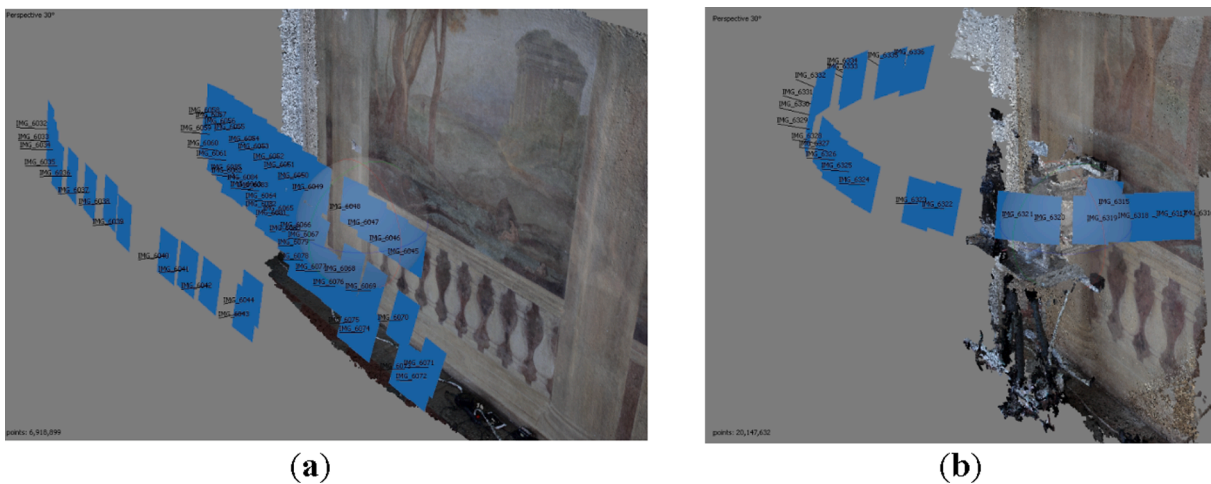
Fig. 6. Schematic of the image taking used to (a) generate the reference orthoimage and (b) determine the position of the MW system in space.

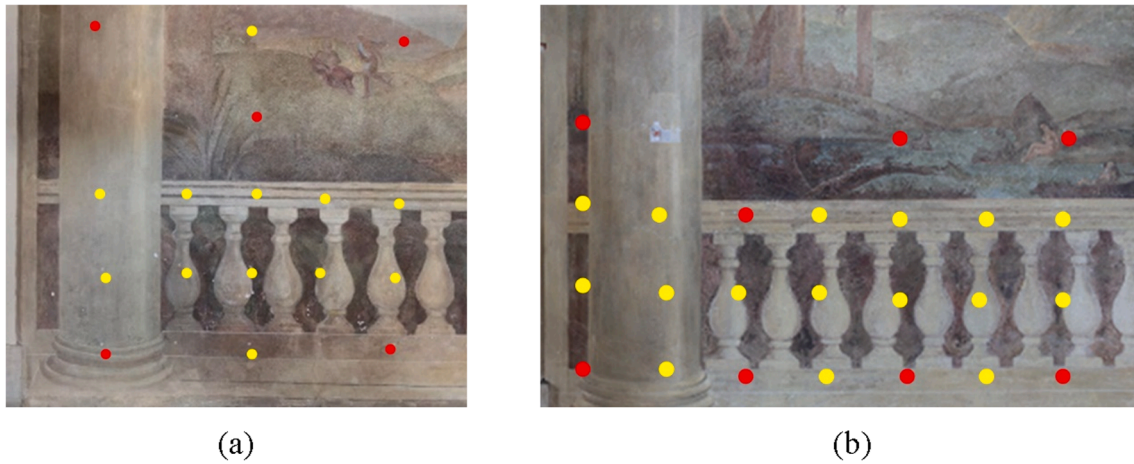
Fig. 7. The sketch of reference point distribution used for image orientation with natural points measured by Total Station (control points – red, check points – yellow) for (a) Test Site I and (b) Test Site II.

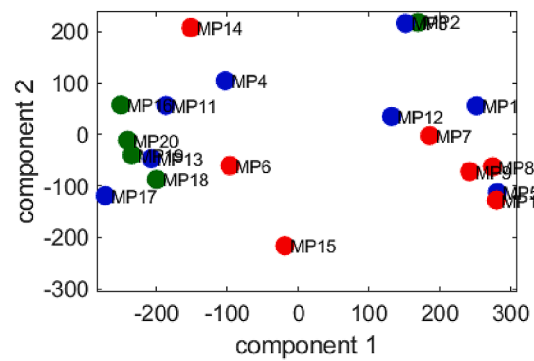
Fig. 15. Data analysis of MW System for moisture detection using (a) Correlation heatmap, (b) *t*-SNE, (c) PCA, (d) K-Means, and (e) Hierarchical Clustering for case study Test Site I setup.

III's Palace in Wilanów. The data from Test Site I and Test Site II are presented in Fig. 15 and Fig. 16, respectively. The correlation heatmap of the data (see Fig. 15a for Test Site I and Fig. 16a for Test Site II) demonstrates various groups, which are highlighted with boxes in green, yellow and red colours based on the pin-type moisture meter measurements that are also provided on the right side of the graph. The majority of MW grouped data can be aligned with the pin-type moisture meter data. However, there are individual positions where the MW data do not correlate with the pin-type moisture meter data. This could be caused by the different moisture content on the surface and inside the measured wall, i.e., the MW system is able to penetrate through the measured wall

and determine the presence and location of moisture within the wall, which can be confirmed by the undertaken laboratory study on the brick experimental setup. Further analysis was carried out using the same clustering techniques used in the brick experimental setup, namely (1) *t*-SNE, (2) PCA, (3) K-Means and (4) Hierarchical Clustering, which are presented in Fig. 15 and Fig. 16 for Test Site I and Test Site II, respectively. The clustering for Test Site I was set to determine three clusters in the data based on the pin-type moisture meter data (three thresholds for moisture content). The K-Means method was able to clearly identify three clusters in the data, whereas the *t*-SNE and PCA results provided overlapping clusters. The Hierarchical technique identified two main groups and numerous sub-groups. Furthermore, all the methods

identified one outlier in the results, namely “MP15”, which can also be observed in the correlation heatmap (see Fig. 15a). The potential reason for this outlier is thought to be a foreign object’s presence inside the wall. Performed clustering analysis demonstrated that the MW system’s data does not fully align with the pin-type moisture meter data as it was expected due to the penetration capability and influence of the presence and location of moisture within the wall on the MW signal. The precise quantitative measurement of moisture inside the measured wall is impossible due to the use of destructive methods. However, the MW system demonstrated the ability to estimate the moisture presence and its location inside a wall structure.

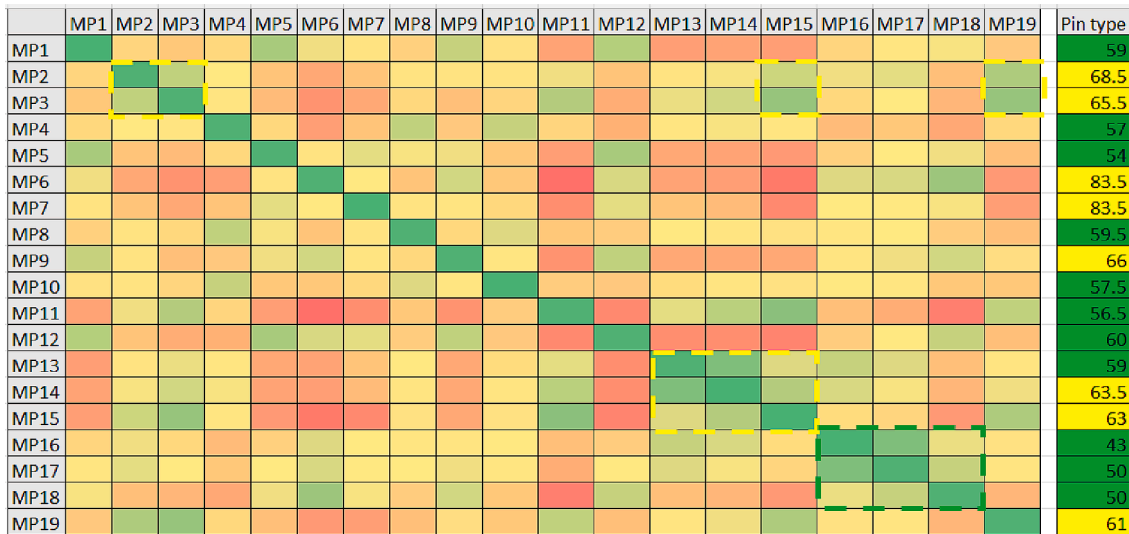
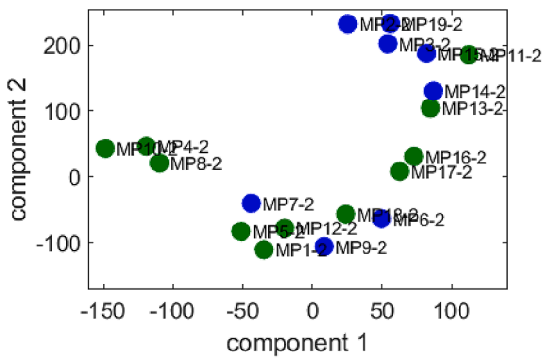
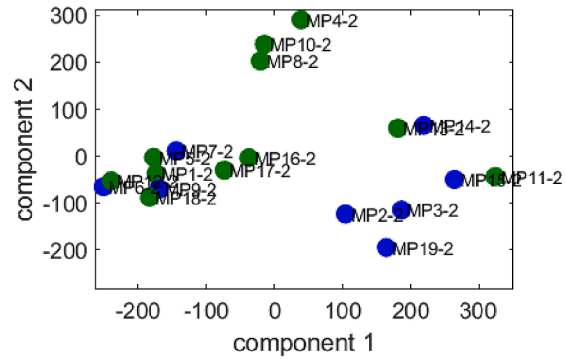
**Fig. 16.** Data analysis of MW System for moisture detection using (a) Correlation heatmap, (b) *t*-SNE, (c) PCA, (d) K-Means, and (e) Hierarchical Clustering for case study Test Site II setup.
