Performance-based methods for masonry building rehabilitation using innovative leaching and hygrothermal risk analyses

ANA BRÁS¹, ANDREIA VALENÇA¹, PAULINA FARIA¹

¹ NOVA University of Lisbon, Dep. Civil Engineering, 2819-516 Caparica, Portugal

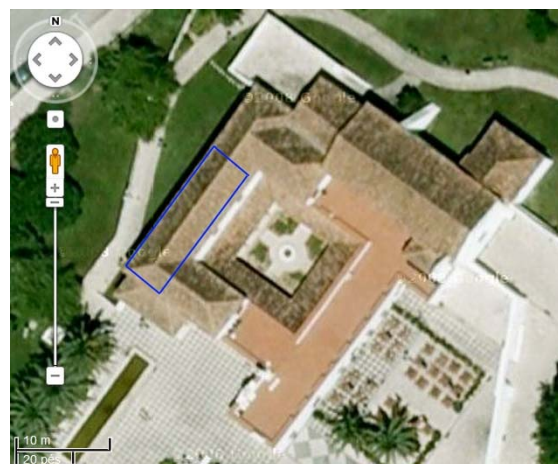
Figure 4 - General view of the convent and its orientation. The blue rectangle shows the main area where is the library (1st floor) and where the U3A (ground floor) will be implemented [28].

The historical investigation previously made to the Convent enabled to understand the adopted techniques used in oldest interventions and the characteristics of materials used on those restoration works (in particular concerning the use of new materials) and their compatibility with existing materials [1]. Figure 4 presents the general view of the convent and its orientation.

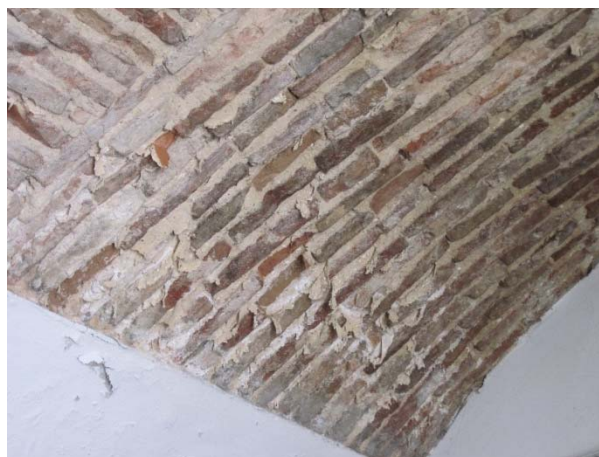
Figure 5 - Presence of salts and leaching phenomena of the mortar joints of the brick masonry vault confirms the migration of binder from the original lime mortar.

Originally the vaults of the convent were covered. Currently some of them are unplastered, showing their structure, namely the one presented in situation C – Table 1. In this situation, some salt crystallization and leaching phenomena of the mortar joints between brick masonry could be observed (Figure 5).

Leaching phenomena presented in this convent probably occurs not only due to the extended water presence and infiltration from the terrace above the vault (situation D - Table 1), but also due to the lack of protection of the vault structure enabling the ceramic elements and the lime mortar from the joints to be directly affected by indoor hygrothermal conditions. This exposure to several cycles of different relative humidity (RH) could affect the lime mortars microstructure, leading to a decrease of adhesion and mechanical strength with time [24, 31, 33, 34].

Problems in the terrace flat roof water proofing system of the convent and on its own positioning under ceramic floor tiles lead to water infiltration and damage of masonry walls and vault (situation D - Table 1). The lack of pending at the terrace able to drain rainwater for collection devices has serious consequences on the building functioning, namely in the structural performance of the vault mentioned in Situation C - Table 1, where water infiltration occurs leading to leaching phenomena of the mortar joints of the brick masonry vault.

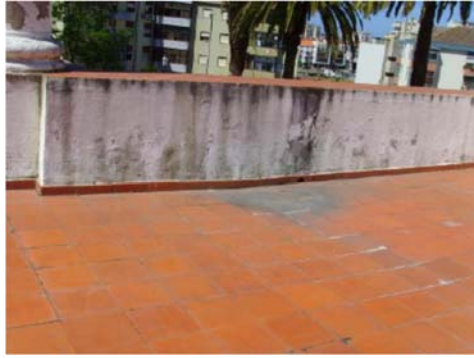
Figure 6 - Terrace covering with ceramic roof tiles. Water accumulation due to insufficient slope of the terrace floor.

Besides that, the previous construction works made in the 90's at the terrace, with the construction of a new cement based mortar layer and placement of the ceramic floor tiles (Figures 6 and 7) at the top of the hidden masonry arch increased the weight above this structural masonry, leading to crack evolution. This set of cracks could represent significant danger and a pre-collapse situation (situation E – Table 1) [1, 24].

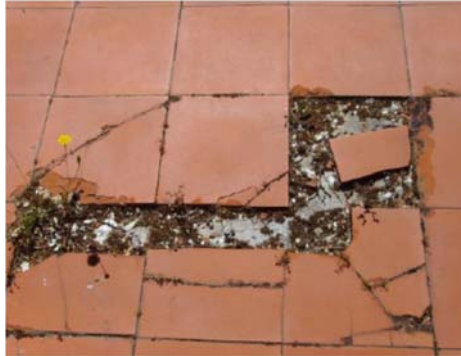
Figure 7 - The inexistence of expansion joints at the ceramic tiled floor leads to its fracture and to the cracking of cement based mortar layer under tiles, contributing for inefficient roof water proof and therefore leading to leaching of the mortar joints between brick masonry vault.

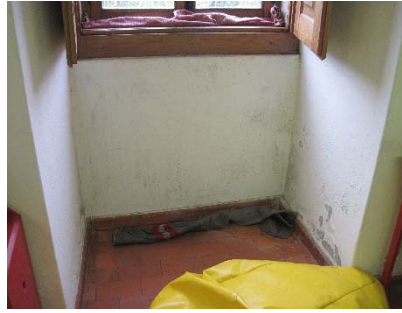
Figure 14 - Detail view from the interior showing the wood window and the thickness of exterior walls.

Historic buildings like this convent are usually made of solid masonry walls and single glazed wooden windows (Figure 14). The rehabilitation of this kind of old buildings requires an upgrading of the shell so that comfortable temperatures and relative humidity can be maintained to keep up with modern life requirements.
