THE INTEGRATION OF THE MULTI-TEMPORAL CONSERVATION WORKS AND NON-INVASIVE MEASUREMENTS

In 2017, The Rescue Project was undertaken in the Blessed Ladislav's chapel in St. Anna's Church in Warsaw (Poland). The chapel, due to its spatial disposition - location from the escarpment side at the north wall of the church nave, belongs to the most endangered architectural fragments.

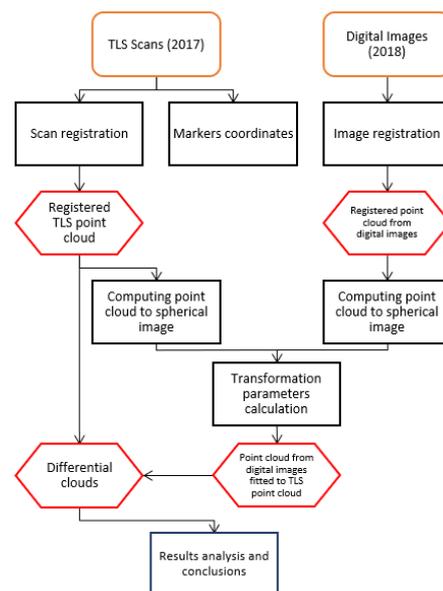
Figure 1: The schematic of the performed investigation.

Data from two different sources were used for this research: TLS scans obtained in 2017 and digital images from 2018. Data processing can be divided into three main parts. 1) Data registration to get two registered point clouds, 2) Registration of these clouds with each other, and 3) Data comparison.

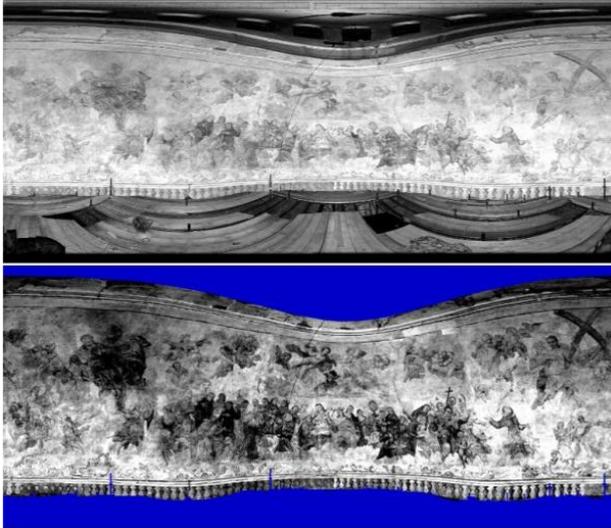
Figure 2: Spherical image of the dome before filtration (top image) and after filtration (bottom image).

Before processing the TLS data, it was decided to automatically filter the point clouds based on the analysis of the laser beam intensity (too low and too high removed) and by removing isolated points (filter out points from the data set whose nearest neighbour (point) has a distance greater than the 10 cm). This was followed by manual filtering of areas that were not of interest. Such areas included the scaffolding and the lantern located on the upper ring of the dome. The result of the filtering is shown in Figure 2.

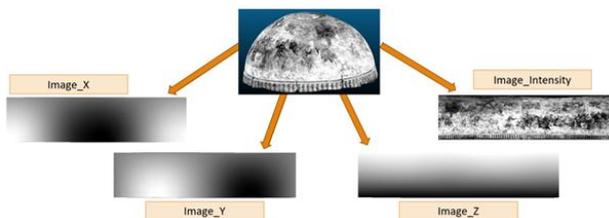
Figure 3: Diagram presenting the generation of spherical images from the TLS point cloud.

After filtering point clouds, co-registration of two data sets was carried out. Both point clouds were transferred into orthoimage, based on cartography and map projections methods. For every point, new XY coordinates were calculated. Coordinate Z stands for point attributes, e.g., RGB components or original coordinates X, Y and Z (Fig. 3). From those new point clouds, rasters were generated.

Next, based on X, Y and Z rasters, coordinates in both point clouds coordinate system were interpolated (Fig.3). Finally, having XYZ values of keypoints, it was possible to calculate transformation parameters for one of the point clouds (Fig. 5). The results of the point cloud registration are shown in Table 1.

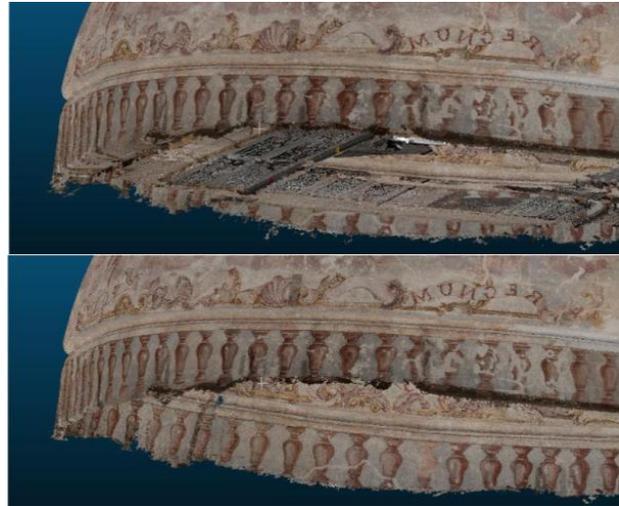
Figure 4: The result of the MVS point cloud filtration.

Like the point clouds acquired from Terrestrial Laser Scanning, the point cloud was filtered automatically. For these purposes, the Statistical Outlier Removal (SOR) (Point Cloud Library, 2021) algorithm was utilised (Fig. 4). Only solid fragments of scaffolding were removed manually.

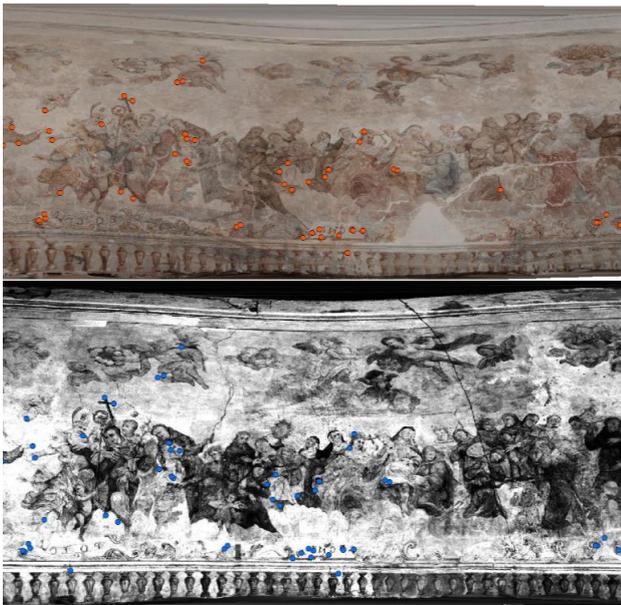
Figure 5: The example of the corresponding points distribution on the fragment of the spherical images.

The previously mentioned SIFT algorithm was used to find keypoints between RGB orthoimage from 2018 and intensity orthoimage from 2017. The example of tie points on TLS and RGB spherical images is shown in Figure 5.

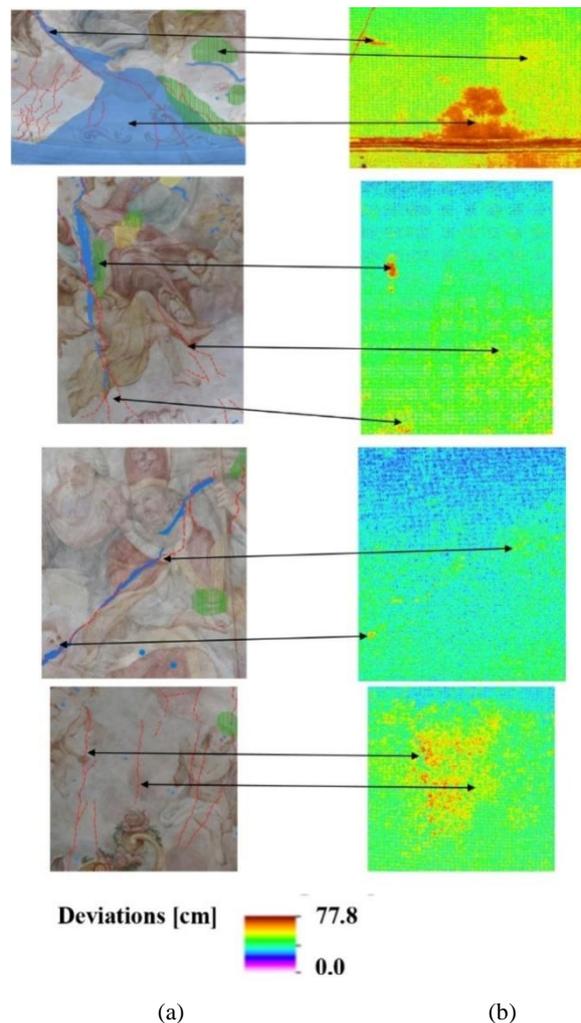
Figure 7: Comparison of the damage map from classical conservation works (a) and deviations maps acquired from differential point clouds (b)..

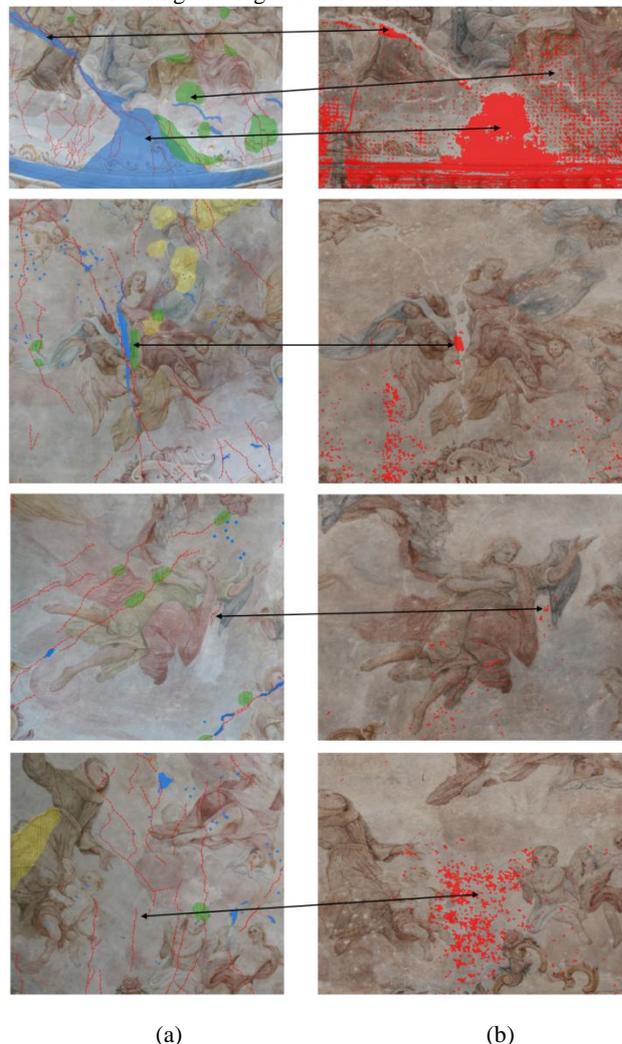
Figure 8: Comparison of the damage map (a) and vector layer acquired from differential point clouds (b).

Having registered point clouds with each other, it is possible to analyse changes that occurred during conservation work. Calculated distances between both point clouds show the localisation of cracks and damages on the dome wall. Along with that, the size and depth of crevices can be measured. Acquired distance point cloud also was transferred into orthoimage. For improved readability of the location of the damages final raster was vectorised, filtered out of the noise. Vector layer was applied to the orthoimage from images. Polygons represent places where the distance between both point clouds is greater than 2.8 mm. To verify the results vector layer was compared with a damage map of the dome, developed by the conservation team using traditional methods (Fig. 8).

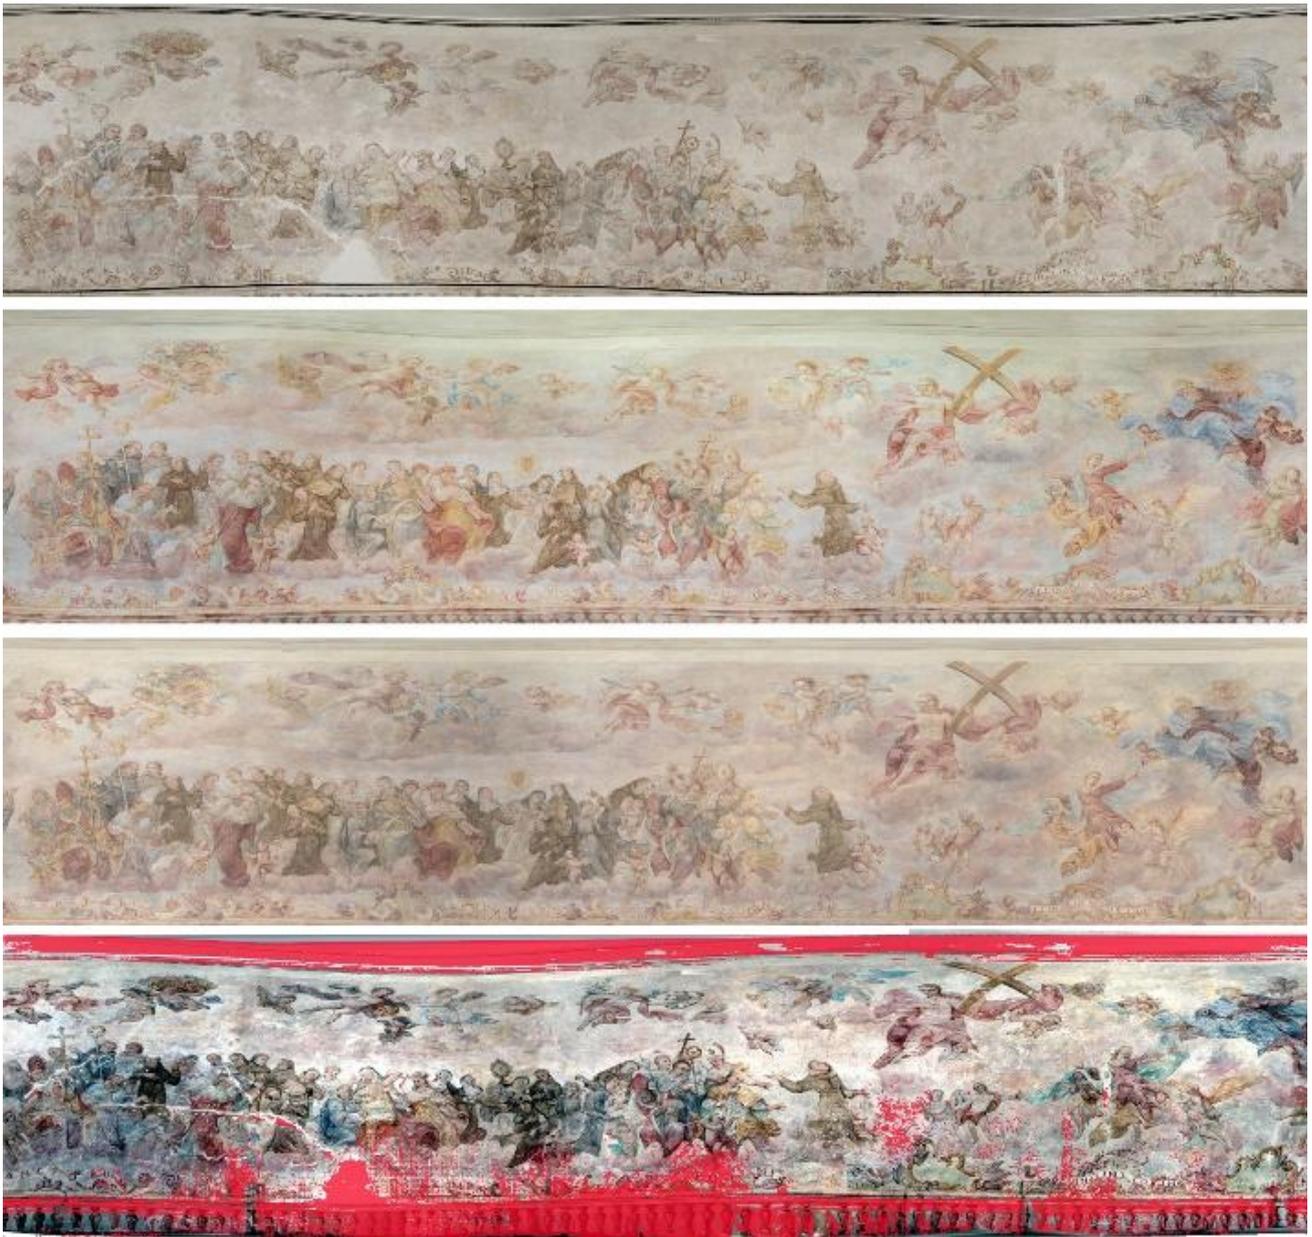
Figure 9: Multitemporal panoramas(before, during and after conservation works) with the map of automated detected areas for conservation works (red areas).

Based on panoramic photos of the entire scene juxtaposed with precise images of its fragments and an analysis of the preserved relics, supported by art historical research, it was possible to read the meaning of the paintings in the dome and to recognise particular saints and their attributes (Fig. 9).
