Desiccation cracking at field scale on a vegetated infrastructure embankment

**Yu, Z, Eminue, OO, Stirling, R, Davie, C and Glendinning, S (2021)
Desiccation cracking at field scale on a vegetated infrastructure
embankment. Géotechnique Letters, 11 (1). pp. 88-95. ISSN 2049-825X**

This paper presents a desiccation crack monitoring campaign conducted on a full-scale, vegetated infrastructure embankment subjected to one-year of seasonally variable weather. The field survey involved direct measurement of naturally developed, annually reoccurring cracks in a heavily instrumented, clay fill embankment (BIONICS, Newcastle University). Transient crack morphology was captured in terms of opening width, length and depth, in addition to meteorological and near-surface soil hydrological conditions. In order to assess any correlation between crack development and weather-driven changes in near surface soil conditions, the volume of cracks was estimated using an empirically derived equation. This work identified crack behaviour in four stages: initiation, expansion, contraction and closure. These stages and the distribution of cracks on the slope are closely related to prevailing atmospheric

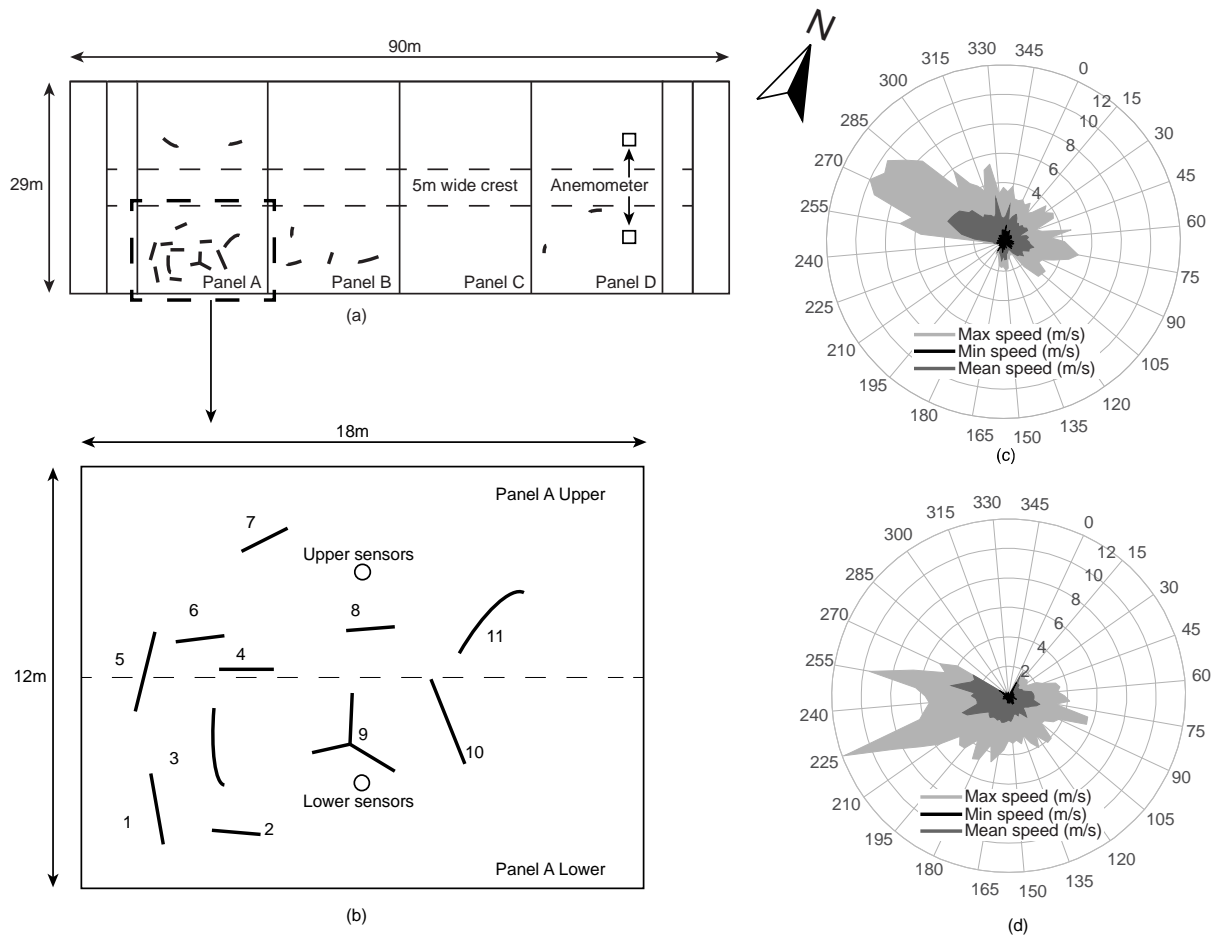
Figure 4. Embankment layout showing crack distribution and wind exposure with respect to slope aspect. (a) Overview of cracks at the BIONICS embankment; (b) Crack distribution on the upper and lower (6 m) halves of Panel A South; Wind exposure on (c) north slope and (d) south slope.

The majority of cracking occurs on the poorly compacted Panel A, as shown in Figure 4a, with 11 of the total 19 cracks present on the south slope (Figure 4b). Six cracks (#4-8 and #11) were found on the upper section and five cracks (#1-3 and #9-10) on the lower section. Cracks #4-11 had been identified by researchers from the same group prior to the start of this survey and are considered long-standing features although are comparable in scale and behaviour to those identified at the start of this survey. Figure 5 illustrates the discrete, linear

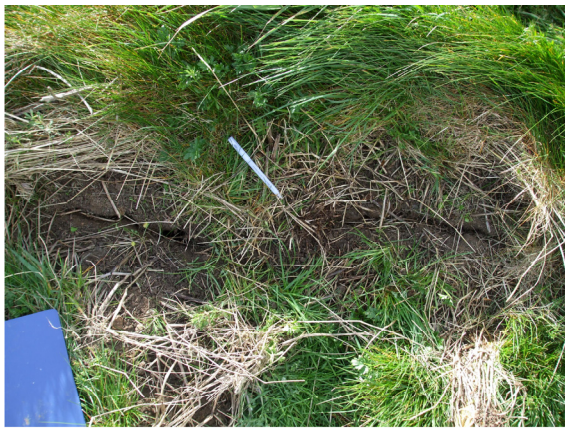
Figure 5. Photograph of crack #10, a representative embankment crack.

cracking style typically seen in this context which is hypothesised to be due to the presence of dense vegetation. This style of cracking is in contrast to the branching, connected polygonal style typically seen in laboratory experiments (Tang et al., 2008, 2011; Costa et al., 2013; Bordoloi et al., 2018; Cheng et al., 2020a) and sparsely vegetated field sites (Dyer et al., 2009; Li and Zhang, 2011). The key mechanical difference between vegetated and non-vegetated soils is the permeation of roots which influences both the generation of suction (Ng et al., 2019) and tensile strength in the form of fibrous root reinforcement (Tang et al., 2012). The work of Bordoloi et al. (2018) investigated the influence of vegetation on cracking with a dedicated laboratory study. They found that grass species reduced the maximum crack intensity factor by 20% compared to bare soil. However, it is difficult to achieve the same maturity and density of vegetation as found in the field in small-scale laboratory experiments. Wind roses (Figure 4c & 4d) demonstrate the difference in exposure across the embankment. The prevailing wind direction is south-westerly with maximum wind speeds between 10-12 ms^{-1} . The wind directions recorded on both sides display a sheltering effect due to the embankment orientation with maximum magnitudes on the north slope suppressed. Besides wind exposure, the southern aspect will also experience greater solar radiation and longer daylight hours. Exposure to the prevailing wind and solar radiation will promote drying on Panel A south which together with a greater diversity of vegetation, may be responsible for the majority of cracking being observed on this slope.
