# Bio-Stimulated Surface Healing of Historical and Compatible Conservation Mortars

**Abstract:** The main focus of this research was the bio-stimulated healing of cracks in lime mortar samples (historical and newly designed). The investigation started from comprehensive characterisation of historical mortars, while in the next stage a compatible conservation mortar was designed and characterised, with special attention given to the contact zone formation between original and conservation mortars. The next step was the design of a bio-stimulating crack-sealing agent, a two-component liquid system: bacteria culture *Sporosarcina pasteurii* DSM 33 and nutrients. Both historical and conservation mortar samples were used in order to study their potentials for bio-stimulated surface-crack repair. The experiment lasted for 150 days, allowing the ureolytic bacteria *Sporosarcina pasteurii* DSM 33 to induce the precipitation of calcium carbonate into cracks and heal the damaged surface of the tested materials. The healing phenomenon was continuously monitored during a period of 150 days. Special attention was given to the evaluation of the morphology, chemical and structural characteristic

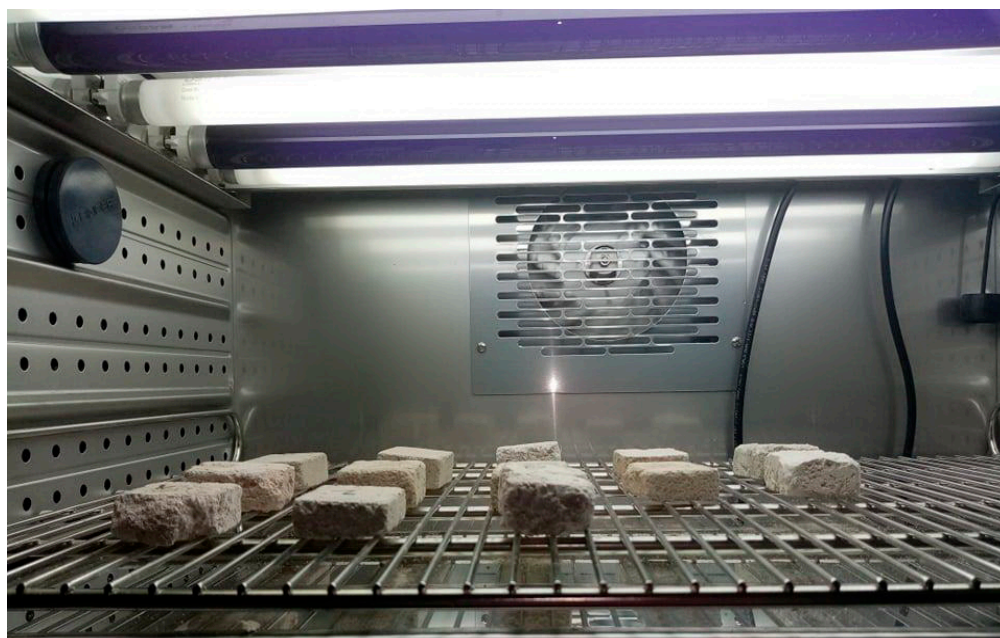
**Figure 3.** Artificial ageing of the MM mortar samples in the chamber.

The artificial ageing procedure was set up based on the average climatic parameters in Serbia, relevant scientific publications, our previous experience and an already proven methodology for the design of compatible systems [4,6]. In the first 5 days, the MM samples were exposed to room conditions ( $T = 20\text{ }^{\circ}\text{C}$  and  $\text{RH} = 60\%$ ), after which they were placed in a climate chamber for one month, combining exposure to high and low temperatures and different relative humidities ( $T = 30\text{ }^{\circ}\text{C}$  and  $\text{RH} = 80\%$  for 5 days,  $T = 0\text{ }^{\circ}\text{C}$  and  $\text{RH} = 60\%$  for 24 h, repeated for 5 cycles in total). Then, the MM samples were again subjected to room conditions for 7 days. After the artificial ageing in laboratory (Figure 3), the MM samples were analysed.

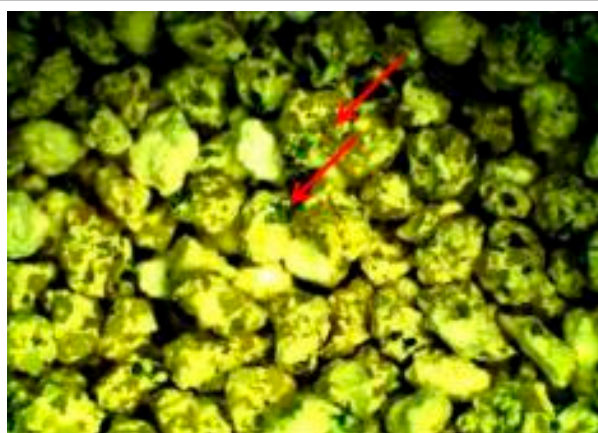
Fraction 1000–710  $\mu\text{m}$   
Agglomerated binder fraction;  
magnification  $\times 45$

Based on the sieving and microscopic analyses (Table 2), it was revealed that the fractions larger than 710  $\mu\text{m}$  represented agglomerated binder/lime lumps and the particles in the size interval 710–63  $\mu\text{m}$  clearly indicated the morphology and colour characteristics of sand and crushed bricks, whereas the fraction smaller than 63  $\mu\text{m}$  represented solely the binder. Based on the obtained results, the binder-to-aggregate ratio of the historical sample was calculated, while the chemical analyses (treatments with hydrochloric acid and sodium carbonate) determined the mass percentage of the sand and the crushed bricks in the aggregate.

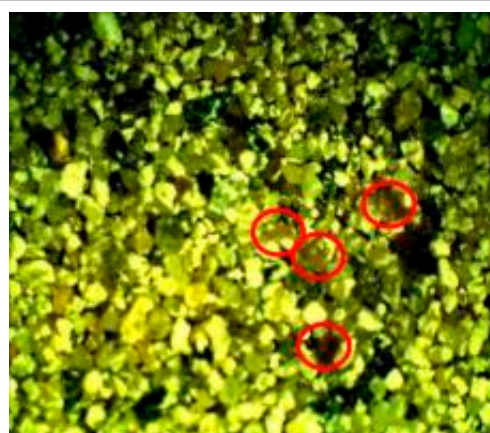
Fraction 250–125  $\mu\text{m}$   
Crushed brick particles marked;  
magnification  $\times 20$

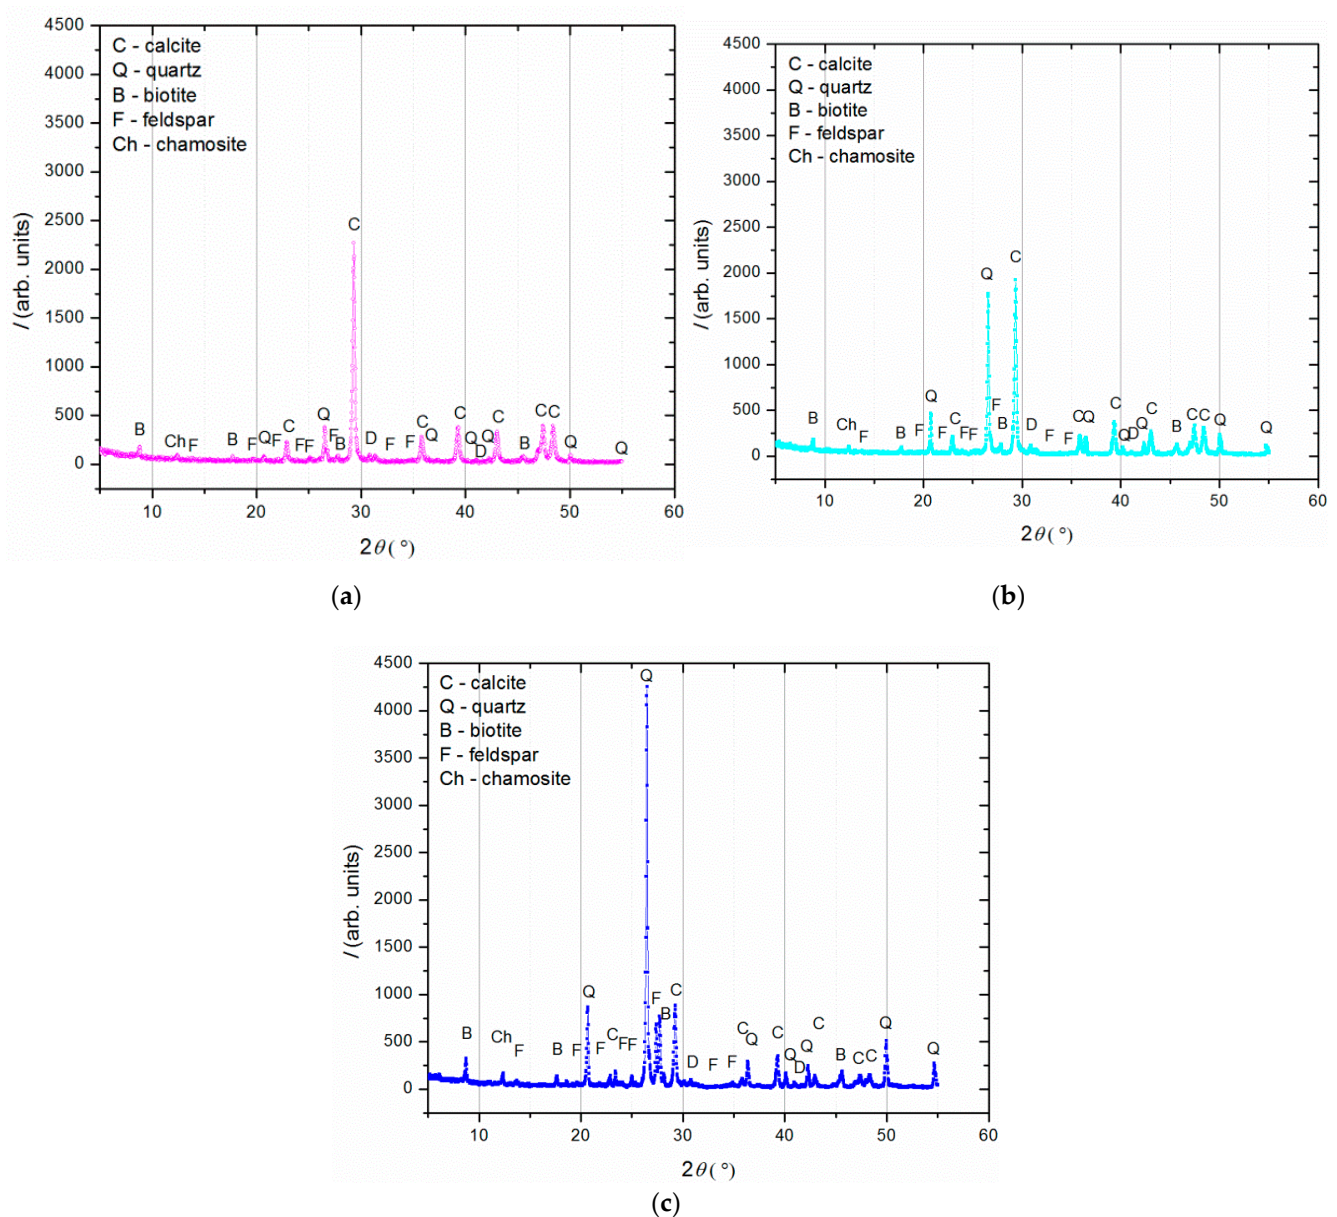
**Figure 4.** XRD analysis of (a) binder (fraction < 63  $\mu\text{m}$ ); (b) agglomerated binder/lumps (fraction > 710  $\mu\text{m}$ ); (c) aggregate (710–63  $\mu\text{m}$ ).

XRD analysis (Figure 4) was performed on three separated fractions: (a) binder,  $<63 \mu\text{m}$ , (b) agglomerated binder,  $>710 \mu\text{m}$  and (c) aggregate,  $63\text{--}710 \mu\text{m}$ . In the case of the examined fractions, the following mineral crystalline phases were detected: calcite [ $\text{CaCO}_3$ ], quartz [ $\text{SiO}_2$ ], biotite [ $(\text{K}(\text{Mg},\text{Fe})_3(\text{AlSi}_3\text{O}_{10})(\text{F},\text{OH})_2)$ ], feldspar [ $\text{KAlSi}_3\text{O}_8\text{--NaAlSi}_3\text{O}_8\text{--CaAl}_2\text{Si}_2\text{O}_8$ ] and chamosite [ $(\text{Fe}_2,\text{Mg})_5\text{Al}(\text{AlSi}_3\text{O}_{10})$ ]. In the case of the binder fraction ( $<63 \mu\text{m}$ ), as expected, a significantly higher proportion of calcium carbonate (calcite) was identified, while in the case of the aggregate fraction ( $710\text{--}63 \mu\text{m}$ ), a dominant presence of quartz was found. The identified calcite in the aggregate fraction was a consequence of limestone being used for the historical mortar preparation. The identified biotite was more significant in the case of the aggregate in relation to the binder fraction, which was expected since this mineral is usually present in river sands. Additionally, the slightly higher intensity of the identified chamosite in the aggregate relative to the binder fraction was a consequence of the already-identified particles of the crushed bricks. Finally, in the agglomerated binder/lumps (fraction  $>710 \mu\text{m}$ ), the dominant mineral form, namely calcite, corresponded well to the composition of the binder fraction ( $<63 \mu\text{m}$ ) except for the presence of quartz, which was intercalated in the agglomerated binder/lumps.

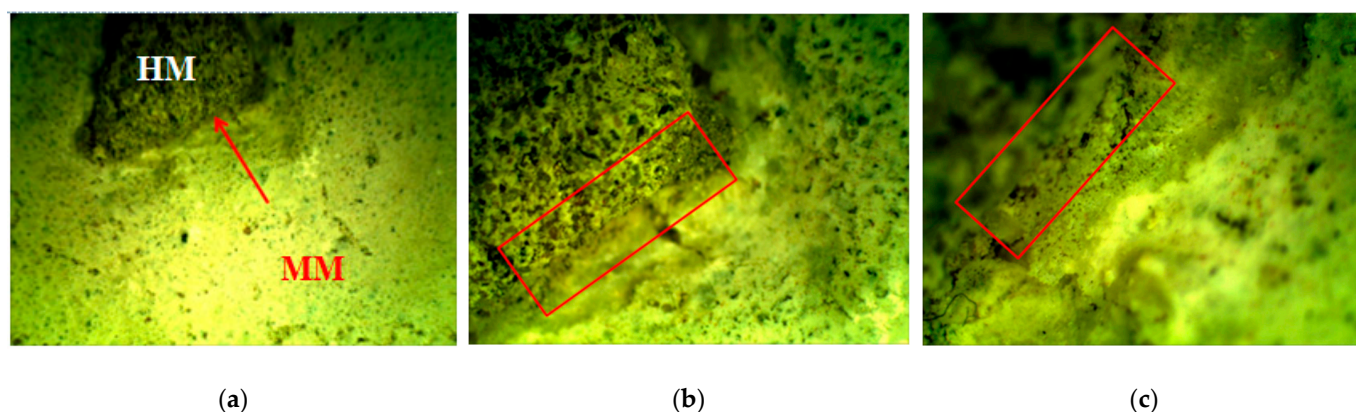
**Figure 5.** Stereo-optical microscopy: marked contact zone formation between original HM and chosen new mortar MM, magnification: (a)  $\times 6.5$ ; (b)  $\times 20$  and (c)  $\times 40$  [6].

The mutual interaction and cohesion between the original historical mortar (HM) and the laboratory-prepared conservation mortars (MM) was studied. A small fragment of the HM sample was put inside the most-promising new MM sample, as shown in Table 4. The interaction between the two samples was studied by using a stereo-optical microscope. During the carbonation/hydration process, a contact zone without cracks was formed between the original (HM) and the new (MM) sample. The morphology investigation, as shown in Figure 5, of the contact zone showed that the formed area had a satisfactory appearance (without cracks) [6,21].

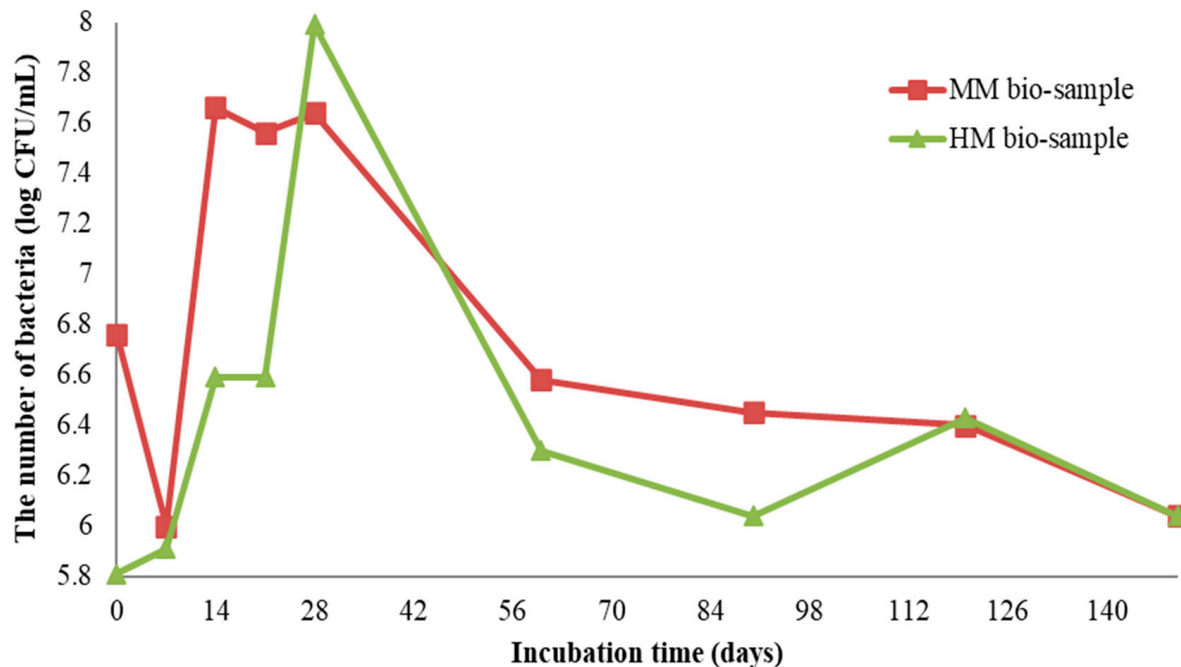
Figure 6. Enumeration of *S. pasteurii* DSM 33 on MM and HM bio-samples [6].

The growth profiles of *S. pasteurii* DSM 33 on the HM and MM bio-samples are shown in Figure 6. The initial number of bacterial spores of *S. pasteurii* DSM 33 in the suspension was  $8.3 \log \text{ CFU/mL}$  (CFU—colony-forming unit). After the application of  $100 \mu\text{L}$  of suspension onto/into the crack, the number of bacterial cells was above  $5.8 \log \text{ CFU/mL}$ , dependent on the sample type (HM or MM). Within the first two months of incubation, the concentration of the cells was increased by at least  $2 \log \text{ CFU}$  units. Decreasing trends for both the bio-samples were observed at the end of the incubation period. At the end of the experiment, the concentration of vegetative cells of *S. pasteurii* DSM 33 was above  $6 \log \text{ CFU}$  units. According to the obtained results shown in Figure 6, it can be suggested that the observed concentration of vegetative cells could sustain the MICP process. Although the number of bacteria varied with time, it could be clearly concluded from Figure 6 that the cell concentration did not go below  $6 \log \text{ CFU/mL}$ , even after 140 days. This number of cells was more than enough to encourage and sustain the MICP process and induce the precipitation of crystal forms in the crack zone during the experiment time [22].

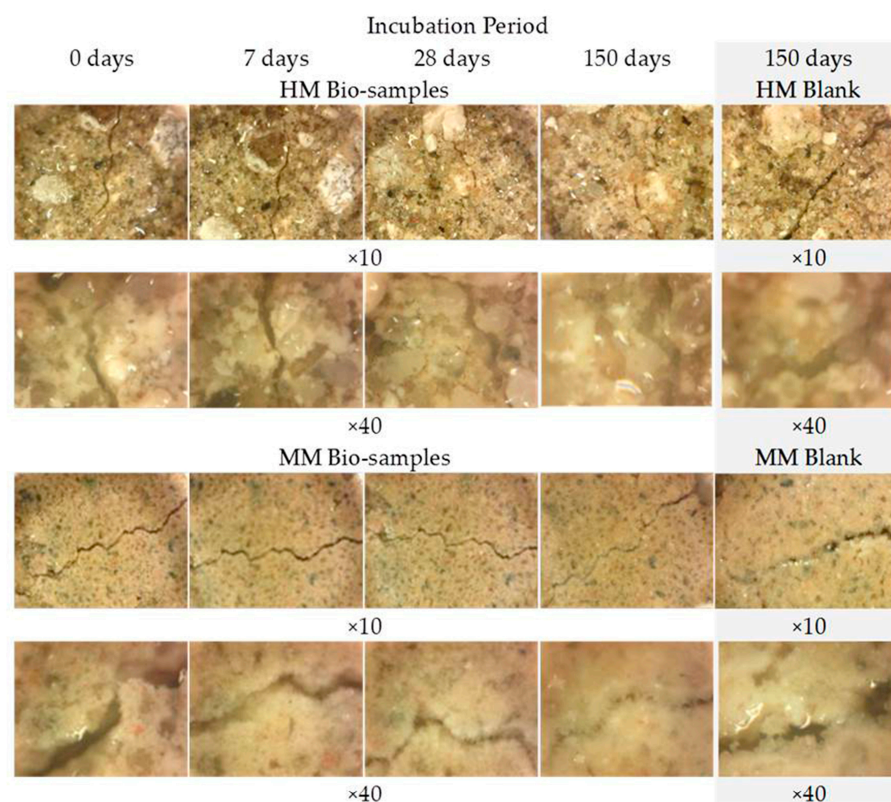
**Figure 8.** Microscopic images of HM and MM bio- and blank samples [6].

The images obtained by the digital optical microscope in the different phases of the experiment (0 days, 7 days, 28 days, 150 days) visibly indicated that the crack repair process was indeed obtained in the HM and MM bio-samples (Figure 8).

Comparing the microscopic images of the HM and MM bio-samples with the HM and MM blank samples after 150 days, the surface-crack repair of the MM bio-samples was more pronounced and visible, as shown in Table 5 (the growth of needle-like crystals from the crack edges was identified). This could be explained by the fact that in the case of model mortars (MM) there were more calcium ions available for the bio-stimulated calcium carbonate precipitation, as at the time of the experiment, carbonization was still an on-going process. In the case of the historical bio-samples, the crack widths were similar or slightly lower compared to the original samples, and there was not a big difference in the closure ratio between 28th and 150th days of the experiment. Evidently, in the case of the “mature mortars”, much more than bio-stimulated carbonate sprouts is needed for the crack-healing process after 28 days. These results were in agreement with the results shown in Figures 6 and 7. Namely, the ureolytic activity started, but the bacteria-induced precipitation slowed down due to a lack of free calcium ions in the historical samples. In order to obtain more information about the crack-repair effects in the case of the MM bio-samples, an SEM investigation was applied, while the historical samples were not examined further.

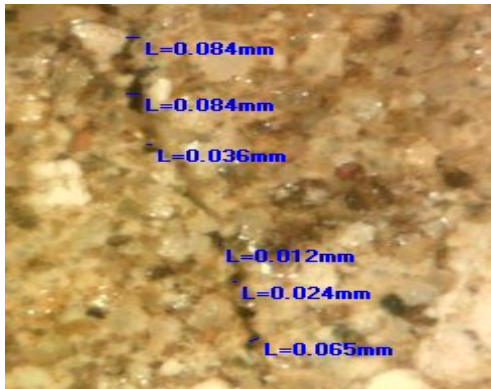
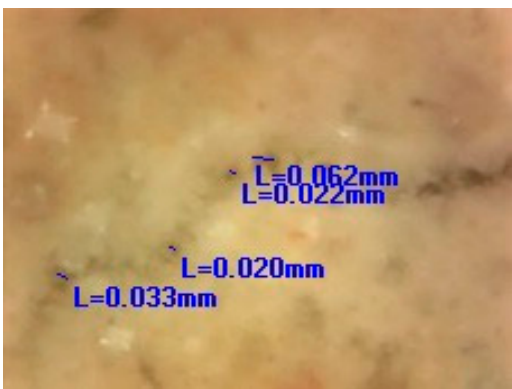
150 days HM sample		150 days MM sample

Sample		HM Bio-Samples	MM Bio-Samples	
0 days, crack width, mm	Measured	0.045; 0.67; 0.045; 0.115; 0.090; 0.067	Measured	0.070; 0.094; 0.071; 0.098; 0.091; 0.085;
	Average	0.0715	Average	0.084
150 days, crack width, mm	Measured	0.084; 0.084; 0.036; 0.012; 0.024; 0.065	Measured	0.033; 0.020; 0.022; 0.062;
	Average	0.051	Average	0.034
Magnified detail of the measurement position

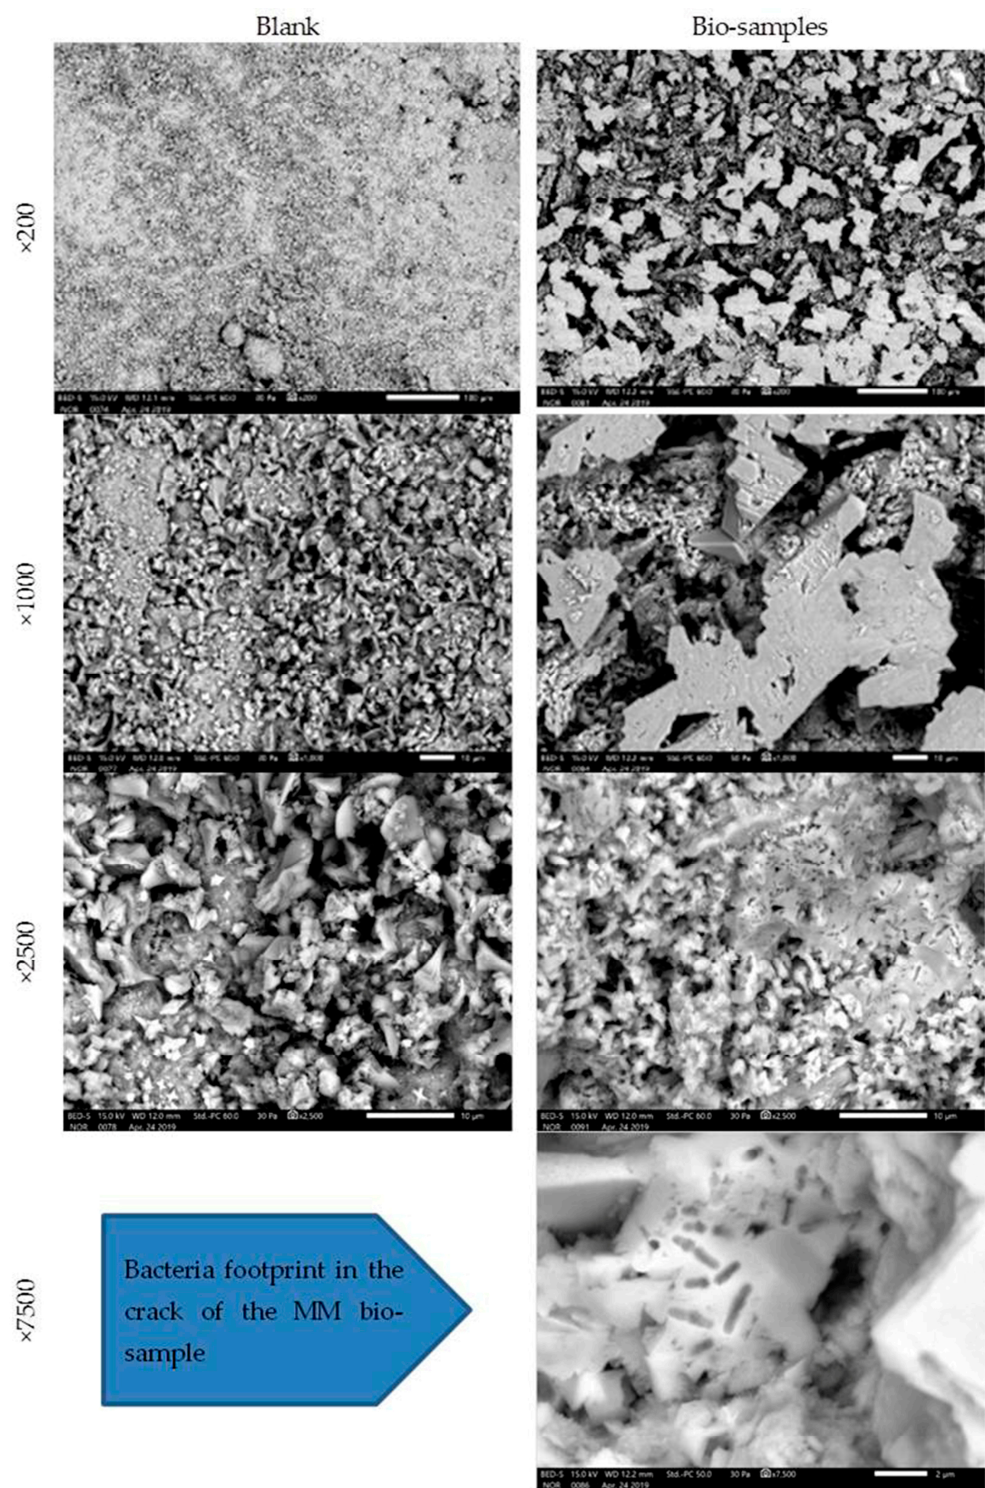
Figure 9. Microscopic images of MM bio- and blank samples after 28 days of incubation [6].

The MM bio-samples and blanks were analysed on the 28th day of incubation (Figure 9).

The obtained SEM images revealed evidence about the nature and structure of the precipitate. In the SEM images, the difference was easily observed between the blank and bio-samples of the MM after 28 days of incubation. The difference was in the clearly detectable presence of  $\text{CaCO}_3$  crystals in the precipitate of the bio-samples. Under a magnification of  $\times 7500$ , the image of the MM bio-sample revealed a bacterial footprint (impressions) in the designed crack.

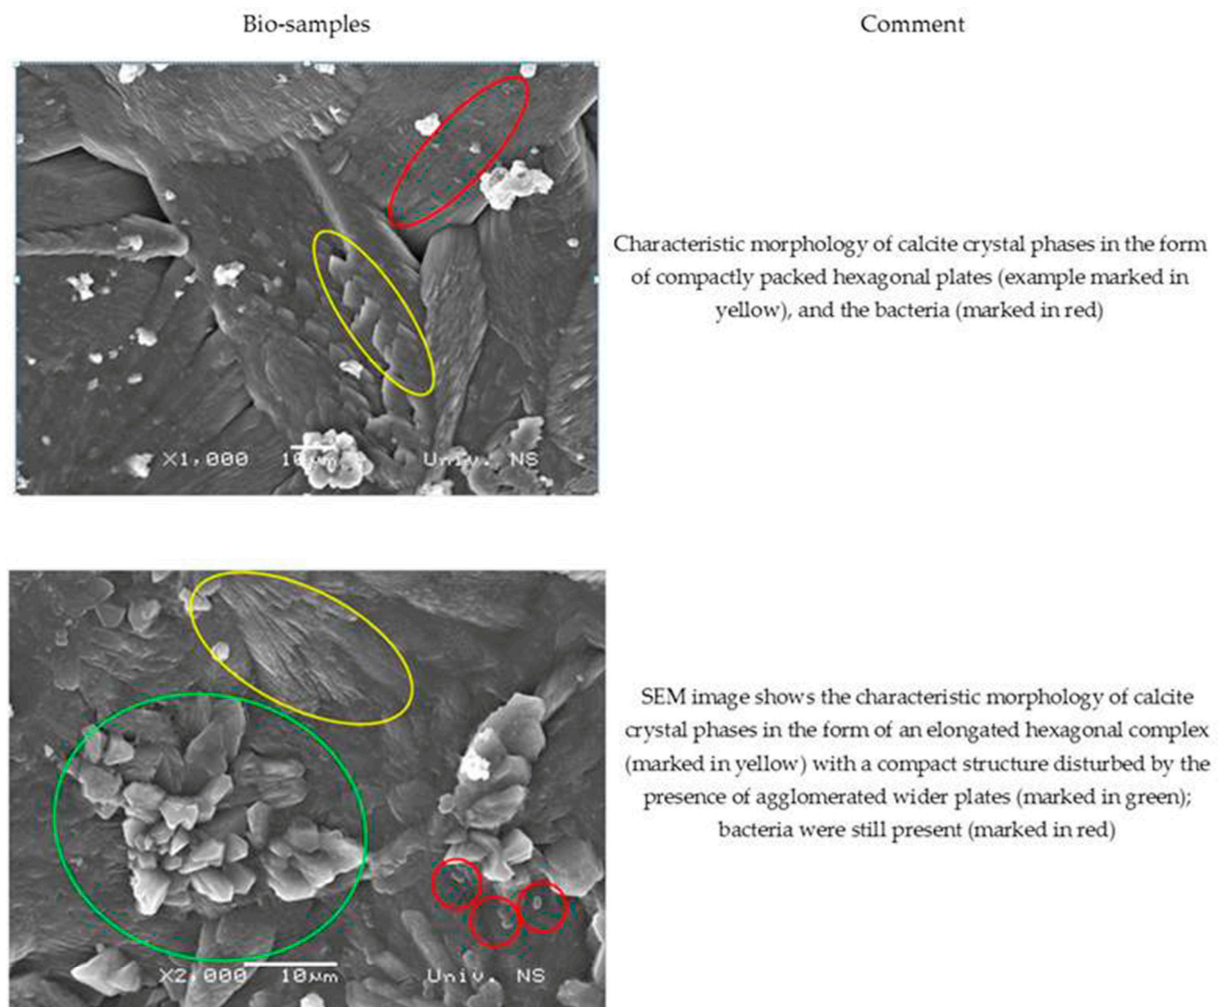
**Figure 10.** SEM analysis of MM bio-samples (precipitate formed in cracks) after 150 days of incubation [23].

The SEM images of the MM bio-samples after 150 days of incubation (Figure 10) reveal the effects of the advanced bacteria-stimulated formation of calcium carbonate in the cracks.

As shown in Figure 10, the SEM images of the MM bio-samples indicated the morphology of the surface crystal structures. The footprints of vegetative cells were not observed at the surface of the MM bio-samples. On the other hand, a sporogenic bacterial form (marked in red in both pictures) was detected around the already-formed  $\text{CaCO}_3$ . Evidently, the identified bacterial spores stayed inactive from the beginning of the incubation period, and  $\text{CaCO}_3$  precipitation became a more important factor with increasing age in the humid environments.

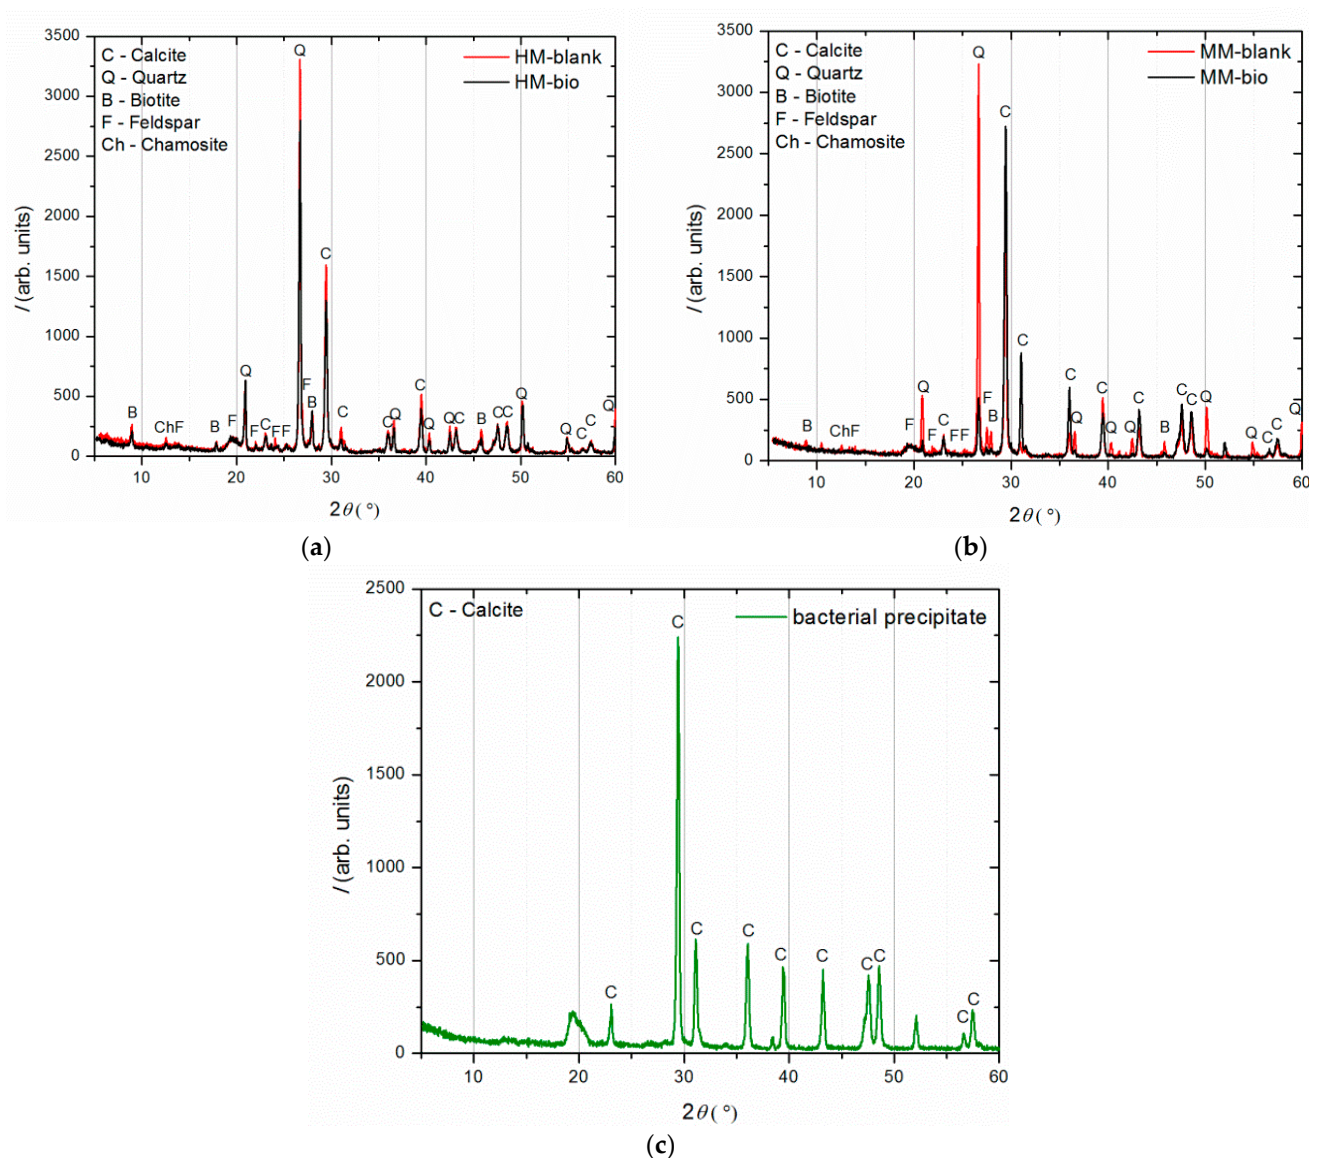
**Figure 11.** XRD analysis after 150 days of incubation: (a) HM blank and HM bio-samples comparative results, (b) MM blank and MM bio-samples comparative results, (c) sole bacterial precipitate.

The phase composition of the historical and model blank and bio-samples was examined by XRD analysis after 150 days of incubation. For each sample, the material subjected to these measurements was collected from the crack area in order to determine the crystalline structures formed during the healing process. Figure 11a shows the diffractograms of the historical mortars (HM blank and HM bio-sample), plotted together for comparison. Similarly, the XRD patterns belonging to the model mortars (MM blank and MM bio-sample) are shown in Figure 11b, while the pattern of the sole bacterial precipitate, taken from the MM bio-sample, is shown in Figure 11c.

Comparing the XRD patterns of HM blank and HM bio-samples (Figure 11a), there were no significant differences except for the intensity of all the diffraction peaks being reduced for the HM bio-sample. In contrary to this, comparing the MM blank and MM bio-samples (Figure 11b), the MM blank sample had a much higher quartz maxima than the MM bio-sample, while the MM bio-sample had a much more intense calcite maxima in comparison to the MM blank sample. This implied that strong calcite precipitation occurred in the MM bio-samples, in the region of the crack-healing area.

The comparison of the obtained results between the HM bio- and MM bio-samples confirmed that the bacteria-induced precipitation was limited in the HM samples because of the lack of free calcium ions. Namely, the “young” mortars with incomplete carbonation, as it was the case with the MM bio-samples, which were exposed to wet conditions, had a suitable quantity of free calcium ions inside ready for the healing processes [24]. The XRD analysis of the sole bacterial precipitate showed the presence of pure calcite, which confirmed that the increase in the calcite content in the healed MM bio-sample was a consequence of the bacterial activity. The unassigned peaks in Figure 11c belonged to the
