Field Survey of 2021 Typhoon Rai –Odette-in the Philippines

Field Survey of 2021 Typhoon Rai –Odette- in the Philippines

Storm surge, Philippines, Typhoon Rai, Field survey

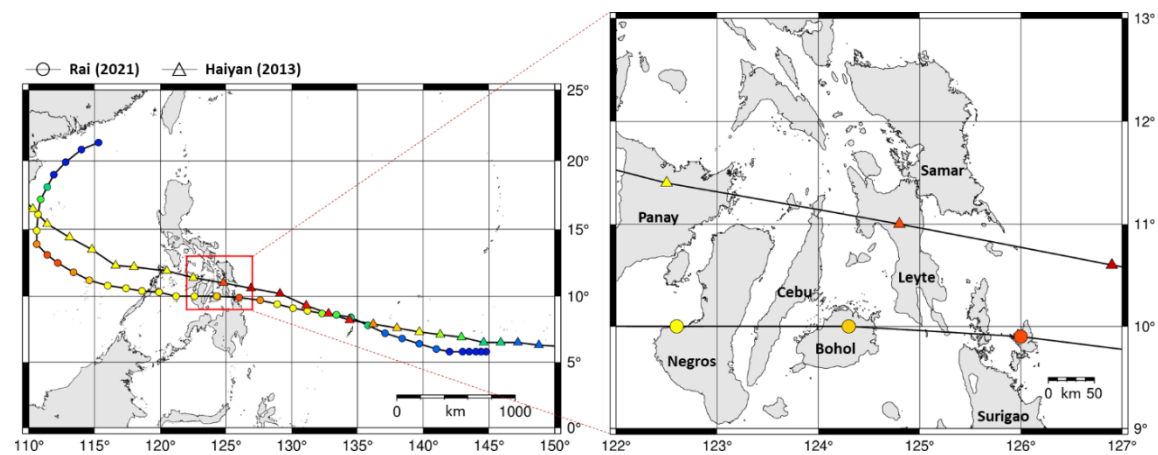
Figure 1. Typhoons Rai and Haiyan Best Track Data from the Japan Meteorological Data (JMA).

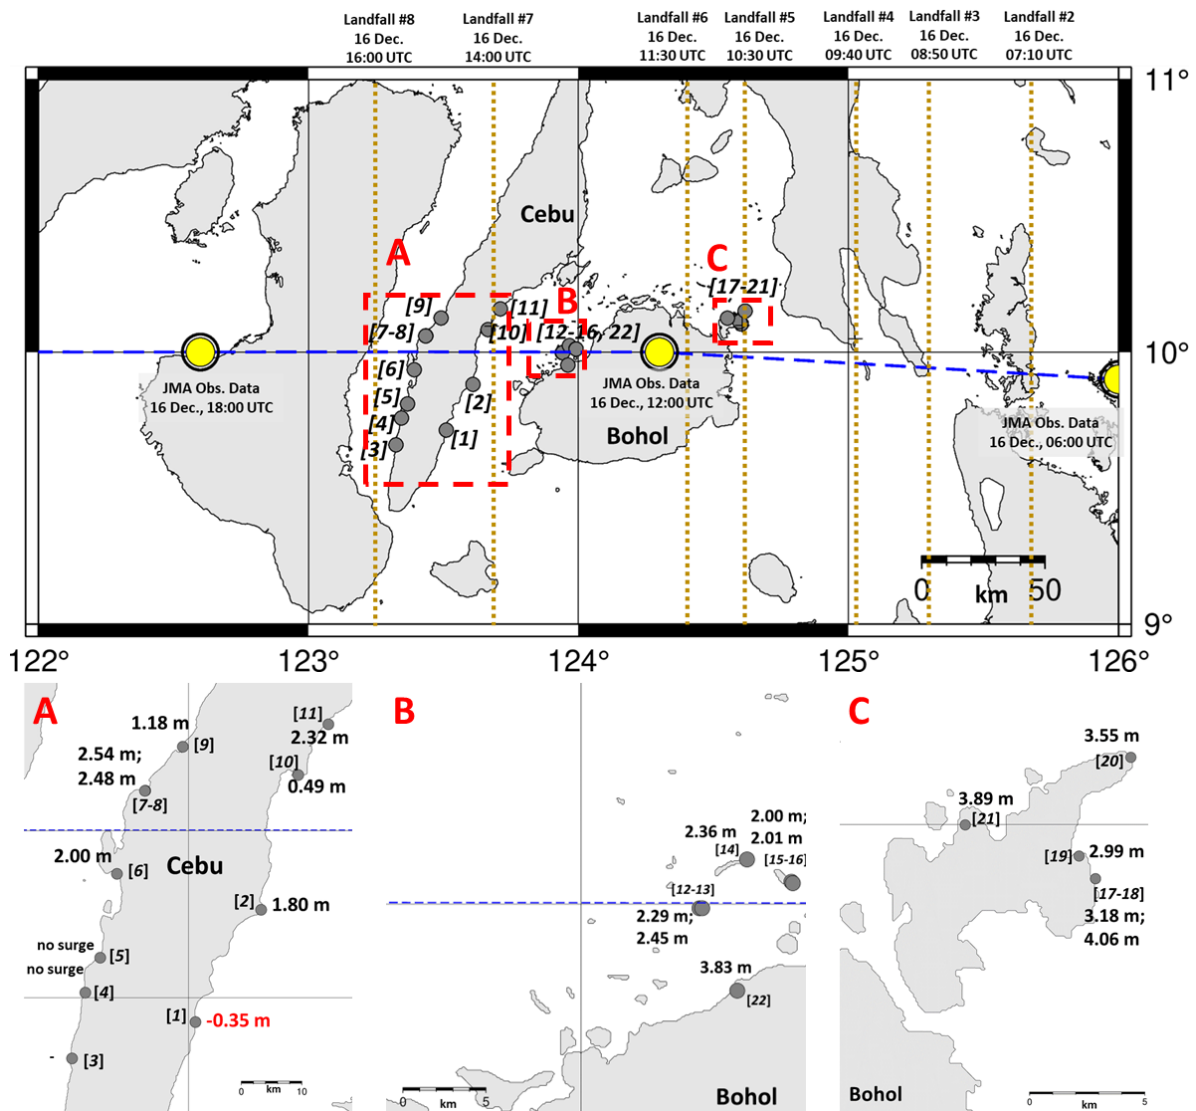
Figure 2. Path of the typhoon, location of the points surveyed (in brackets), and estimated storm surge (in meters) at each location (see Table 1).

The measured storm surge inundation and run-up heights are summarized in Table 1 and Figure 2. A total of 22 points were surveyed (including several points where no reading could be taken. The maximum storm surge inundation height (4.24 m) was recorded at Tubigon port, in Bohol (See Figure 2). The total level was determined with reference to Cebu tidal station datum.

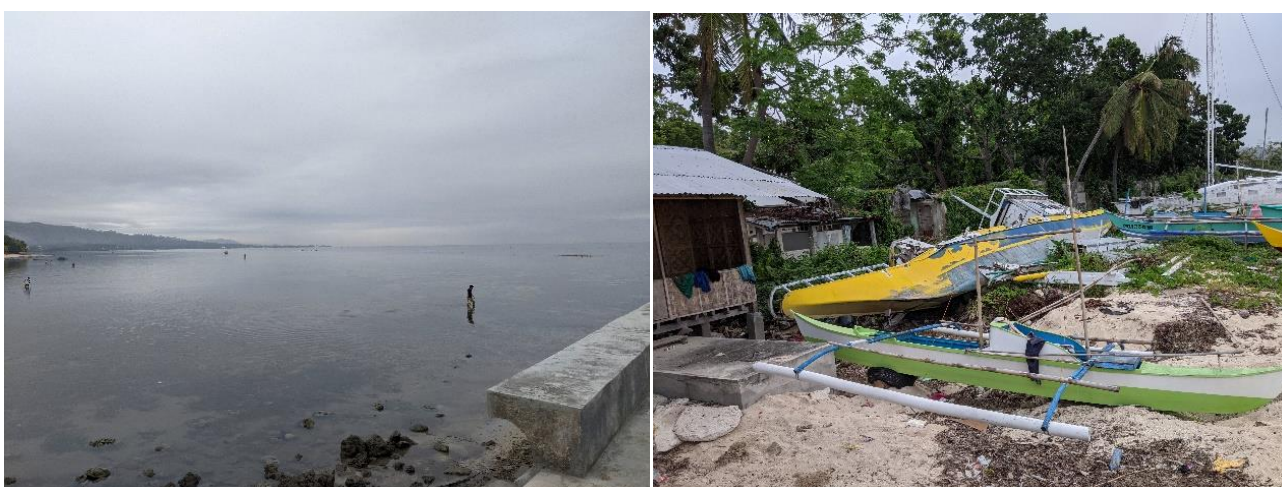
Figure 3. Left. Shallow bathymetry around the port pier of Alcoy. Right. Boats washed onshore by the waves.

The survey started from Cebu City and proceeded southwards to Alcoy town. The town has a small port, around which some small single story holiday cottages are located. The sea in the vicinity of the port is shallow, with a wide reef flat (intertidal area), where local people can walk and gather seafood (see Figure 3). A local resident interviewed indicated that there was no storm surge and that the flood waters they experienced descended from the mountains due to rainfall. The typhoon hit at high tide, with the water reaching the foreshore of the beach, to a level of +0.9 m (according to the resident, the waves reached the entrance of the property, which was about 10 metres from the shoreline). This corresponded to an estimated storm surge of -0.35 m (when the tide at the time of the passage of the typhoon was taken into account, see Table 1).

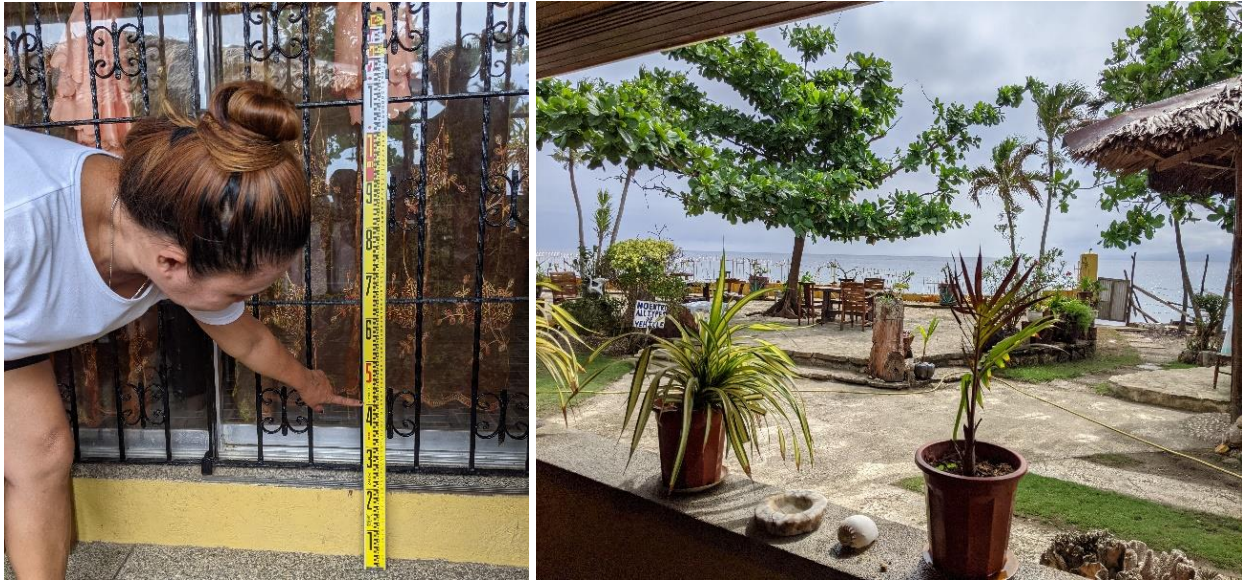
Figure 4. Left. Resident indicating the inundation height at a house located close to the shoreline. Right. The seawall in front of the house had been built to slightly different levels.

The area surveyed in Carcar City is known as Sitio Bantayan in Barangay Tuyom. The resident of a coastal house indicated that the storm surge was limited in height, although waves were high and there was considerable splash, causing localised damage to houses situated right next to the water (see Figure 5). The maximum storm surge was 0.49 m, measured on the fourth step of a staircase used to access the narrow beach in front of the property (residents noted that this level was higher than they would have expected at that time, but not that much more than usual high tides). The family stayed in place and did not evacuate, and structural damage was generally low in the area.

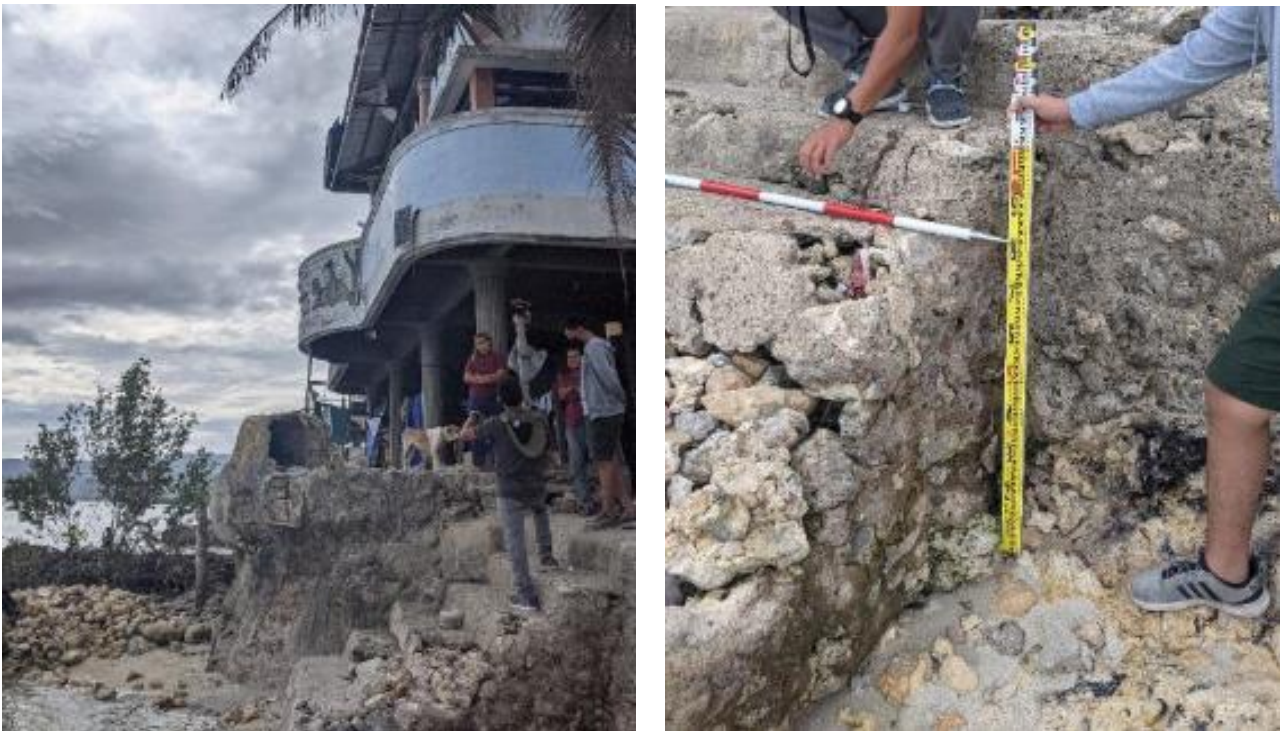
Figure 5. Left. Minor damage to houses located right next to the waterfront. Right. The storm surge only reached the middle of a small staircase used to reach the beach.

The area surveyed was the port of South Poblacion, where the water reached the top of the pier and inundated it to a level of 0.77 m above its floor (+3.53 m). At the time of the passage of the typhoon (Dec 16th at ~20:00) the tidal level at Carcar Bay station (nearest tidal station) should have been +1.25 m, indicating a skew tide of 2.32 m (it is worth noting that the maximum tide on that day was supposed to be +1.43 at 09:23, and the lowest tide +0.12 m at 04:03). There was considerable splash from waves and some houses near the waterfront were damaged. The pier also suffered medium damage, as shown in Figure 5.

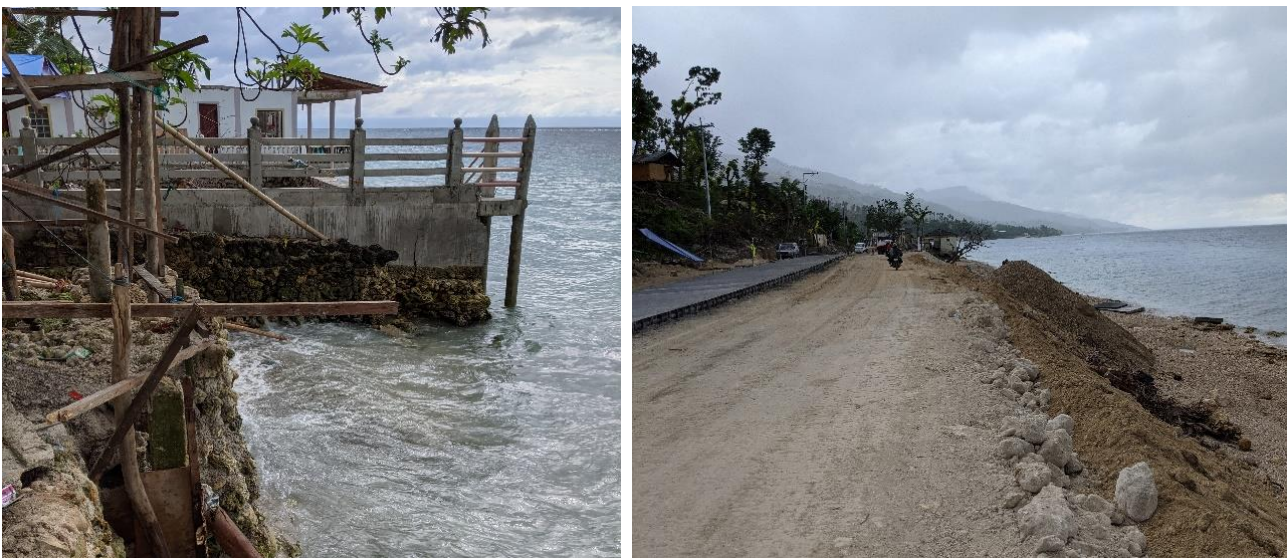
Figure 6. Left. In Malabuyoc houses were built on top of the beach, in many cases by reclaiming land. Right. The road between Malabuyoc and Alegria suffered severe scour damage and in some places was completely removed, with recovery activities underway at the time of the survey.

It should also be noted that the distance between Cebu and the island of Negros to the west (both islands are separated by the Tañon Strait) is quite short, and that there are thus limitations to the size of the waves that can develop due to the short fetch in the area. This, together with the protecting coral reef, explains why houses could normally be built right up to the shoreline without suffering damage, although in this event the powerful wind-generated waves caused much damage. In several sections of the coastline between Malabuyoc and Alegria the road had suffered significant scour and collapsed into the sea, with construction work taking place to rebuild it. In one stretch from Alegria to Badian the section under construction was over 3 km, with maybe half of that being caused by the complete collapse of the road into the sea (see Figure 6).

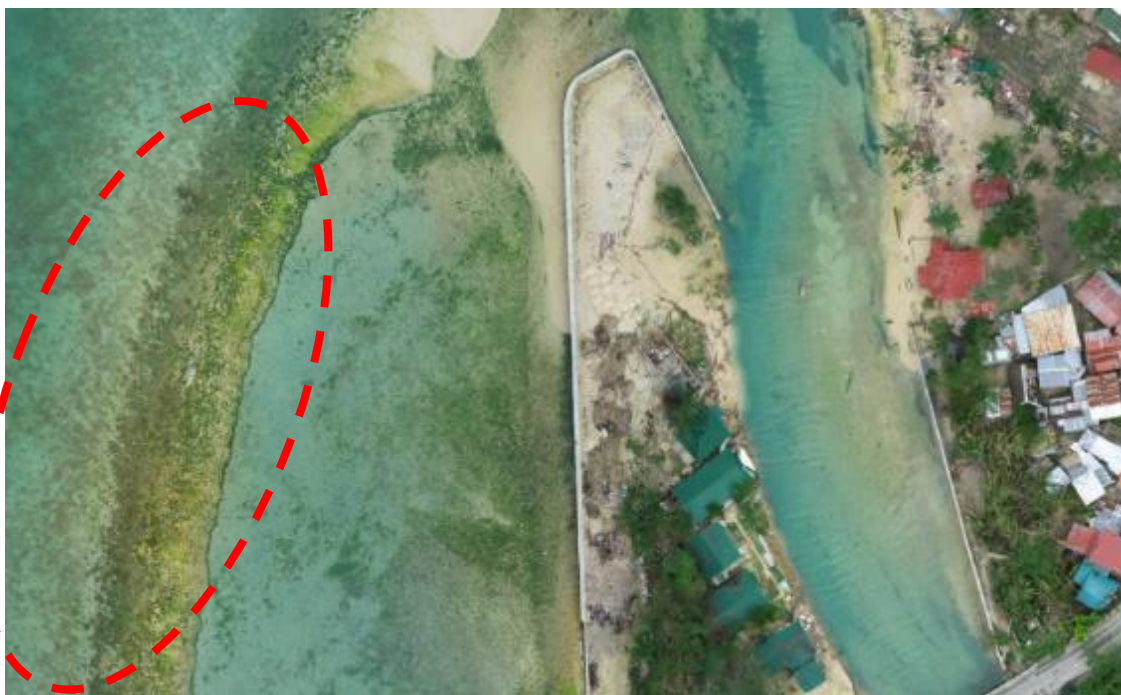
Figure 7. Boulder ridge created by the typhoon offshore Badian (from aerial drone surveys by the authors).

In Badian the coastline in front of Barangay Matutinao was surveyed, which had a seawall that survived the event, although some damage to its top return wall was observed. It was interesting to observe that in this area a boulder ridge had been created by the typhoon, at a distance of ~110 m from the seawall (see Figure 7). According to a local diver these boulders had been taken from the coral slope, from a depth of around 8-9 m. The corals in the area had been almost completely wiped out by the typhoon, which hit at high tide. However, no storm surge was reported in the area, with the observed damage to houses taking place as a result of the high waves and powerful winds.

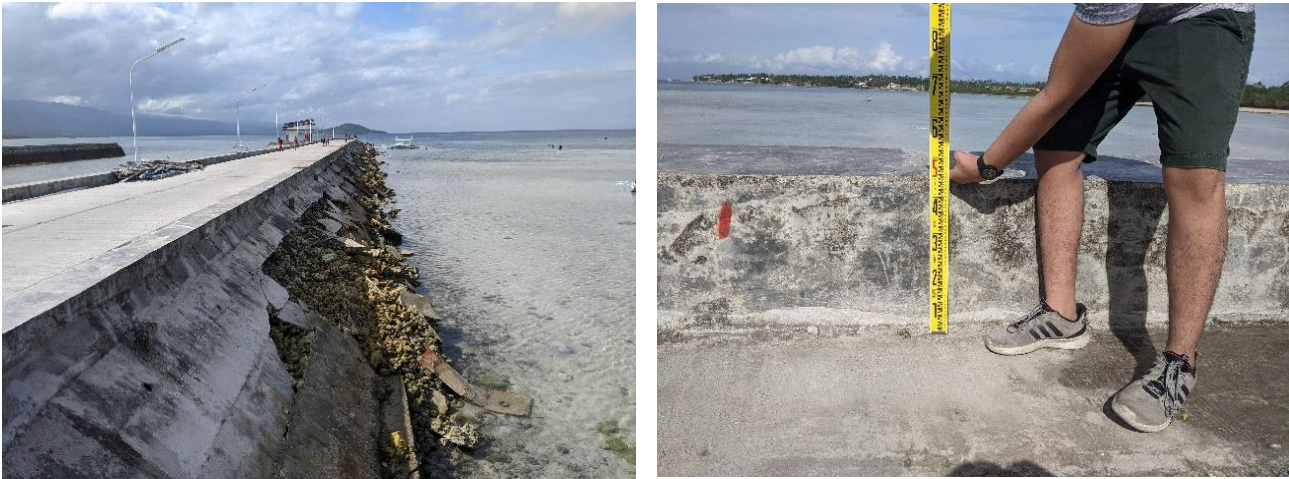
Figure 8. Left. Damage to port pier at Moalboal. Right. The storm surge level reached the top parapet on the side of the port pier.

At the port at the centre of Moalboal town a member of the coastal guard, who was the last person to evacuate the area at 22:30 on the day that the typhoon hit, after instructing all remaining fisherman to leave (some had not evacuated with the rest of the population in order to secure their boats), indicated that the storm surge reached the top of the pier (to a level of +3.23 m). The waves overtopped the pier and then inundated the houses behind (although the water that flooded the pier itself was mostly due to the overtopping waves). The pier itself suffered medium damage, with some of the concrete revetments slabs breaking and revealing the rubble fill (see Figure 8). Prior to the storm there were 280 registered boats in the area, but only 30% remained (and of those many had still not been fully repaired). At the edge of the reef flat there was a boulder line/ridge, which was already there before the coastal guard started working at Moalboal (likely transported there by an earlier typhoon event). It is unclear why this event did not transport or remove any boulders in the area (possibly due to the direction of the waves and local geography).

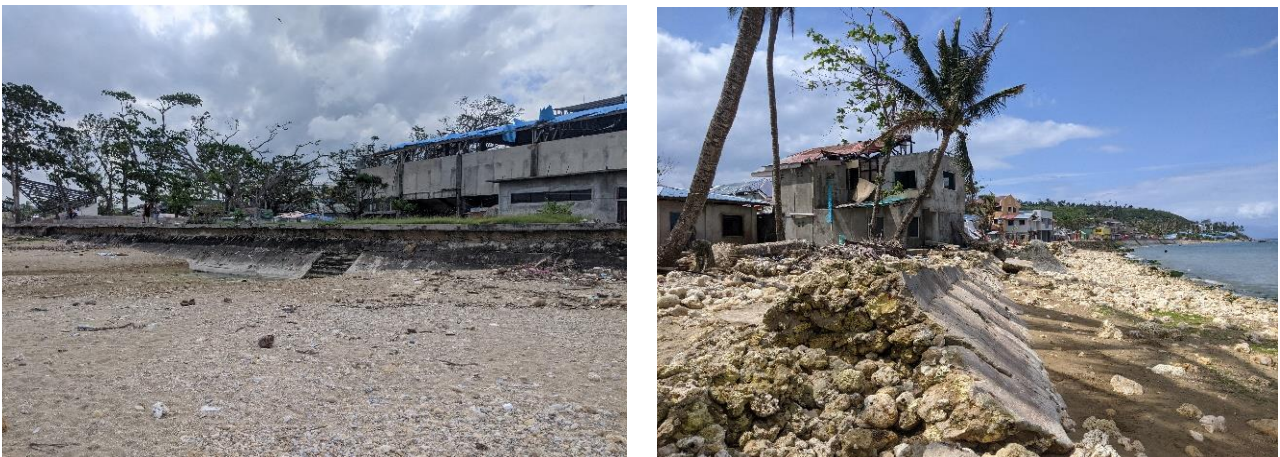
Figure 9. Left. The storm surge reached the top of the seawall in front of Dumanjug market. Right. The storm surge overtopped some of the older seawalls, with scour taking place behind them due to the waves.

At the Municipality of Dumanjug north of Moalboal the coastal area surveyed was in front of the open-air market, which was protected by a series of seawalls built at different times using a variety of designs. Two points were surveyed. At the first point two fishermen indicated the storm surge reached the top of the seawall, to a level of +2.91 m, but did not overtop it (see Figure 9). At a second survey point, about 100 m further down the coastline, residents indicated the inundation level at their house, to a level of 1.57 m above ground floor (again, to level of +2.91 m). The house was situated 30 m from the water, and suffered partial damage (it was built using concrete columns and a wooden/steel roof, with the roof being partially damaged by the waves). At this point the seawall suffered substantial damage, with much of the material behind it being removed by the waves (see Figure A8).

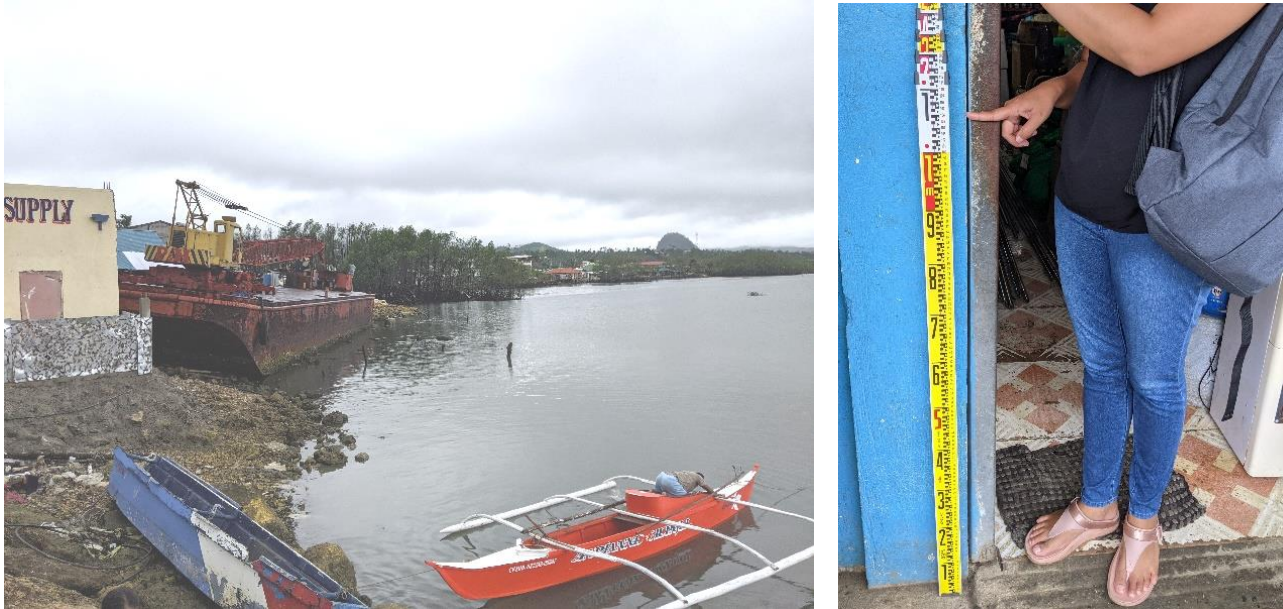
Figure 10. Left. Barge slammed into houses close to Tubigon port. Right. Inundation level in the shop seen on the left side of the figure.

The town is located in the northern part of Bohol, and has a ferry port with numerous daily connections to Cebu Island. A barge was carried by the surge and slammed into houses next to the port (See Figure 10), although many of them were subsequently rebuilt. At a house next to this barge, the inundation level reached 1.07 m above the floor, although there was substantial run-up that reached the main church of the town (situated around 430 m from the shoreline).

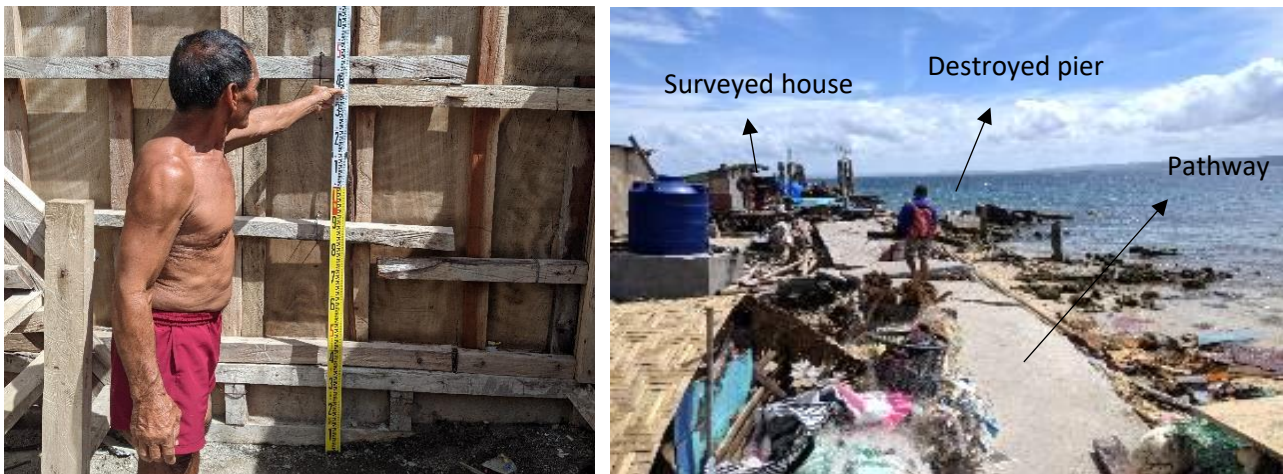
Figure 11. Left. A resident indicates the level of the water in front of the barangay hall. Right. At the right side of the photo is one of the houses surveyed in front of what is left of the pier (structure on the right side)

The storm surge submerged the low-lying Pangapasan island to a depth of 1.36 m (as measured in front of the barangay hall, see Figure 11). Many of the wooden buildings in the islands, and others that were sturdier but situated next to the sea, were destroyed by the waves. An elevated pathway that runs around the edge of the island, which offered some protection to houses situated inside of it (as opposed to those between it and the beach, which suffered more damage). One of the barangay councillors was interviewed, who reported that his house –a stilted construction located next to the shoreline- was washed away at 22:00. This happened due to the waves lifting his house and then transporting it away (although he had evacuated to his mother’s house within the island).

The residents of a wooden house situated next to one of the piers in the island (which was completely destroyed by the waves, see Figure 11) indicated that the water reached a level of 1.22 m from the floor of the house). They initially evacuated to the school, which was destroyed and this forced them to relocate to the 2nd floor of another house.

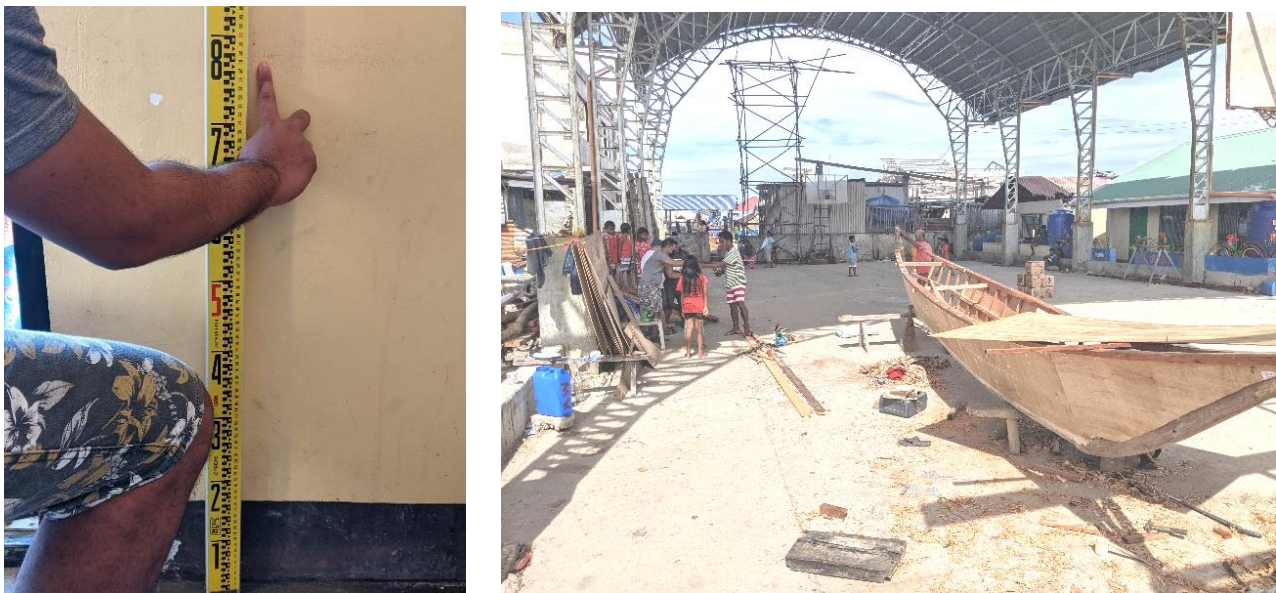
Figure 12. Left. Mudline in the barangay hall. Right. Basketball court adjacent to the barangay hall (building on the left side) and the remaining rainwater collection systems (blue cylinders on the right side).

This small island was one of the worst affected by the *2013 Bohol Earthquake*, currently suffering the most severe inundation during high tides, and is arguably the most impoverished settlement within those the Danajon bank. Many of the houses built around the circumference of the island were damaged or completely destroyed by the waves. A new barangay hall had been built next to the basketball court in the two years prior to the survey, and was covered by a steel roof which survived the winds with little damage. The barangay hall was built to a level higher than the buildings around it, although the storm surge flooded to a level of 0.77 m above the floor (as indicated by a mudline on the walls, see Figure 12). Most islanders evacuated to the 2nd floor of the barangay hall, although when the roof collapsed they had to descend to the ground floor (where they stood with water up to their waists).

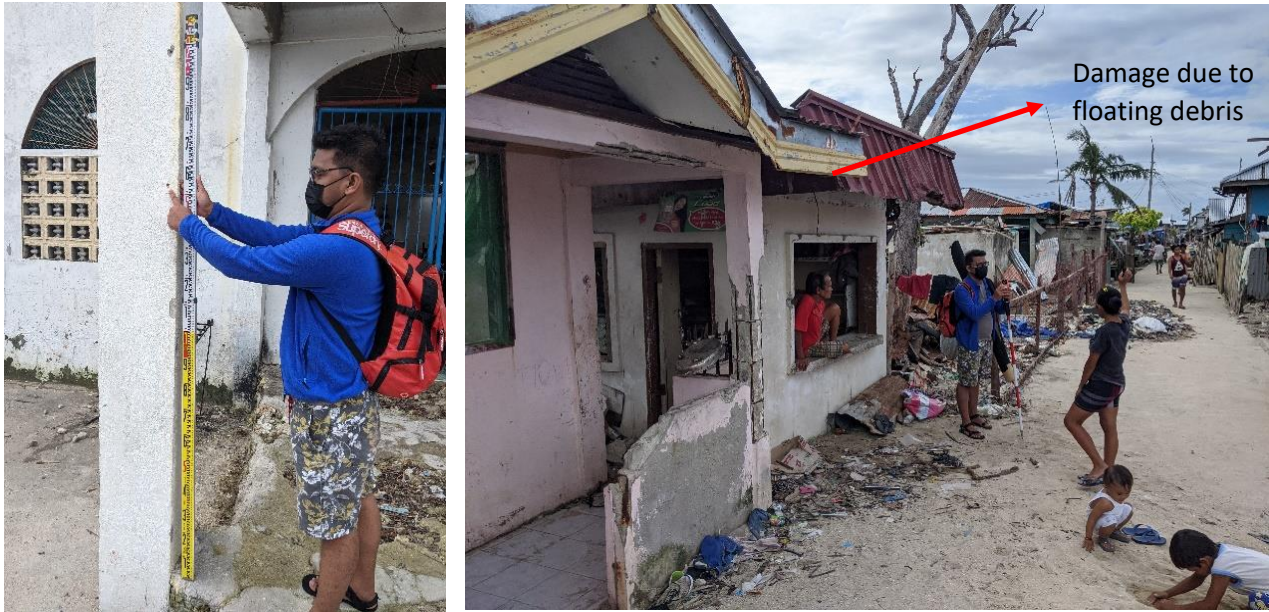
Figure 13. Left. Flooding level in front of the church of Isla Batasan. Right. Damage on edge of a roof due to floating debris.

This narrow-elongated island is protected around its circumference by mangroves that were planted over a decade ago, though many of them suffered due to the typhoon. There is only one path in the island that traverses it from one edge to the other, with houses located at each side of the road (see Figure 13). Measurements were taken at two locations. The church was flooded to a level of 1.53 m above the floor (see Figure 13). Another house located at a short distance away from the southernmost edge of the island was flooded up to the roof level, with locals indicating the debris damage it sustained. Interviews with the locals also indicated that, to the best of their knowledge, no families had permanently relocated to the mainland due to the typhoon. Indeed, many houses had been rebuilt to some degree, and the settlement appeared to be on a recovery path.

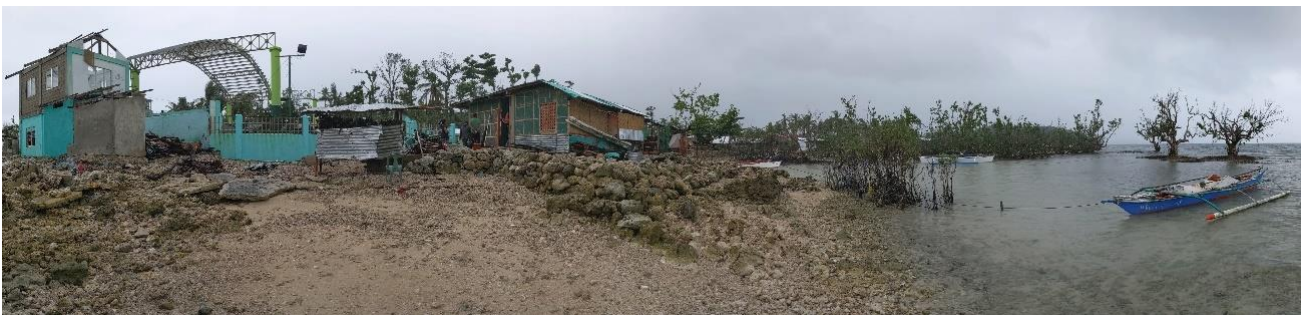
Figure 14. Rebuilt coastal house (at centre of the picture), adjacent to the basketball court.

This barangay faces the open ocean, and would have been subjected to the full force of the typhoon. In the area surveyed there was a basketball court, with residents of a house adjacent to it having been interviewed by the authors. The house was completely destroyed by the typhoon, leaving a thick pile of coral stones and gravel on top of it (the thickness of this layer was estimated at ~0.5 m, based on the interviews and the level of the rebuilt frame of the door, see Figure 14). Residents left this layer of rubble and, by the time of the surveys, they had rebuilt their house on top of it (the house also doubled as a small shop). While they had evacuated at 18:00 before the storm surge manifested itself, they indicated that they later found some of their belongings inside the basketball court (fully protected by concrete walls which survived the event), which indicated that it is likely that the storm surge was up to a level of +3.13 m. A resident of a nearby house indicated the run-up level on the side of an adjacent hill –they had also evacuated, but found many of their possessions along the typical debris line that forms on the side of hills after storm surges-, which corroborated the water levels estimated by the other household.

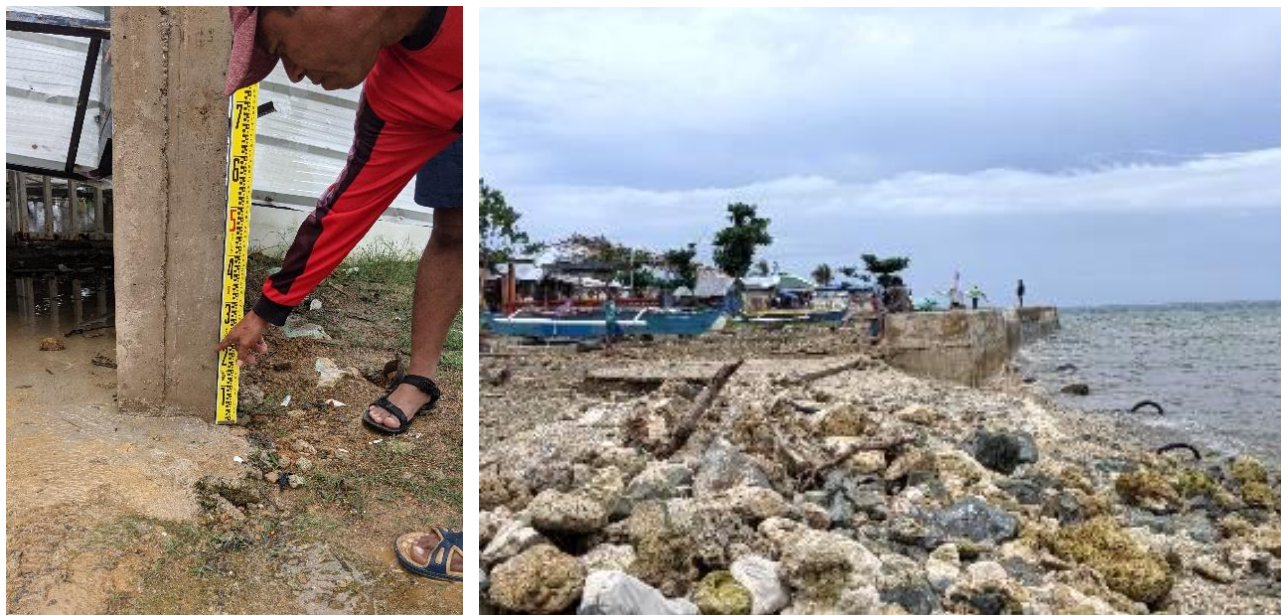
Figure 15. Left. Inundation level in front of the basketball court of barangay Santo Rosario. Right. New (far side of picture) and old (close side of picture) seawall at barangay Tugas.

The residents of a small concrete house where four other families evacuated (a total of 22 individuals, although the house was only dozens of metres from the shoreline) indicated that, at a barangay meeting the morning before the typhoon struck, residents had agreed to evacuate by 16:00 (by 14:00 the winds were already strong, and many of the houses in this area lost their roofs). The storm surge did not reach the house, although waters rose to a level of 0.19 m above the floor at a pillar next to the basketball court (at a distance of ~30 m from the coastline, see Figure 15, left).

In this area there was a seawall constructed around the edge of the settlement, with the newer concrete one surviving intact (though there was severe scour behind it), while the older one collapsed (see Figure 15, right). Houses located between the seawall and the road were completely destroyed by the waves, with a few having been rebuilt by the time of the survey (although by their own means, as they received no help from authorities or NGOs). Residents of one of the houses indicated that by 16:00 the winds were strong, and by 19:00 waves started to splash over the seawall, with the waters eventually reaching a level of 0.83 m above the floor (time at which they evacuated).
