Recovery and Identification of Burnt Remains in a Military Theatre of Operations:

The Warrior Six

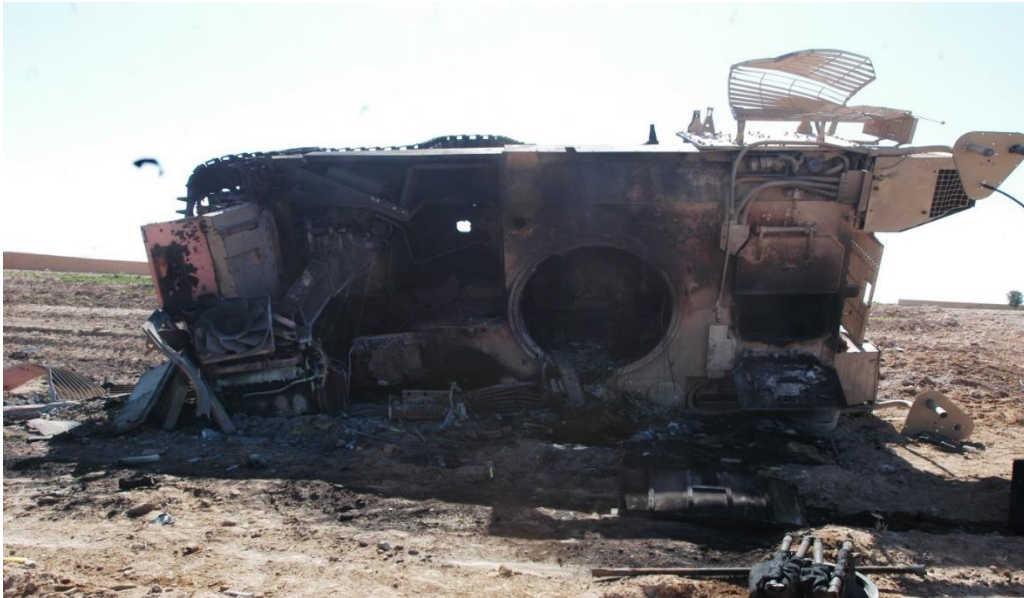
The turret was blasted off in the explosion and the vehicle was thrown onto its side (see Image 1), it set on fire and all six soldiers onboard were killed. The soldiers inside had been carrying a large amount of ammunition therefore the fire inside the vehicle was instant and intense. The bodies of Soldiers A, B and C, were ejected from the main part of the vehicle at the time of the incident and those of Soldiers D, E and F remained within the vehicle.

image 1: The Warrior vehicle blasted onto its side at the site of the explosion.

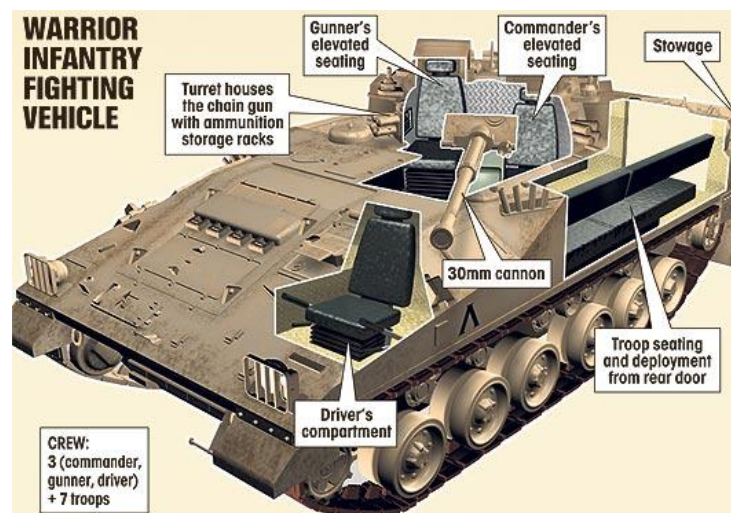
Figure 2: Design of a Warrior Fighting Vehicle Showing Position of Troops

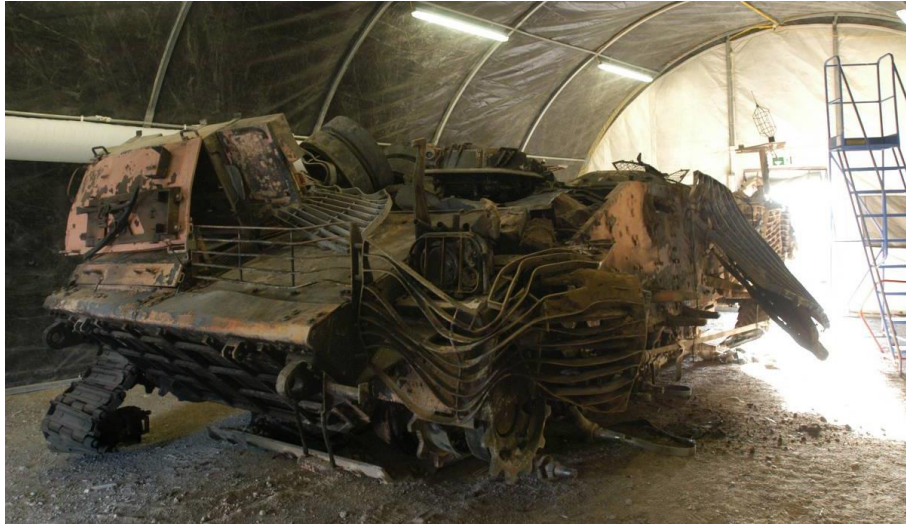
image 2. Exterior of Warrior vehicle struck by IED.

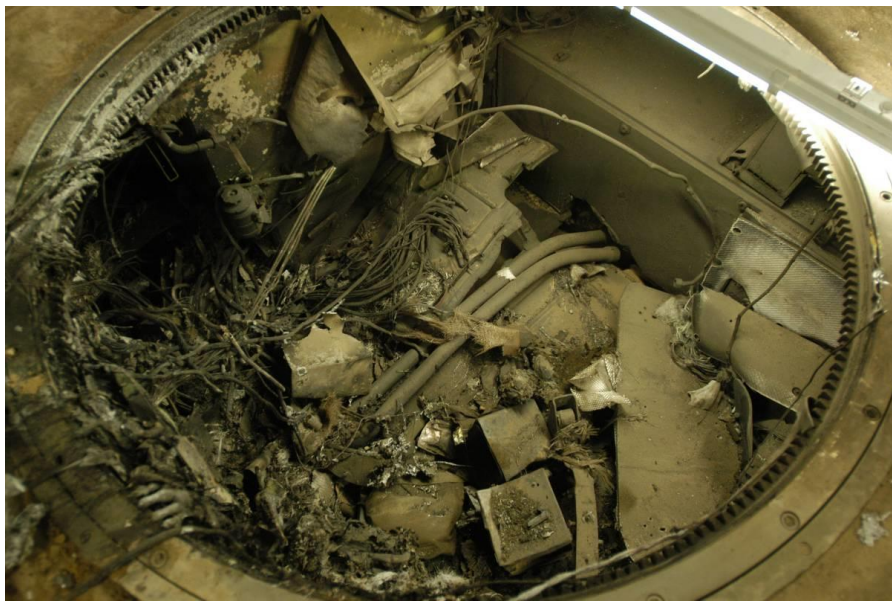
The interior of the Warrior vehicle could be viewed by standing on its roof and looking through the aperture left by the ejection of the turret in the blast (see Image 3). From this position it was possible to see that the interior of the vehicle was completely burnt out, filled with debris and burnt human remains. The majority of the disassociated bone fragments appeared to be completely calcined. As such, it was immediately apparent that it would not be possible to identify and re-associate these fragments with the main body parts of the soldiers by DNA analysis, and that other methods would have to be employed.

Image 3: Inside the vehicle, viewed through aperture left by ejection of the turret

During the preliminary assessment it was possible to see only two large body parts clearly. One (Soldier D) was in the driver's compartment and the other (Soldier E) was lying in the central region of the back of the vehicle. A possible third soldier (Soldier F) was partially visible, covered in rubble and lodged

underneath one of the rear seats. An inspection of the inside of the detached turret revealed that there were multiple fragments of burnt bone inside it which would also require excavation.

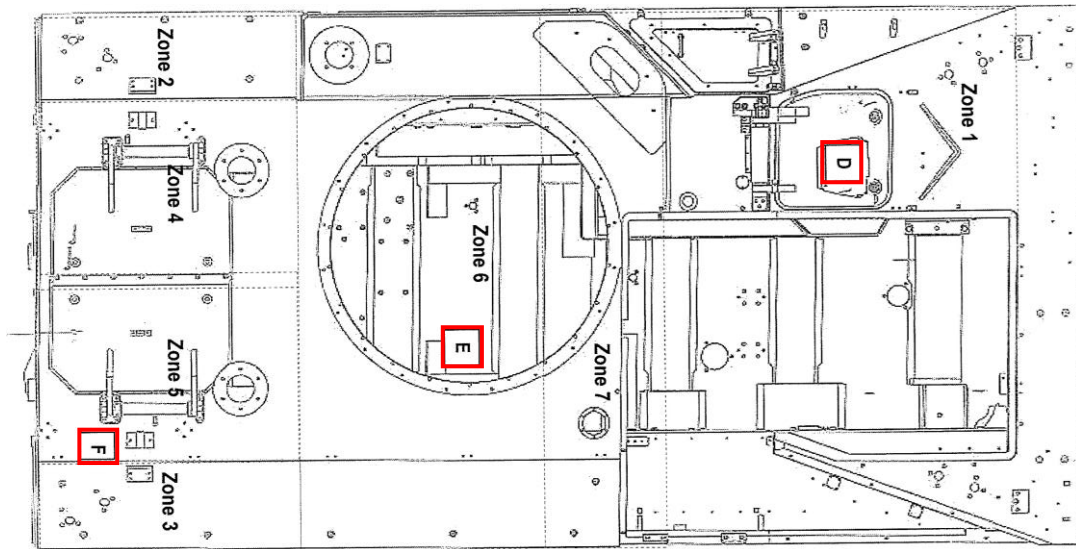
and the location of the main body parts. Figure 3 is a drawing which illustrates the zones and the incomplete bodies / body parts within the vehicle, produced prior to excavations commencing. The descriptions below Image 3 provide further detail of the Zones.

Figure 3: Plan drawing of the Warrior vehicle showing zones and location of main body parts for Soldiers D, E and F

Zone 1: The driver's cabin which formed a separate unit at the front of the Warrior vehicle. There was a small tunnel behind the driver's seat which would normally allow access from the driver's cabin to the rear of the vehicle. This was largely blocked by the driver's seat and usual access into the cabin would be through a door in the roof above the seat. The effects of the blast had caused the entrance of the tunnel to become blocked which meant that the cabin was effectively a sealed unit through which no fragments could pass in or out.

Zone 2: The area which extended along the top of the rear seats on the left-hand (driver) side of the vehicle. It included the side of the vehicle up to the level of the roof. The interior had been burnt away to expose recesses which formed metal shelves in the side of the vehicle.

Zone 3: The area above the rear seats on the right side of the vehicle, which extended up to the roof. It corresponded to Zone 2 on the opposite side, and it too was burnt out exposing metal shelves.

Zone 4: The floor at the rear of vehicle on the left side, beneath the seats and Zone 2. It extended as far as the end of the seats and inwards towards the middle of the vehicle where it met with Zone 5.

Zone 5: The floor at the rear of the vehicle underneath the seats on the right and Zone 3. It extended as far as the end of the seats and inwards towards the middle of the vehicle where it met with Zone 4.

Zone 6: The floor area in the centre of the vehicle beneath where the turret had been. It started at the ends of the seats on both sides where Zones 4 and 5 finished, and extended forwards for the full width of the vehicle as far as the edge of the breach in the floor caused by the explosion.

Zone 7: The interface between Zone 6 and Zone 1, this was a somewhat arbitrary area extending from the other side of the breached metal floor, across the full width of the vehicle, to the rear wall of the drivers cabin and Zone 1.

Zone 8: The interior of the turret which had been blasted off the roof of the Warrior vehicle.

In addition to the fragments and body parts inside the Warrior vehicle there were three body bags which contained burnt bone, soft tissue and earth recovered from the scene. The contents of Bag Z had been collected from directly underneath the turret and beneath the bodies of Soldiers A and B, so a preliminary assumption was made that the fragments within it belonged to them. Also recovered from the same location was a collection of 18 bones which had been exhibited separately. As these had fallen out of the turret when it was lifted, they were subsequently re-bagged as one collection, labelled Z2, and noted as also probably belonging to soldiers A and B. The other two body bags had not been assigned a letter, so they were labelled Bags X and Y by the anthropologist. These bags contained bone fragments that had spilled out of the vehicle through the aperture left by the turret. They had been closely associated with Soldier C but could also have originated from the commingled remains of Soldiers E and F in Zones 4, 5 and 6 (See Figure 3).

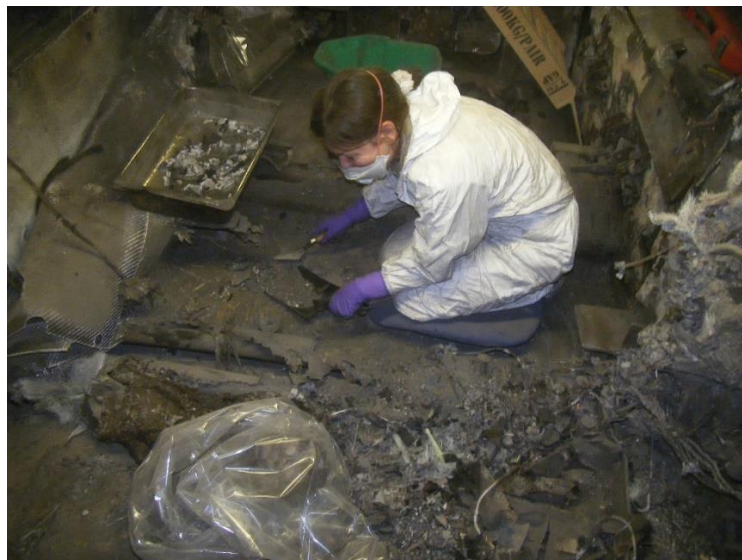
The large pieces of debris were removed from the top layer of rubble and preserved in a designated area within 'K Compound'. Following pre-excavation photography of the zone, the larger fragments of bone were recovered individually by hand and transferred to the temporary mortuary. The smaller fragments of bone which could not be separated from the dust and debris were removed by trowel and put into trays which were labelled according to zone. This material was then sieved by RMP and RAF police officers who had undertaken training in the recovery and identification of fragmented remains (a sieving station had been set-up adjacent to the vehicle). It was agreed that a 4mm mesh would achieve optimum recovery of identifiable fragments whilst still allowing the pace of the excavations to be maintained. All bone fragments recovered from the sieving were taken to the temporary mortuary for examination by the forensic anthropologist and the sieved material was retained. Image 4 shows the excavation in progress.

Image 4: Excavation of Zone 6 within the Warrior Vehicle

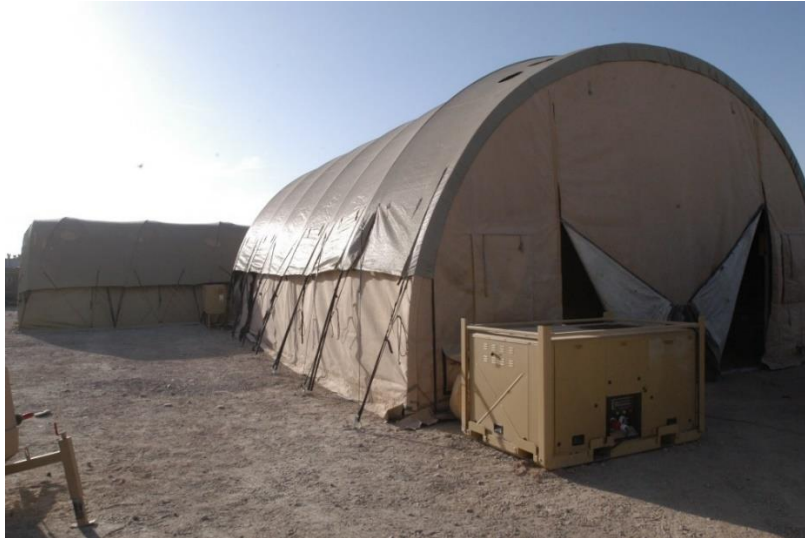
Image 5: Tent housing the Warrior vehicle with temporary mortuary to the rear, 'K Compound', Camp Bastion

A temporary mortuary was constructed by RMP officers within 'K Compound' immediately following the incident and prior to the arrival of the forensic anthropologist in Afghanistan. Mortuary facilities were available at the Role 3 Hospital but that was located a considerable distance away (Camp Bastion being 35 square kilometres in size) and, as an operational field hospital, it was focussed on treating large numbers of live casualties. The temporary mortuary was situated adjacent and to the rear of the tent which housed the Warrior vehicle and the sieving stations. Logistically this meant that it was easy for the forensic anthropologist and Service Police team to work between the two locations, and the distance for transferring the remains was minimal.

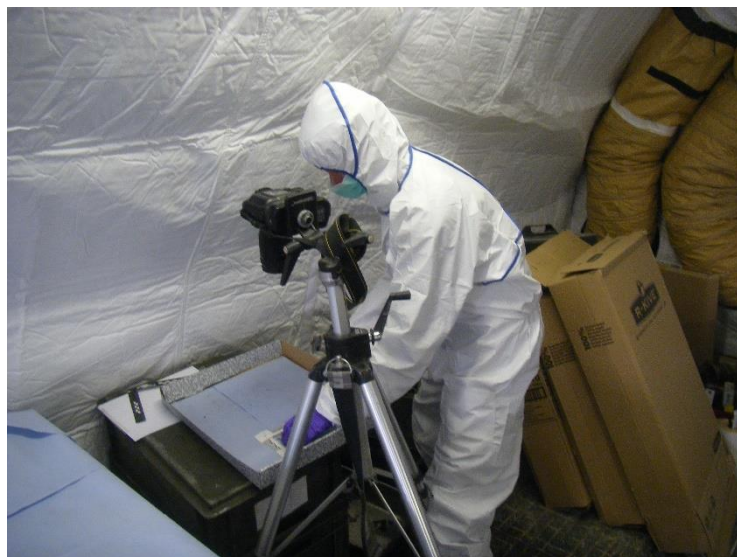
Image 6: RMP Photographer / Exhibits Officer within Temporary Mortuary

Full anthropological examination of the remains was difficult due to their burnt and fragmented condition and as the remains were so fragile, handling of all the body parts was kept to a minimum to prevent further damage prior to full post-mortem examination in the UK. All the fragments and associated items were photographed on arrival in the temporary mortuary by the designated RMP photographer who also acted as exhibits officer (see Image 6).

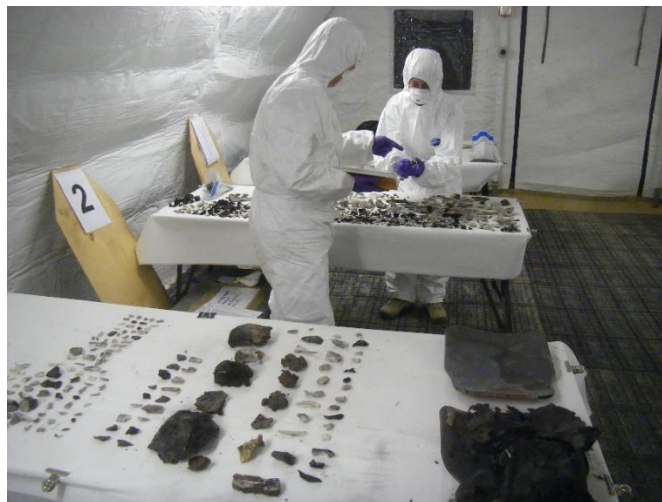
Image 7: Examination of smaller fragments and personal effects in the temporary mortuary

Excavations in the Warrior vehicle had to continue in conjunction with the fragments being received and examined in the mortuary, as there was considerable pressure to repatriate the remains as quickly as possible. To address this and enable progress to continue in both areas, a member of the Police Service team who had completed the specialist training in human remains was appointed as triage officer in the temporary mortuary. The triage officer was responsible for transferring the fragments from the photography station to the correct examination table and dividing them into skeletal elements. The forensic anthropologist periodically reviewed these preliminary identifications in advance of conducting the full examinations. Image 7 shows some of the smaller fragments being laid out on the examination tables together with body armour and other associated personal effects.

Each fragment of bone greater than 4mm in size was examined individually and, where possible, identified according to skeletal element or tooth. Fragment identification was aided by reference to White and Folkens (2005) and dental casts (ESP Adult Teeth Model Set). Observations relating to fragment size, colour and extent of burning were also recorded. The biological sex and ancestry of all six soldiers was already known. Age estimation was based on Scheuer and Black (2000) and Buikstra and Ubelaker (1994). Where available, the appearance of the pubic symphyses (Brooks and Suchey 1990) and the sternal ends of the ribs (Iscan *et al.* 1985) were also assessed. Information relating to age at death was in fact of limited use, as all the soldiers except for one had been within the same age range of 19-21 years. It was not possible to estimate the statures of any of the deceased due to fragmentation and distortion of the long bones caused by the fire. Where there was good preservation of soft muscle tissue on the larger body parts, an assessment could be made of body build. Any dentition was preserved for the specialist attention of a forensic odontologist rather than cleaned and examined. Images 8 and 9 show a typical example of a larger fragment of bone and a tooth root (respectively) which were recovered individually.

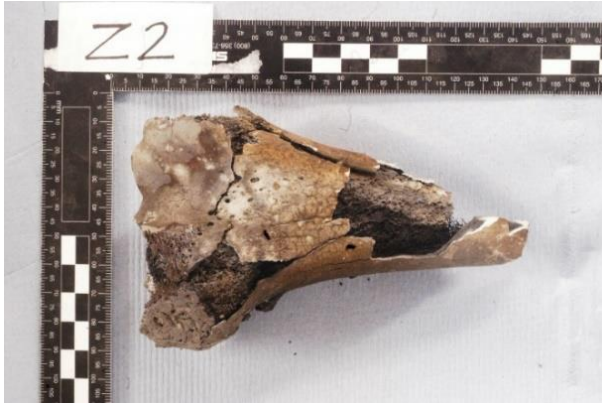
Image 8: Calcined distal end of femur

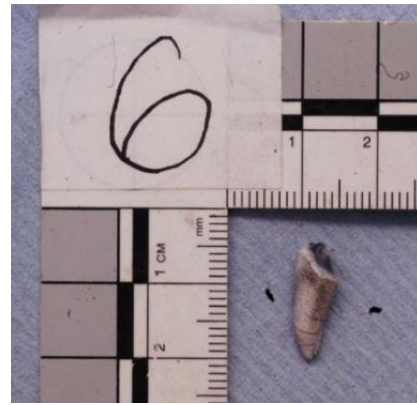
Image 9: Calcined Tooth Root
