#### Article

**Ridwan, R, Jemaa, Y and Yuniarto, E (2023) Various Methods of Strengthening Reinforced Concrete Beam-Column Joint Subjected Earthquake-Type Loading Using Fibre-Reinforced Polymers: A Critical Review. Journal of Applied Materials and Technology. 4 (2). pp. 42-55. ISSN**

# Various Methods of Strengthening Reinforced Concrete Beam-Column Joint Subjected Earthquake-Type Loading Using Fibre-Reinforced Polymers: A Critical Review

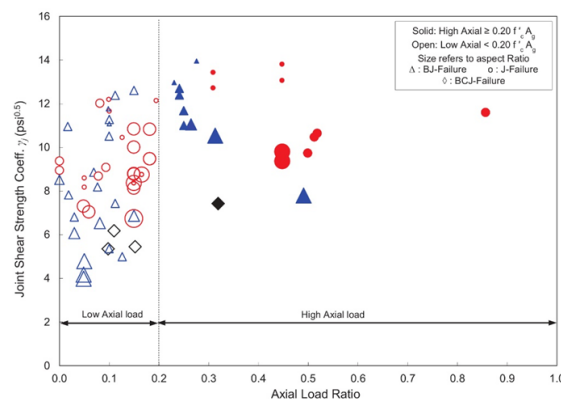
**Fig. 1.** The influence of the axial load applied to the column [15]

The influence of axial load level on the shear strength of RC BCJ is a complex phenomenon due to various factors that affect joint shear resistance. Clyde et al. [16] and Pantelides et al. [17] conducted empirical investigations and stated an increase in joint shear strength with higher axial loads. However, a thorough analytical analysis by Pantazopoulou and Bonacci [18] has indicated that the presence of axial load does not have a significant impact on joint shear strength. Figure 1 presents a graphical representation of the correlation between the axial load ratio and the coefficient of joint shear strength ( $\gamma_j$ ), where  $j$  denotes the joint shear stress scaled by the concrete strength. Hassan [15] has developed this graph based on a comprehensive database of 100 unconfined beam-column connection experiments from various literary sources. The study has identified three distinct failure modes: J, BJ, and BCJ. J failure mode occurs before column and beam bars yield precedes the joint failure, while BJ failure arises when the beam bars yield before the joint fails. On the other hand, failure mode BCJ occurs when both the beam and column bars yield before the joint failure takes place.

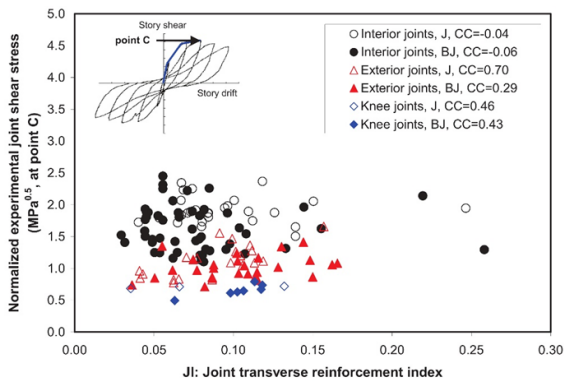
Fig. 3. The significance of confinement on joint shear strength [14]

The confinement index of the joint positively affected the shear strength of the joint. The confinement index of the joint was calculated with  $\rho_{sv}f_{yh}/f'_c$ , where  $\rho_{sv}$  is the ratio of the volumetric joint stirrup,  $f_{yh}$  is the yield strength of the joint stirrup, and  $f'_c$  is the concrete strength. Figure 3 illustrates that for external BCJ that fails in the joint, there were correlation coefficients of 0.70 and 0.74 between the proportion of joint stirrup to joint shear stress and strain at

Point C, respectively. This indicates that the quantity of joint stirrups affected the shear strength of J-failure exterior joints when the joint and beam bars remained elastic [14]. However, in all other scenarios, there seems to be no relationship between the joint transverse reinforcement index and the joint shear stress.

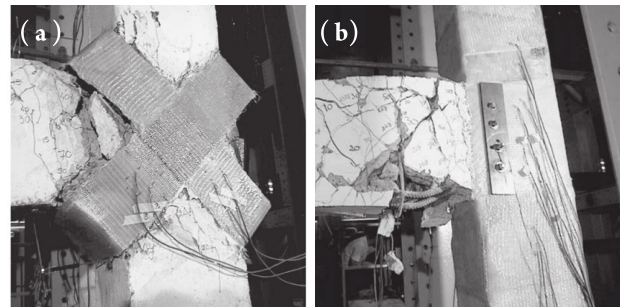
Fig. 4. The investigation by Ghobarah and Said [19] on the failure modes of strengthened specimens: (a) the specimen's shear failure mode was repaired using FRP without anchoring; (b) the specimen's ductile failure mode was repaired using FRP, a cover plate, and anchors through the joint.

Ghobarah and Said [19], El-Amoury and Ghobarah [20] and Ghobarah and El-Amoury [21] proposed performance-enhancing approaches to improve RC BCJ constructed before 1970. These methods involved reinforcing the specimens using steel plates and threaded rods that were core-drilled through the joint, combined with different fibre-wrap rehabilitation techniques, with or without mechanical anchoring. Figures 4 (a) and 4 (b) illustrate that the beams with anchoring failed due to flexural hinging, while those without anchoring experienced joint collapse by shear. The findings highlighted the crucial role of FRP anchorage in the effectiveness of FRP-enhancement methods for joints, showcasing how the recommended approach prevented brittle shear failure, improved the bonding necessity, and minimized the deterioration of joint stiffness.

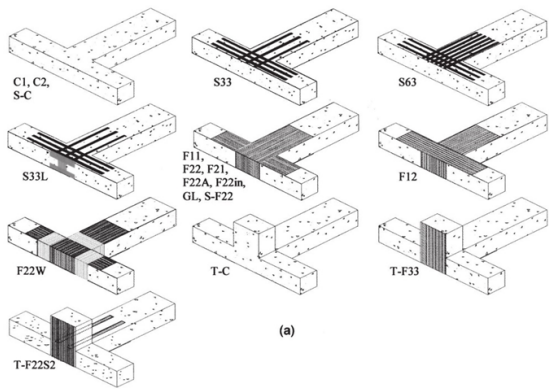
Varying fractions of CFRP and GFRP strips and sheets were utilized on the beam and column to repair the specimens. The fraction of FRP reinforcement refers to the ratio of the cross-sectional area of the FRP material to the cross-sectional area of the reinforced member. Figure 5 shows the application of CFRP and GFRP on the structural elements for each specimen. To enhance the bonding properties between the concrete and the FRP materials, the concrete surface was roughened, and debris was vacuumed away. The FRP layout was then marked on the specimen, and the FRP was cut to the required length. Acetone was used to clean the FRP strips, which were then adhered to the concrete surface using epoxy. A plastic roller was employed to ensure sufficient bonding and then the excess epoxy was cleaned from the concrete surface.

**Fig. 5.** Alternatives application of the FRP strengthening scheme by Antonopoulos and Triantafillou [22]

- a) Specimens with a higher fraction FRP layer had higher load and dissipated energy. However, the enhancement of load and dissipated energy was not equivalent to the addition of FRP as the FRP layer debonded from the concrete surface.
- b) The utilization of mechanical anchorages enhanced the capability of the FRP used in the strengthening scheme.

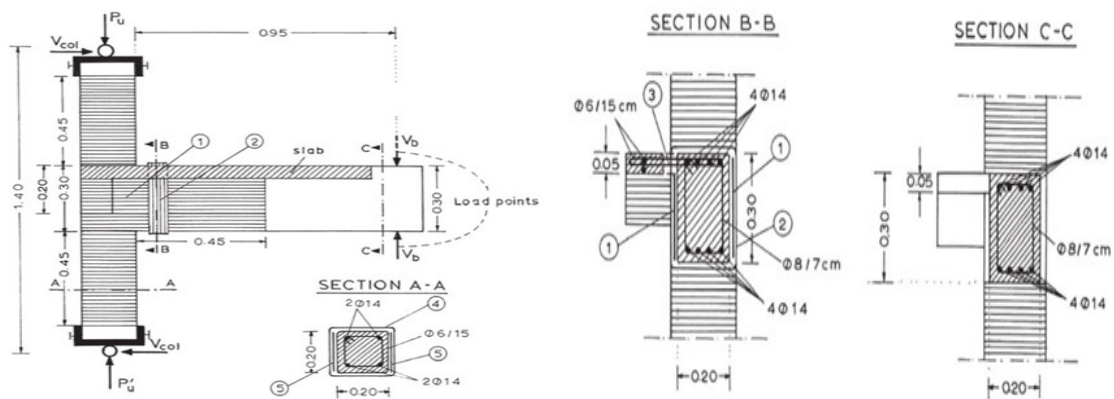
**Fig. 6.** FRP jacketing strengthening schemes [8]

The concrete surfaces were smoothed and rounded and then prepared for FRP strengthening by grinding. The installation of CFRP sheets followed a specific sequence: ten layers were applied in the joint area parallel to the beam's axis, CFRP strips were inserted for anchorage, an opening was created in the slab near the joint for additional CFRP layers around the beam, seven layers were wrapped around the column for increased shear capacity, and nine layers were applied to opposing column faces to enhance flexural strength (Figure 6).

For specimens strengthened with the concrete jacketing scheme, new stirrups were placed in the joint and the lower column. Subsequently, cement was grouted on both sides of the joint and column. The original specimen's concrete cover was removed and the surface was roughened using sandblasting so that the new and old concrete bonded perfectly.

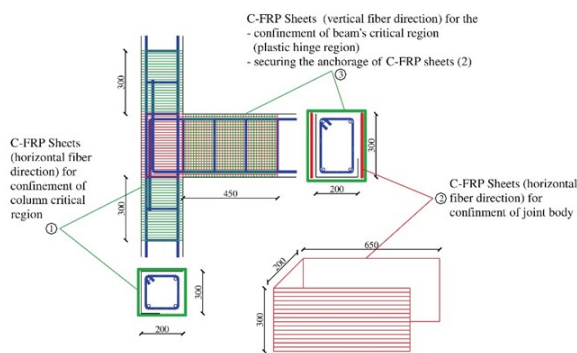
**Fig. 7.** The efficacy of a CFRP sheet strengthening scheme examined by Karayannis and Sirkelis [11]

Karayannis and Sirkelis [11] utilized CFRP and epoxy resin to enhance the behaviour of external RC connections. The initial samples were categorized into two groups: Group A, consisting of samples with no joint stirrups, and Group B representing RC connections with joint stirrups. Within each group, two specimens were subjected to moderate cyclic loads and then each damaged sample was repaired by filling the crack with resin and the other sample was wrapped with CFRP sheets. The third specimen in each group was strengthened with CFRP sheets before being subjected to any loads. The CFRP sheets were applied to reinforce the critical sections of the column, beam, and joint body, as depicted in Figure 7.

The proposed strengthening approach exhibited substantial improvements in the ability to withstand load, dissipated energy, and ductility, effectively shifting the failure

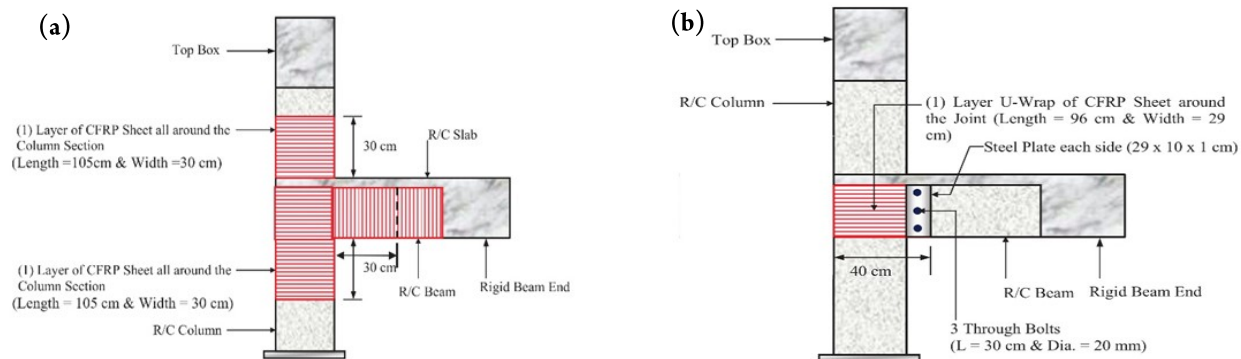
**Fig. 8.** Illustrations of the CFRP application in the strengthened specimen [23]: (a) Depiction of the first scheme; (b) Depiction of the second scheme.

In their study, Alsayet et al., [23] examined the efficacy of CFRP layers to improve the shear strength and ductility of seismically vulnerable external joints. The researchers constructed four specimens to replicate construction practices that did not meet pre-seismic code requirements, specifically lacking sufficient shear strength and transverse reinforcement. Among the specimens, two were left untreated as control samples, while the other two underwent strengthening using CFRP sheets in different ways. In the first configuration, CFRP layers were applied to cover the beam, joint body, and a portion of the columns (Figure 8 (a)). The second configuration focused on enclosing the beam-column connection with CFRP layers, reinforced with steel plates as mechanical anchors to prevent delamination (Figure 8 (b)). All sub-assemblies were subjected to reversal cyclic loads and the static load on the column was given equivalent to 20% of its axial capacity. The results highlighted the significant enhancement of shear strength and deformation capacity in beam-column joints through externally bonded CFRP sheets. The success of the strengthening approach was found to be influenced by the method of CFRP sheet installation and the presence or absence of mechanical anchoring.

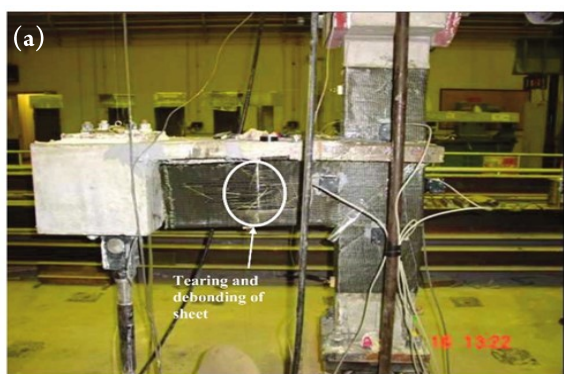
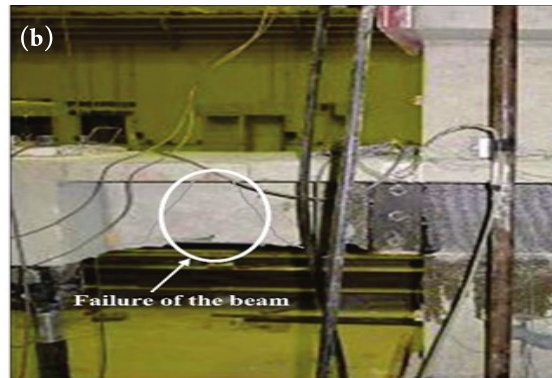
**Fig. 9.** The failure mode observed in the strengthened specimen following the test [23]: (a) Rupture and detachment of the repaired joint's ER1 sheet; (b) Failure of the beam in the repaired joint ER2.

The effectiveness of strengthening scheme #1 was evident as it improved the strength of both the joint and beam. However, without mechanical anchoring, delamination of the CFRP sheets occurred at higher load levels (Figure 9 (a)). On the other hand, strengthening scheme #2 proved to be more efficient by using CFRP sheets in a limited manner, but with the added benefit of mechanical anchoring to prevent delamination (Figure 9 (b)).

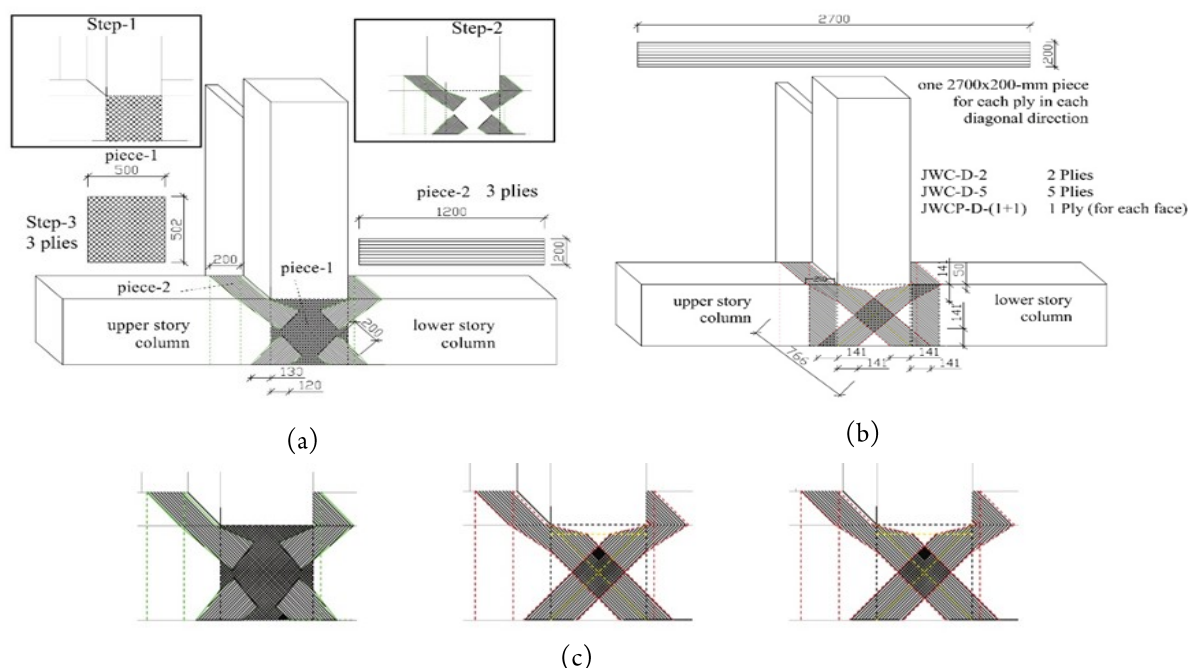
Fig. 10. Strengthening application [24]

were constructed with no stirrups in the joint. The elements of structures, namely longitudinal beam, transverse beam, column and slab, were included in the samples. The samples were subjected to the combination of reversal load on the beam end and static load on the column. The strengthening strategy and FRP installation are depicted in Figure 10. Two FRP sheets were utilized: the first formed a square shape around the joint core, while the second was diagonally positioned on top of piece 1 to ensure adequate anchoring. It was observed that using FRP sheets alone did not effectively prevent longitudinal bar slippage in the beam. Moreover, significant strength reduction appeared in the samples retrofitted with FRP layers and anchor bars.

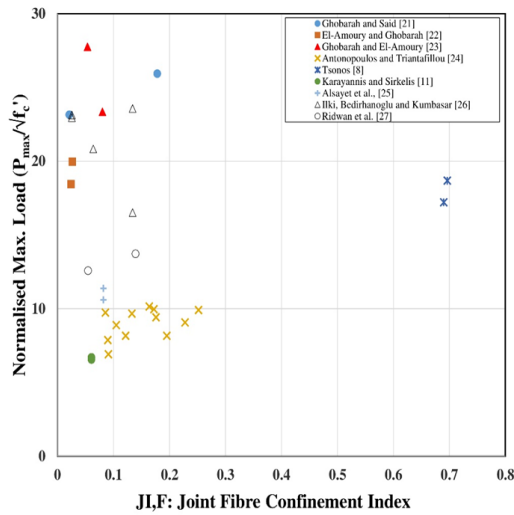
Figure 11 illustrates the load versus confinement relationship of the joint fibre reinforcement, normalized for experimental purposes. The findings suggest that the load behaviour is moderately affected by the confinement provided by the fibre reinforcement within the joint. For specimens with a lower confinement index ( $JL,F \leq 0.3$ ), the normalized load varied between 6 and 27 kN/ $\sqrt{\text{MPa}}$ . On the other hand, the specimens with a high confinement index ( $JL,F > 0.3$ ) had an average normalized load of 18 kN/ $\sqrt{\text{MPa}}$ .

Fig. 11. Influence of fibre confinement index to maximum load

Moreover, Table 2 and Figure 11 provide an explanation that as the axial load on the column increases, the specimens exhibit higher maximum loads. Specimens tested by Ghobarah and Said [19], El-Amoury and Ghobarah [20] and Ghobarah and El-Amoury [21] experienced five times greater axial loads compared to the average load applied to the other specimens. Consequently, the average normalized load at failure for these specimens was 1.9 times higher than the average load of the remaining specimens.

In addition, the specimen strengthened with the deep embedment (DE) method [25] resulted in a moderate normalized load compared to those strengthened with the external bonded (EB) method. The test results showed that the average normalized load of the DE-strengthening method was 93% of that of the EB-strengthening method.

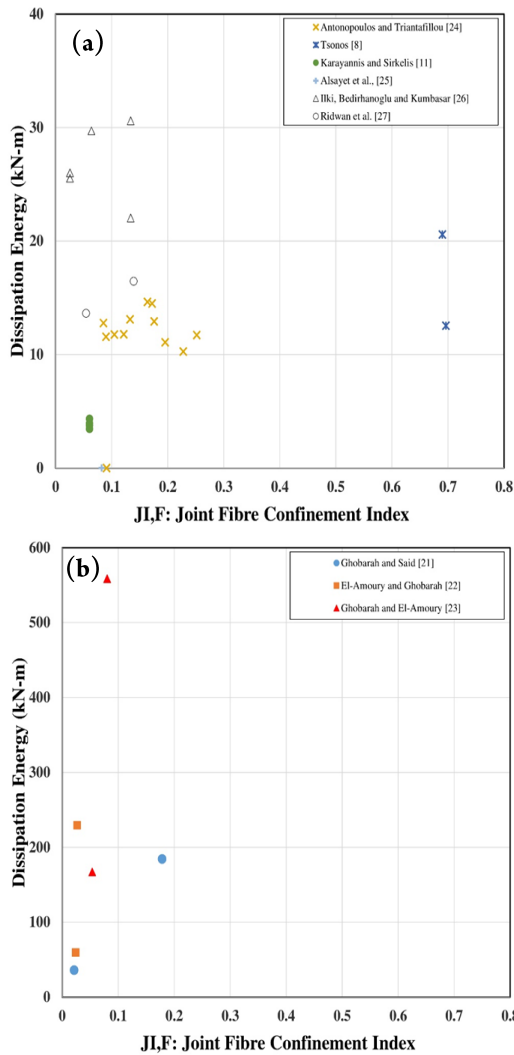
Fig. 12. Influence of fibre confinement index to dissipation energy. (a) Specimens with lower dissipation energy; (b) Specimens with higher dissipation energy.

Figure 12 depicts the relationship between dissipated energy and the fibre confinement index at the joint. The findings suggest that the dissipated energy is somewhat influenced by the fibre reinforcement’s confinement at the joint. For specimens with a lower confinement index ( $JI,F \leq 0.3$ ), the dissipated energy ranged from 3.5 and 558.6 kN-mm. Conversely, the specimens with a high confinement index ( $JI,F > 0.3$ ) exhibited an average energy of 16.55 kN-mm.

Additionally, Table 2 and Figure 12 elucidate that the axial load exerted on the column had a beneficial effect on the dissipated energy of the specimens. Specimens tested by Ghobarah and Said [19], El-Amoury and Ghobarah [20] and Ghobarah and El-Amoury [21] experienced five times greater axial loads compared to the average load applied to the other specimens. Consequently, these specimens demonstrated a remarkable 14.2-fold increase in their dissipated energy.

Furthermore, the specimens strengthened using the DE method [25] also demonstrated moderate dissipated energy compared to those strengthened with the EB method. The test results revealed that the DE-strengthening method achieved an average normalized load of 28.5% compared to the EB-strengthening method.
