The Application of Electromagnetic Waves in Monitoring Water Infiltration on Concrete Flat Roof: The Case of Malaysia

Kot, P, Shaw, A, Ali, A, Alias, A and Riley, ML (2016) The Application of Electromagnetic Waves in Monitoring Water Infiltration on Concrete Flat Roof: The Case of Malaysia. CONSTRUCTION AND BUILDING MATERIALS, 122. pp. 435-445. ISSN 0950-0618

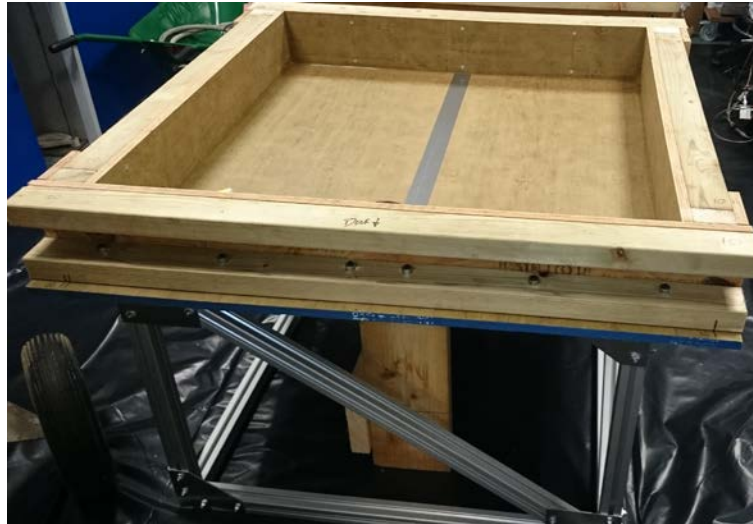
Figure 2: Roof structure frame without reinforcement.

376 Roof structure without reinforcement has dimension 100cm x 100cm x 23cm and is created

377 to Malaysian flat roof concrete proportion standards.

370 It was critical to design and build flat roof structures which would enable multiple test to be
371 undertaken in laboratory environment. One structure has been built without reinforcement
372 (Figure 2) and second structure has been built with reinforcement (Figure 3).

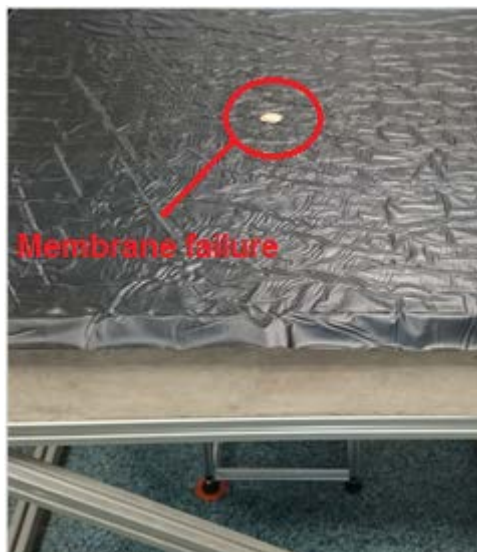
Figure 5: Roof with damaged membrane layer.

387 Figure 4 presents roof structure with a membrane without any faults, Figure 5 presents roof

388 structure with a membrane with a fault.

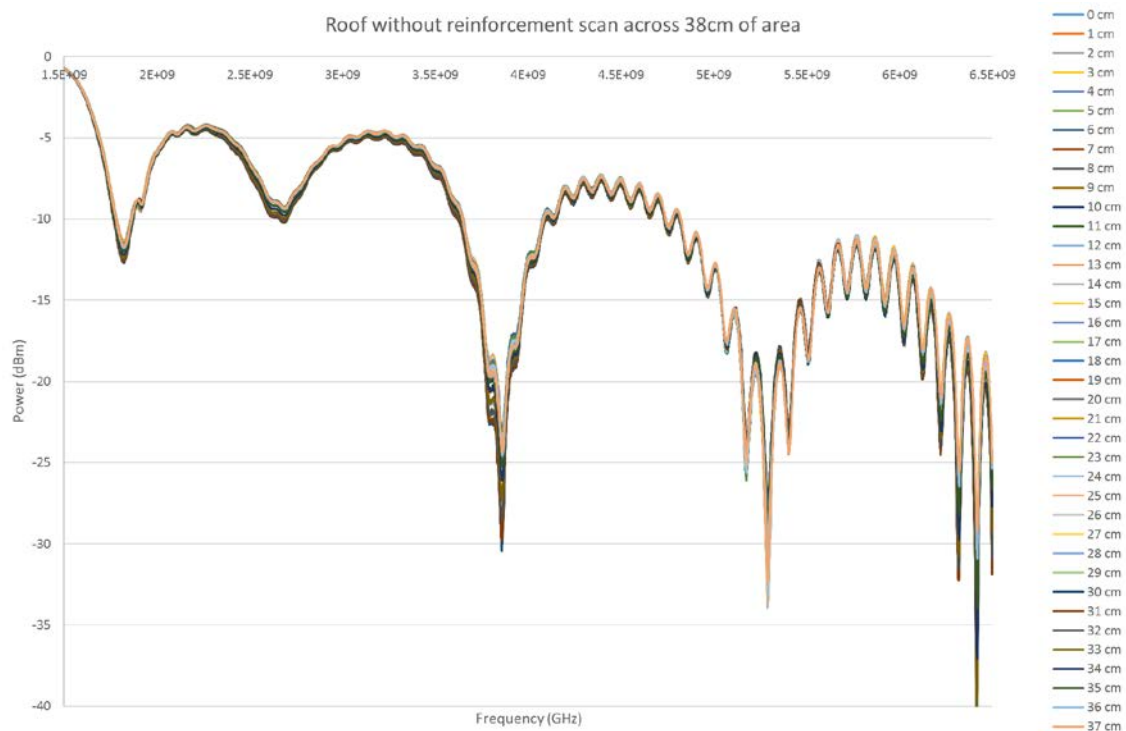
Figure 8: Roof scan without reinforcement.

411 Firstly, it was significant to collect the microwave spectrum signature to be able to identify
 412 uniqueness of flat roof structure. Measurement has been provided on roof structure
 413 without reinforcement, shown in Figure 8. Sensor has been situated 5mm from measured
 414 area and data has been collected across 38cm of the roof structure and recorded at every 1
 415 cm of sensor movement. Antenna has been configured to S11 parameter, which allows
 416 antenna to transmit microwave signal through concrete and to receive reflection signal from
 417 the object which had been under monitoring. Data presented in Figure 8 enables to observe
 418 that microwave spectrum does not change for that roof structure at every 1cm of
 419 measurement. This confirms that specific spectrum is unique for flat roof structure without
 420 reinforcement.

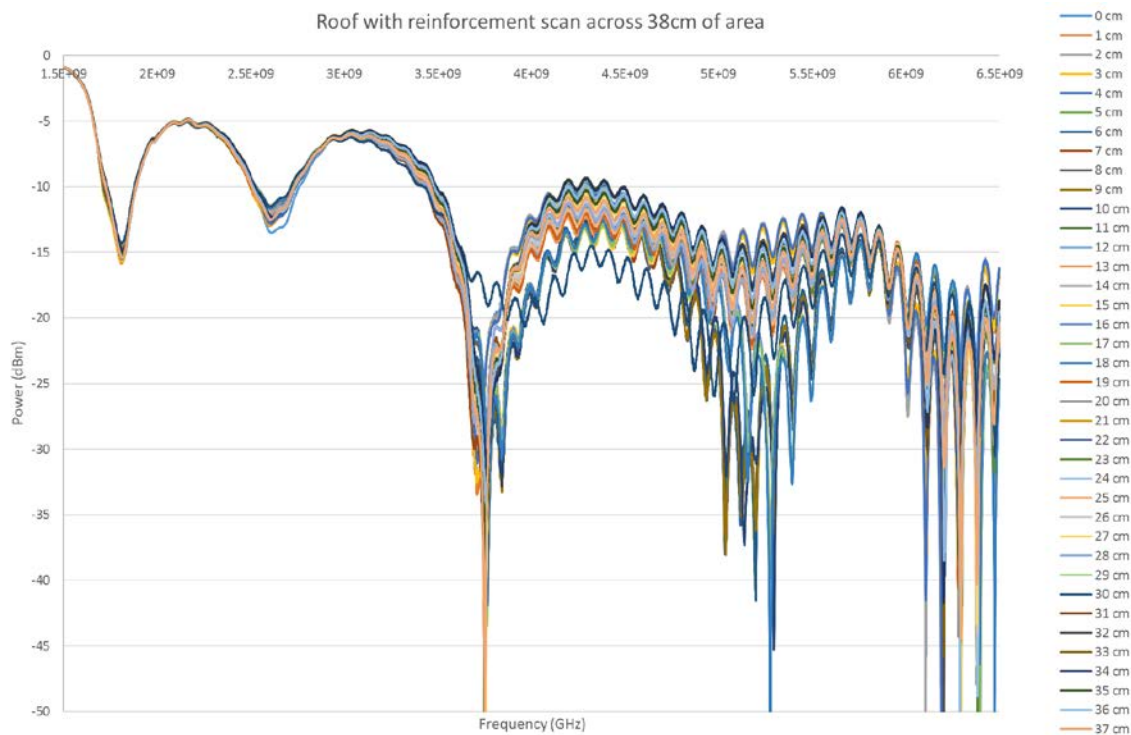
Figure 9: Roof scan with reinforcement.

424 Second experiment has been provided on roof structure with reinforcement and data has

425 been collected across 38cm of roof area. Every 1cm movement has been recorded and

426 analysed. Figure 9 presents results from the sensor. In this experiment antenna has been

427 setup in the same configuration S11 and it was located at the same distance from the

428 object. Unique concrete signature stays the same at the location between the rebar until

429 sensor will change its location closer to the reinforcement bars, then the unique signal is

430 changing due to dielectric properties of steel rebar which enables to identify that material

431 inside of the concrete structure. Microwave spectrum identifying rebar by shifting the signal

433 Developed algorithm allows to provide the distance between the sensor and the

434 reinforcement.

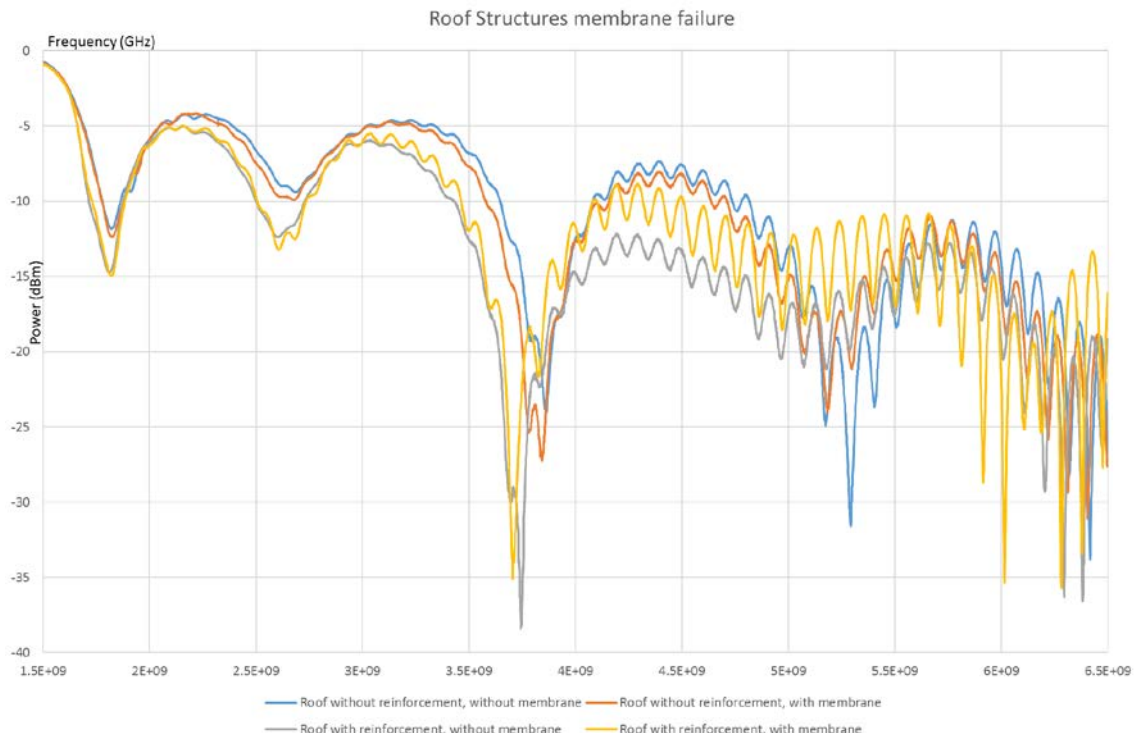
Another experiment that has been undertaken identifying the membrane failure of the flat

of the membrane.

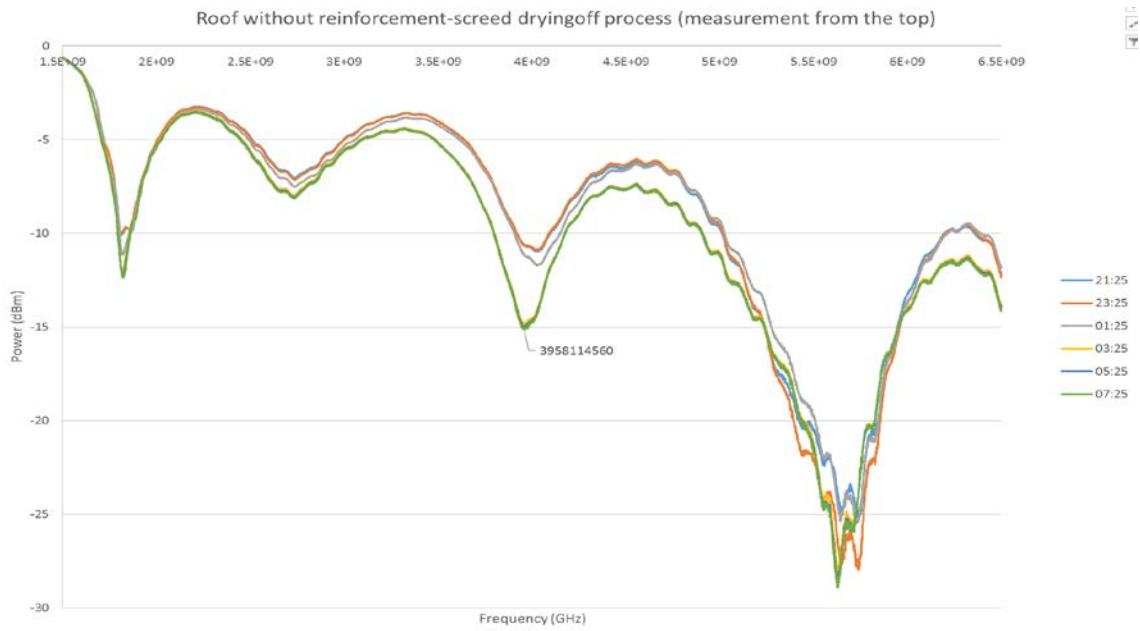
471 Final experiment has been undertaken to monitor drying off process of the flat roof without
 472 reinforcement. Antenna has been placed on the top of the screed layer. Data has been
 473 recorded every 2 hours. Results are presented on the Figure 13. Microwave spectrum
 474 amplitude has been shifted, while flat roof layer has been drying off. Dielectric properties of
 475 water enables water to absorb microwave signal well, which cause amplitude shift when the
 476 water is evaporating from the roof structure.
