The Application of Electromagnetic Waves in Monitoring Water Infiltration on Concrete Flat Roof: The Case of Malaysia

P. Kot¹, A.S. Ali², A. Shaw¹, M. Riley¹ and A. Alias²

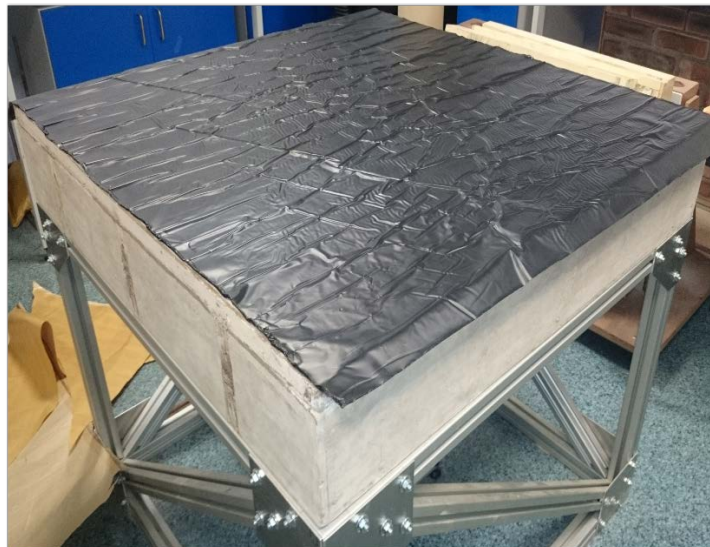
Figure 4: Roof with a membrane layer

387 Figure 4 presents roof structure with a membrane without any faults,Figure 5 presents roof

385 Flat roof structure has waterproof membrane between the screed layers. Waterproof

386 membrane rubber sheet has been used to determine if it is possible to detect any faults.

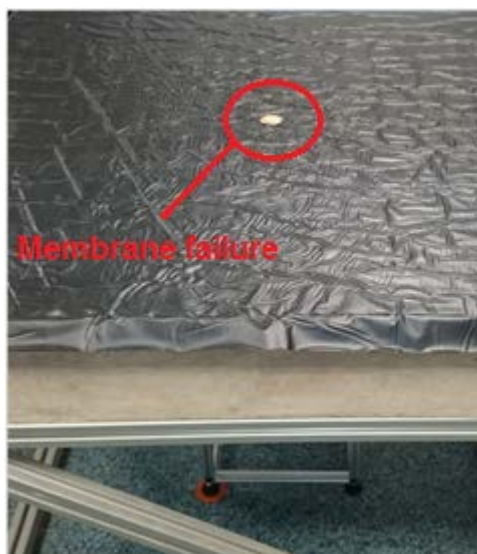
Figure 5: Roof with damaged membrane layer.

388 structure with a membrane with a fault.
