Does a micro-grooved trunnion stem surface finish improve fixation and reduce fretting wear at the taper junction of total hip replacements? A finite element evaluation

Ariyan Ashkanfar, David J. Langton, Thomas J. Joyce

To appear in: *Journal of Biomechanics*

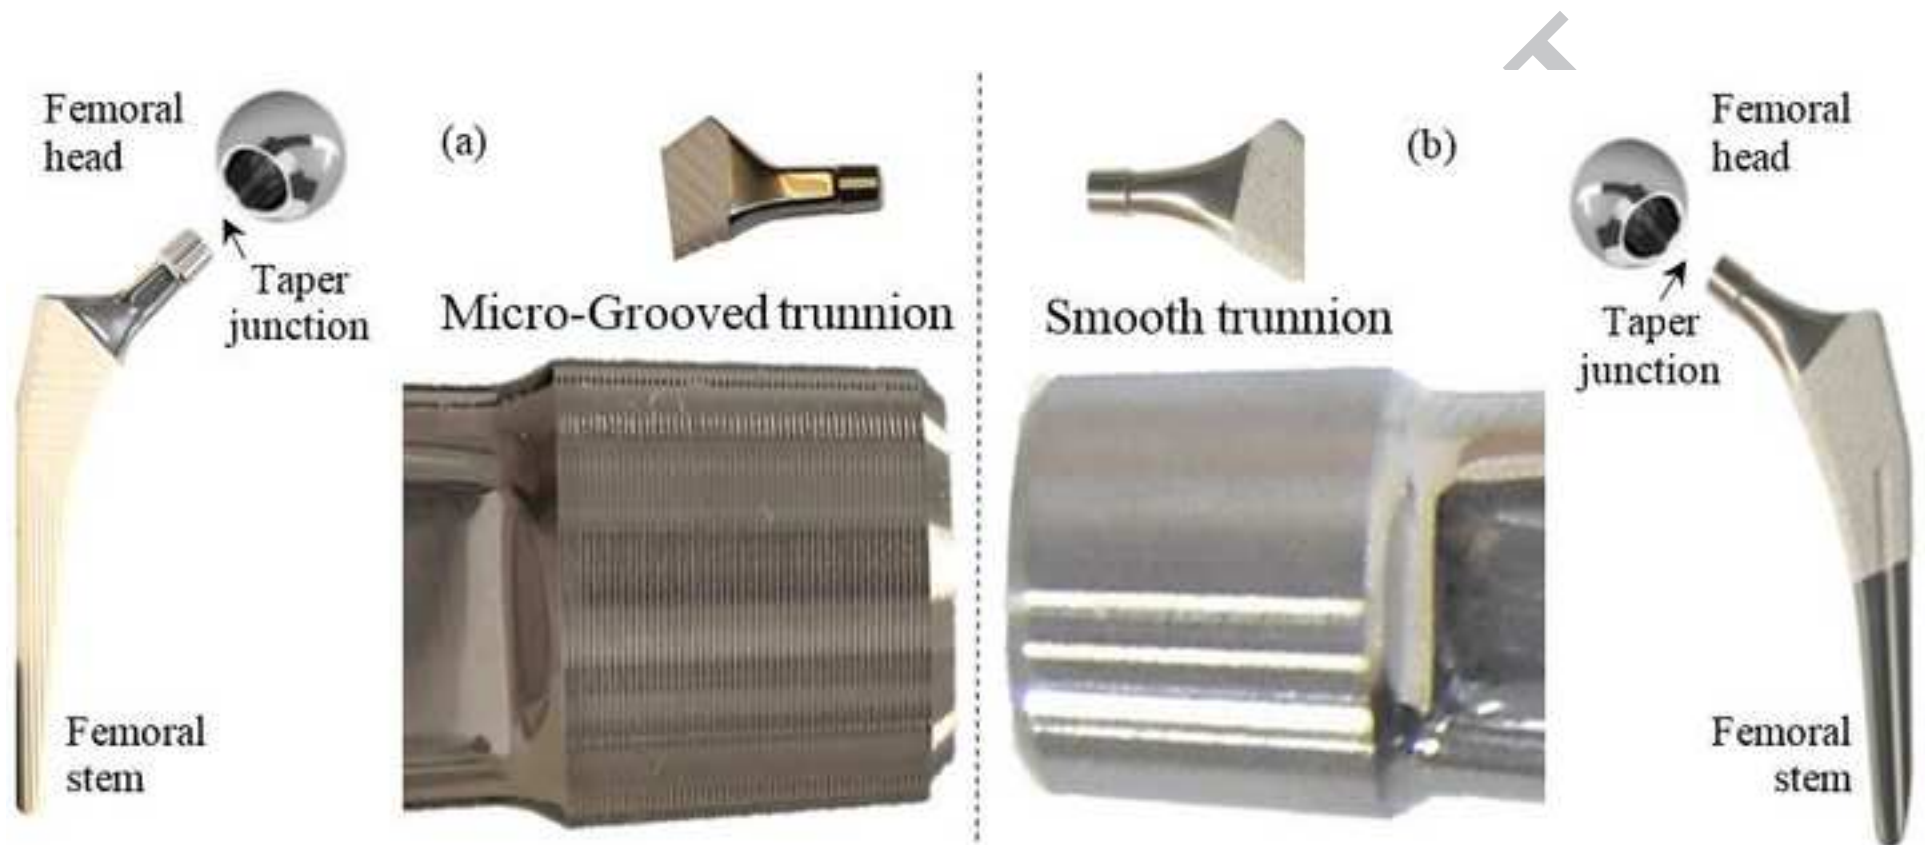
Figure 1: CoCr femoral head and Ti femoral stem of THRs; 36mm femoral head with smooth taper surface finish mated with femoral stems with (a) micro-grooved trunnion stem and (b) smooth surface finish.

The use of separate components (modularity) in total hip replacements (THR) is very common, allowing flexibility intra-operatively to facilitate optimum prosthetic functionality and anatomical fit for individual patients. In addition, modularity allows the use of different materials for different components – e.g. cobalt-chromium (CoCr) for femoral heads due to good wear properties, and titanium (Ti) for femoral stems in order to encourage bone ingrowth. On the femoral side of a THR, the modular connection involves a taper junction between the femoral stem (trunnion) and the internal taper of the femoral head (see

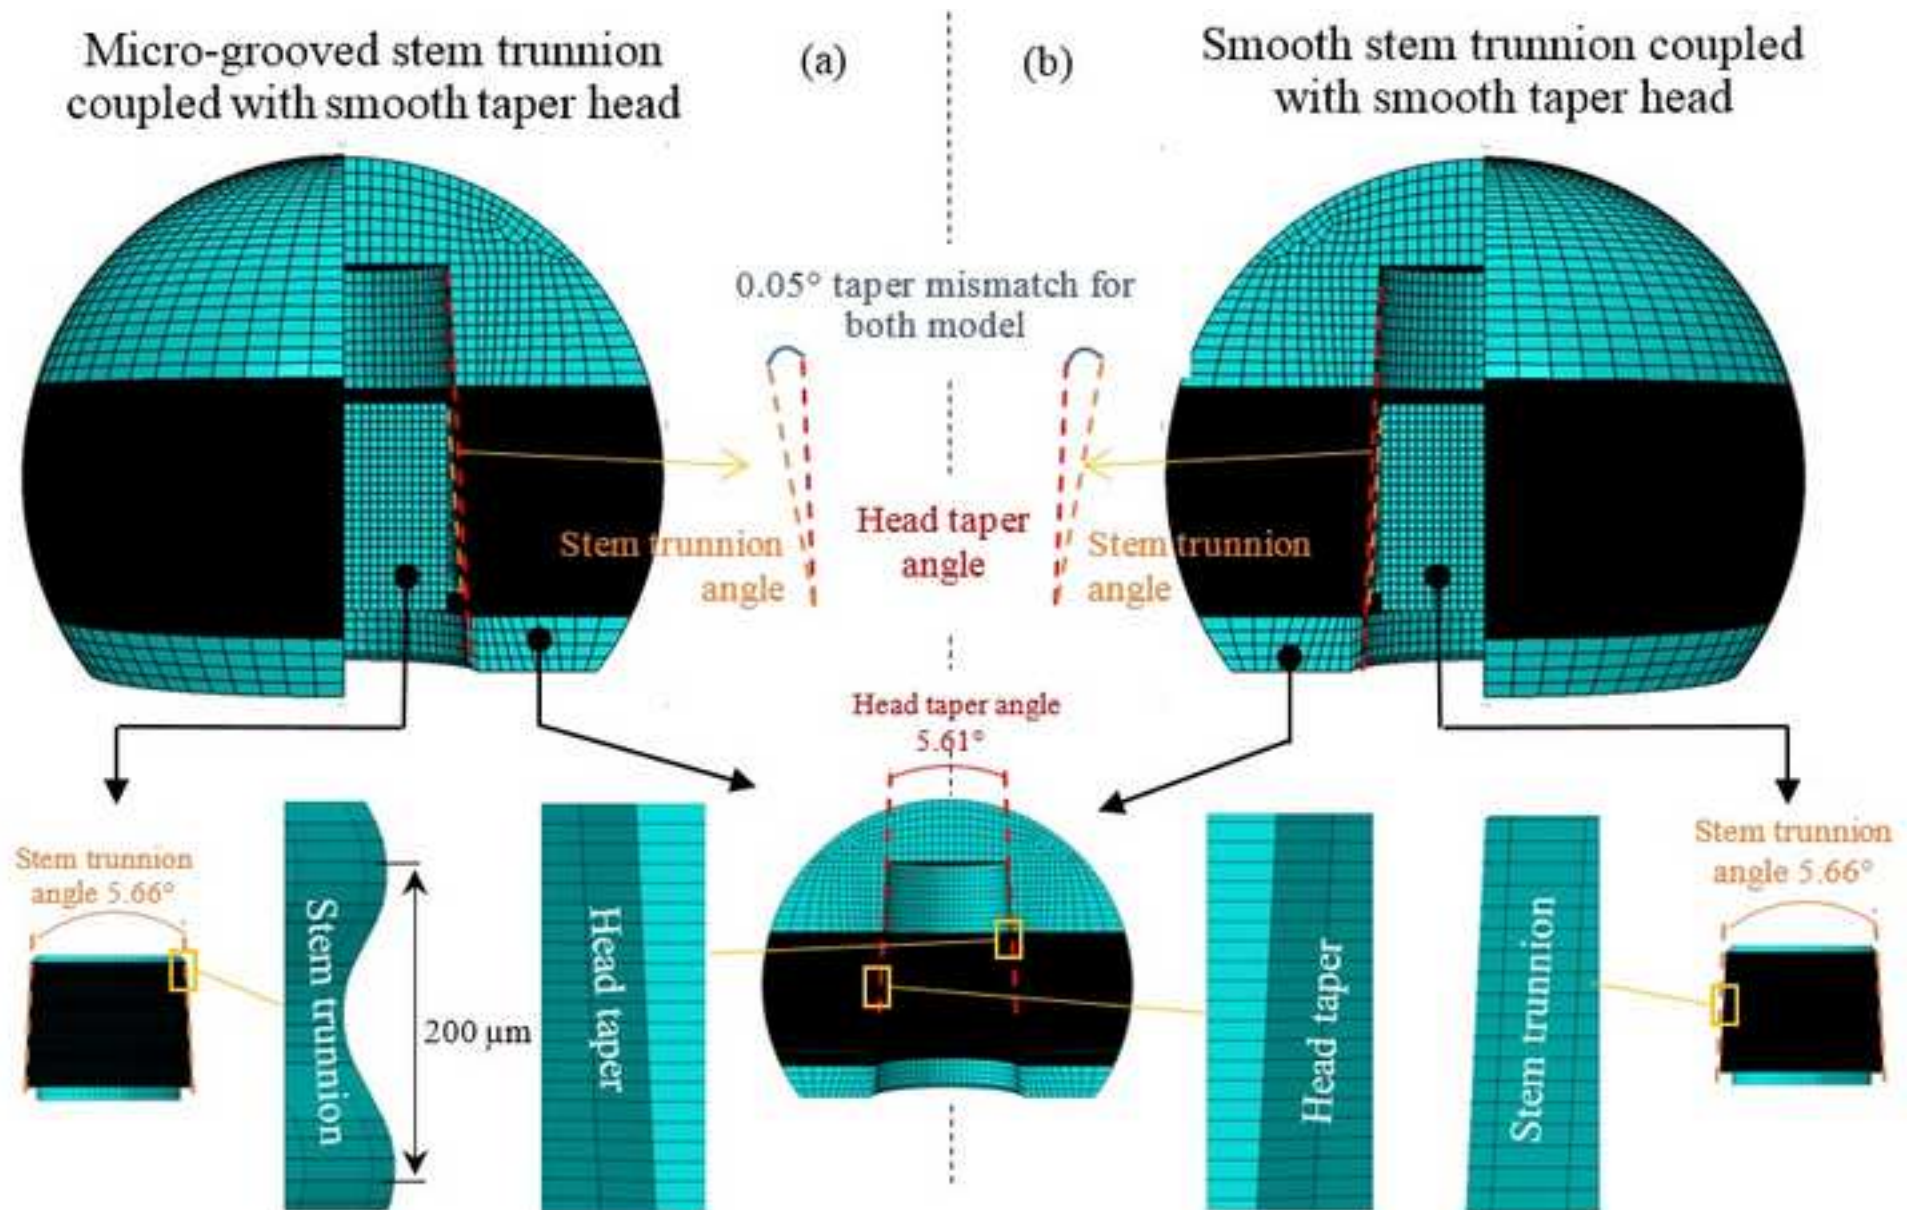
Figure 2: FE model and mesh distribution of the head and stem of THRs; smooth femoral head taper mated (a) with micro-grooved trunnion stem with 200 μ m spacing (Munir et al., 2015) and (b) with smooth trunnion stem; 5°36' head taper angle (in red) and 5°39' stem trunnion angle (in orange) (Brock et al., 2015) produced 3' base-locked taper mismatches for both models.

Two femoral stem FE models, one with machined micro-grooves and the other with a smooth trunnion surface finish, both coupled with a 36 mm diameter CoCr femoral head with a smooth taper surface finish, were modelled in ABAQUS (6.14-3 ABAQUS Inc) (see

Figure 2). A base-locked taper mismatch – where the taper and trunnion surfaces engaged at the base of the interface – of 3° between taper and trunnion was selected (see

Figure 2) (Ashkanfar et al., 2017). The key difference between the models was the trunnion surface roughness as shown in

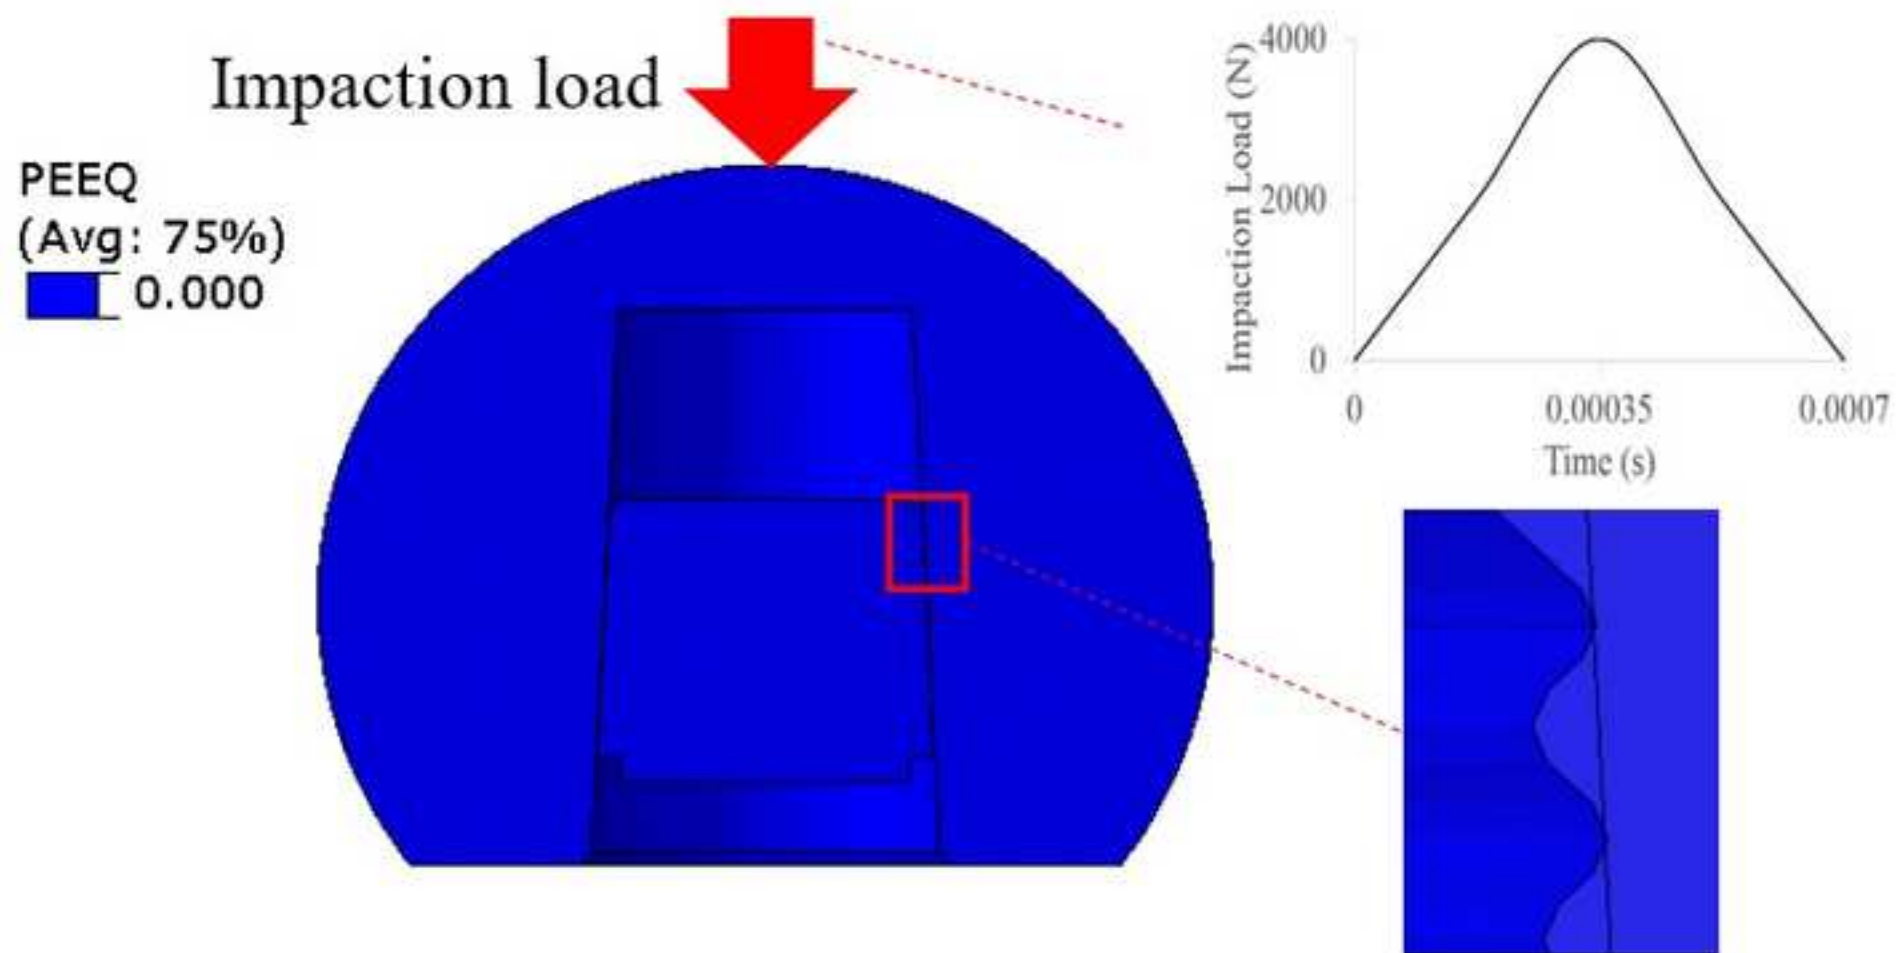
Figure 3: Equivalent Plastic Strain (PEEQ) showed no plastic deformation at the grooves of the femoral trunnion stem associated with FE initial impact Elastic-Perfectly Plastic analysis

The impaction analysis was executed as a dynamic implicit analysis (see (English et al., 2016) and Figure 3 for full details). Furthermore, in this study, the plasticity included in the FE impaction analysis and simulated as an FE Elastic-Perfectly Plastic analysis, was undertaken to investigate whether any plastic deformation of the micro-grooves would occur due to the initial assembly force.

During the impact analysis, 4kN impact load with the load time history as shown in Figure 3 was applied on the top of the femoral head. The overall aim of machining grooves onto the stem trunnion stem is said to be that the grooves enhance the fixation at the taper junction (Munir et al., 2015). However, in this study, the result showed no Equivalent Plastic Strain (PEEQ, ABAQUS field output) as illustrated in Figure 3. Figure 6 details the contact pressure distributions along the trunnion surfaces. As expected, the maximum contact pressure was localised at the distal edge of the models due to the base-locked taper mismatches. The maximum contact pressures were approximately 196 and 385 MPa for smooth and micro-grooved trunnion surfaces respectively. These stresses illustrate that no plastic deformation could possibly occur based on the initial impact assembly load for CoCr/Ti material combination.

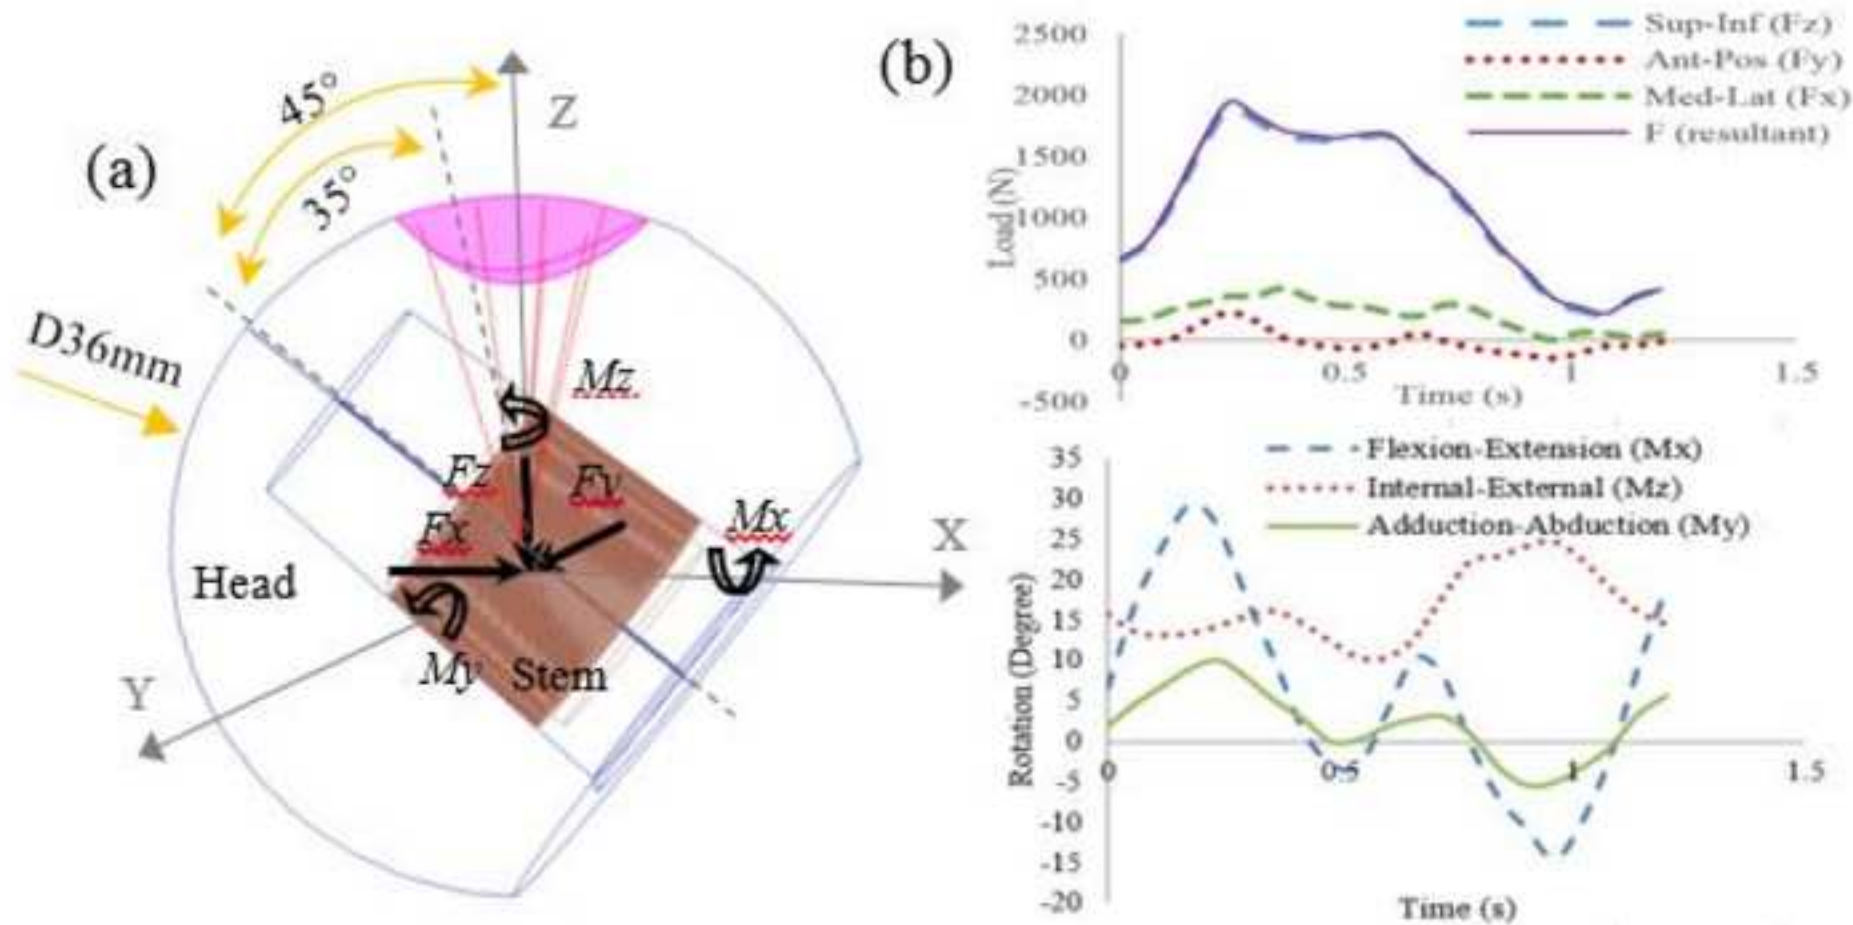
Figure 4: Schematic presentation of the finite element loading

The loads and rotations of a walking step were assigned on the models as shown in Figure 4 and described earlier in detail in (Ashkanfar et al., 2017). These loading and boundary conditions create an efficient and realistic walking simulation which was applied to a dynamic implicit analysis step discretised into 10 equal time intervals over a 1.2 s period.

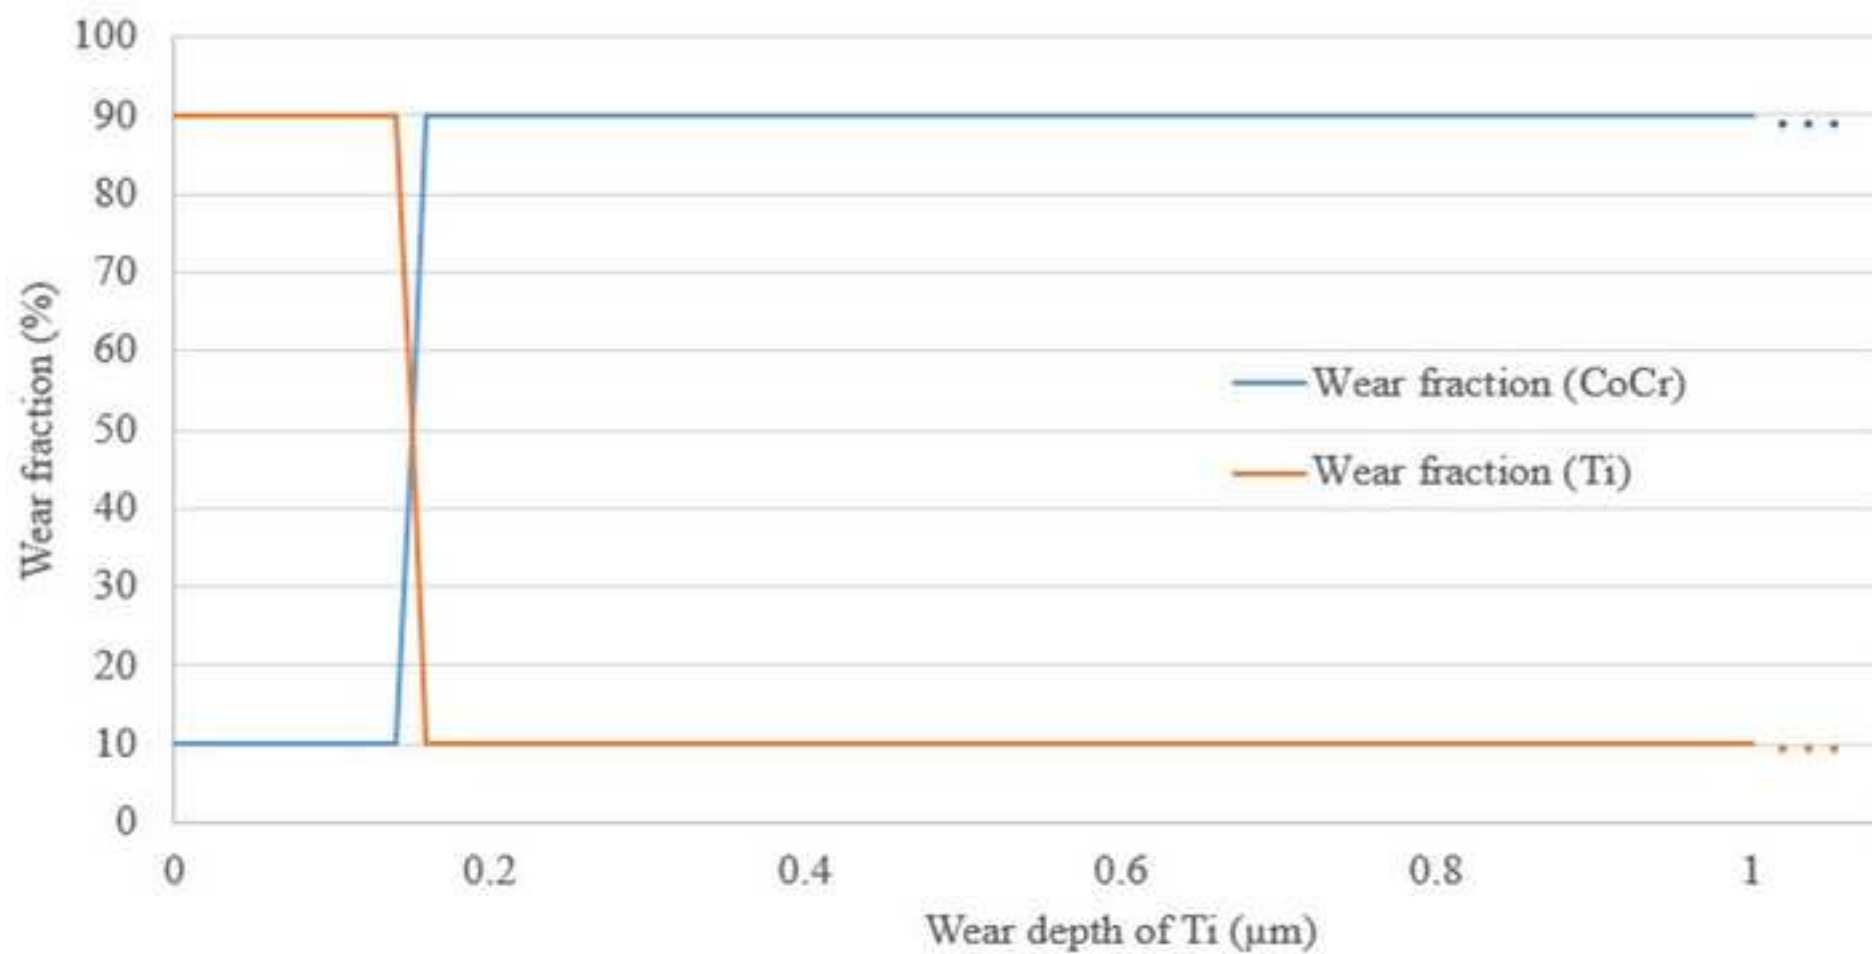
Figure 5: wear fraction between CoCr and Ti material combination over developed wear depths during the wearing procedure

“wear fraction” (English et al., 2015), depends on the specific materials being considered. The wear fraction for a CoCr femoral head and Ti trunnion material combination is mainly based on the theory of Ti hardening in-vivo (Moharrami et al., 2013). Put simply, at first, the Ti trunnion is worn by the harder CoCr head. However, over time an increasingly thick Ti oxide layer builds up. Once it reaches around 150 microns in depth, it has sufficient hardness at sufficient depth to begin to wear the CoCr alloy. This change in hardness, and thus wear, has been modelled computationally by varying the wear fraction during the wearing analysis as shown in Figure 5. While the concept of an apparently softer material wearing a harder material may seem counterintuitive, under fretting conditions (as would be the case in a taper-trunnion junction) such an effect has been seen in multiple tribological studies (Elleuch and Fouvry, 2005; Kayaba and Iwabuchi, 1981; Lemm et al., 2015; Varenberg et al., 2002). In such cases the differential wear has been attributed to “the formation of oxide debris which then became trapped in the contact area and embedded in the softer surface; the hard, embedded particles then abraded the harder” material (Lemm et al., 2015).

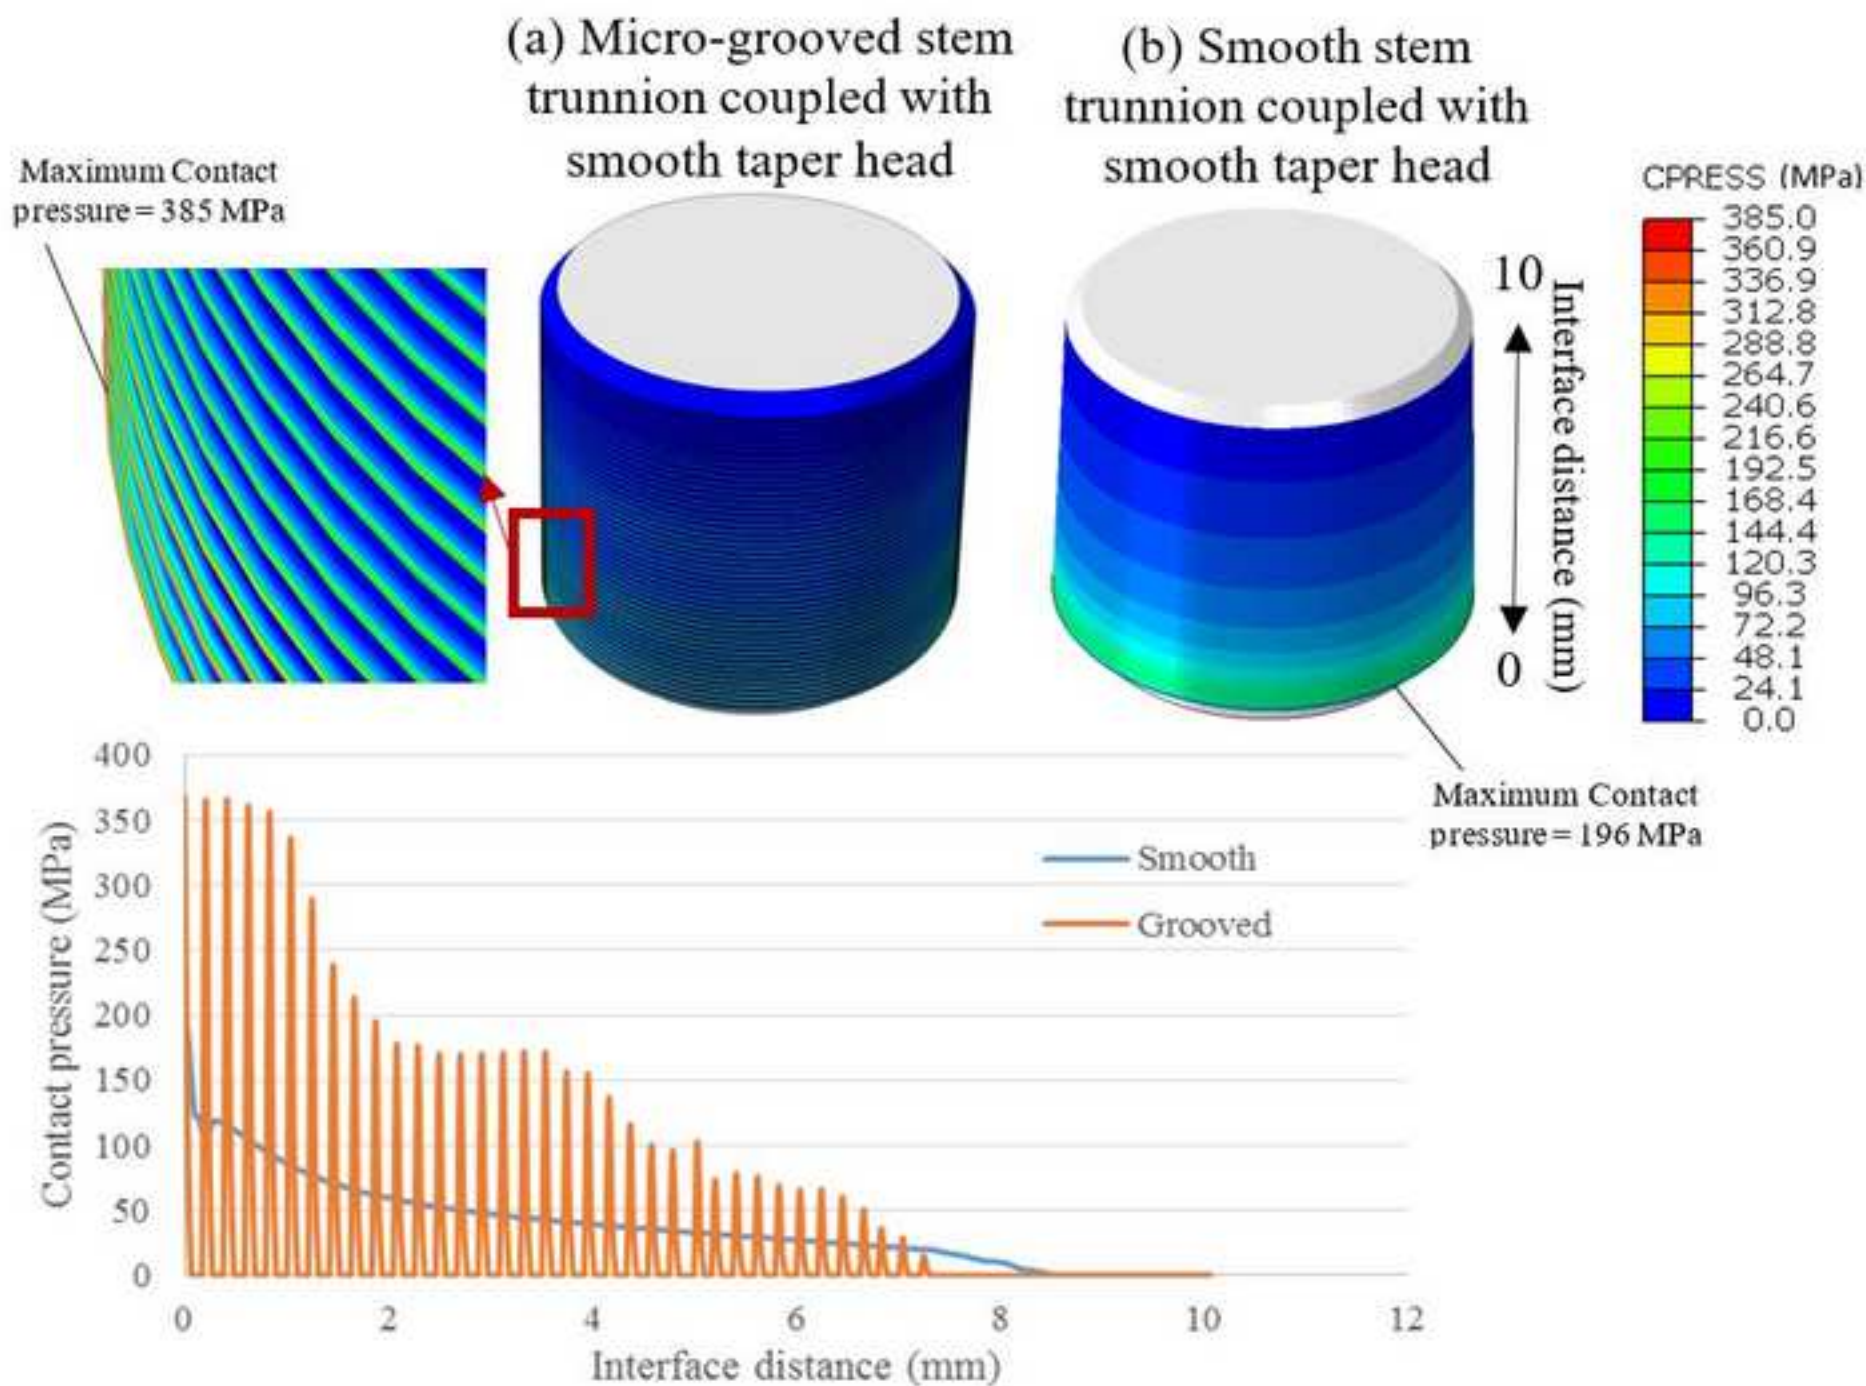
Figure 6: Contact pressure (CPRESS) distribution over the interface of the trunnion stem associated with the initial assembly impaction (4kN) for (a) micro-grooved and (b) smooth trunnion surfaces

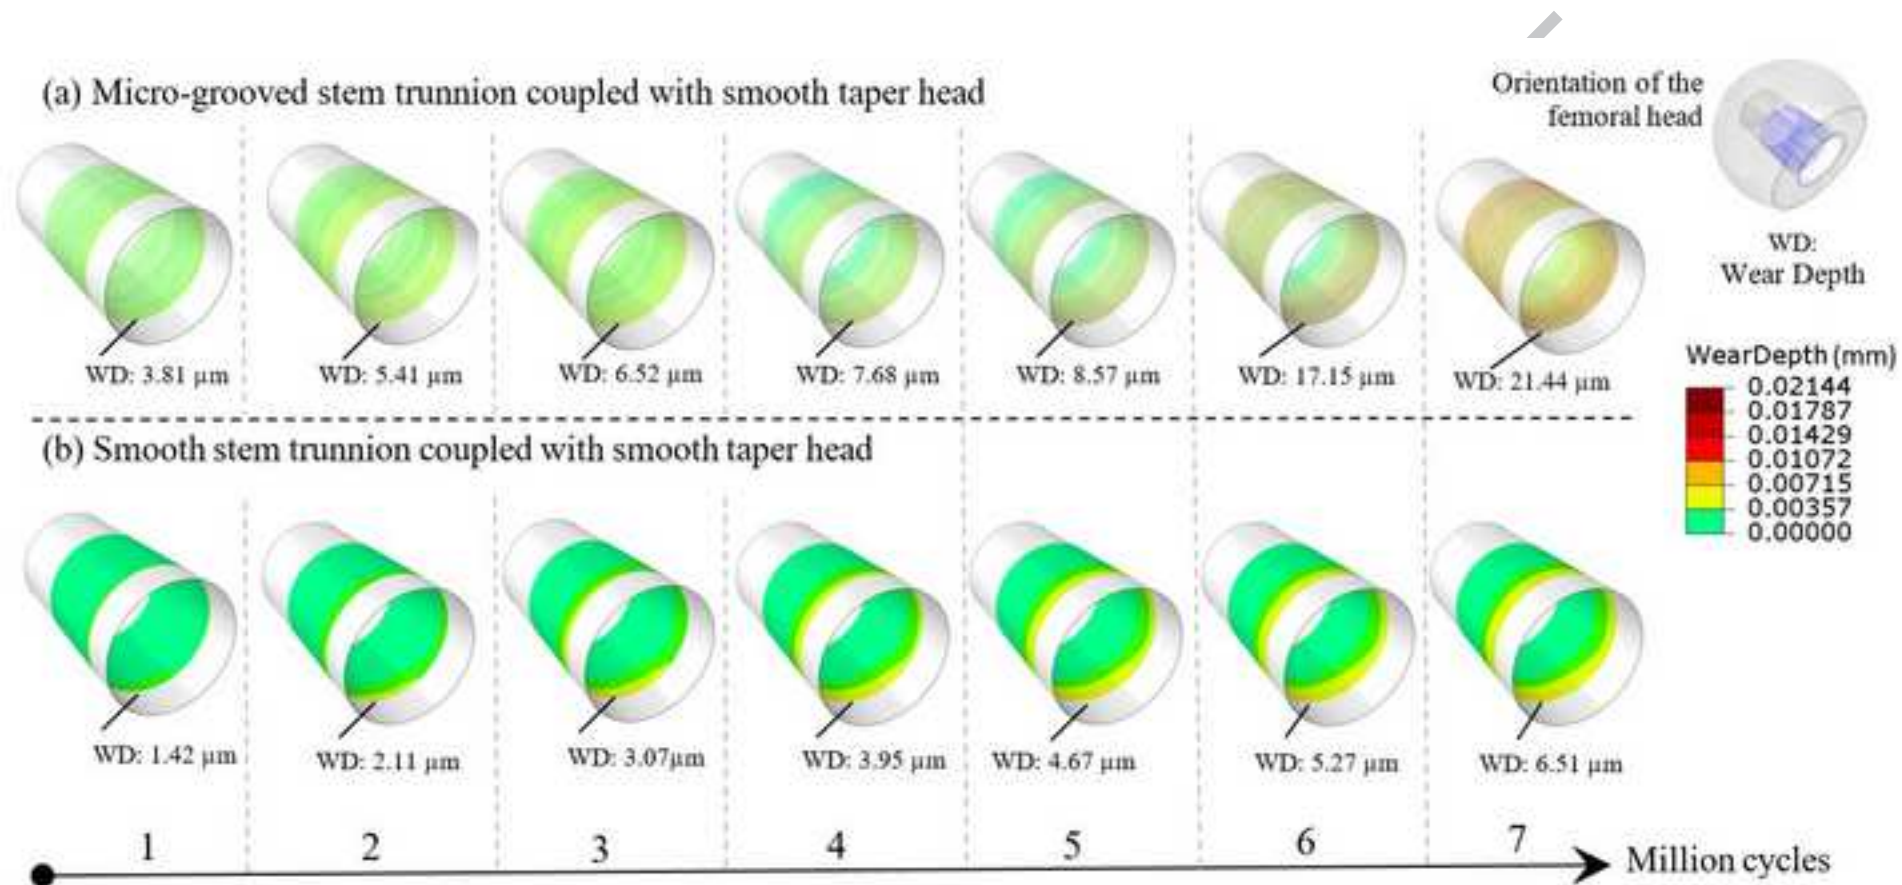
Figure 7: Evaluation of the wear pattern on the smooth head taper surfaces mated (a) with a micro-grooved and (b) with the smooth trunnion surface finish. Note that the specific wear depth (WD) values on the figure show the maximum wear depth at each stage of the analysis.

The evaluation of the wear damage over a 7 million load cycle period is shown in Figure 7, comparing the smooth femoral head taper surface coupled with micro-grooved (Figure 7a) and smooth (Figure 7b) trunnions. As expected the wear depth evolves for both cases as the wear analysis progresses.

Accelerated increases in the wear depth can be seen for the femoral head taper which was coupled with a micro-grooved trunnion after 5 million load cycles where the relative micromotion at the interface starts increasing rapidly. This increase in the micromotion continues until the femoral head starts rotating on the femoral stem with a much larger scale than fretting relative micromotion at 6.8 million load cycles. The maximum wear depth increases from a value around $8.57\text{ }\mu\text{m}$ at 5 million load cycles to $21.44\text{ }\mu\text{m}$ at 7 million load cycles (see Figure 7a). It should be noted that, as the sophisticated FEA model focussed on wear at the micro grooves with a resolution of 0.012 mm , so when the entire taper (approximately 10 mm long) is shown as an image, as in Figure 7, areas of red (maximum wear depth) become difficult to discern on this macro scale. For the femoral head coupled with a smooth trunnion (Figure 7b), however, the wear depth increases at the distal edge of the contact interface to approximately $6.51\text{ }\mu\text{m}$ at 7 million load cycles. The wear damage at the interface is distributed more uniformly and circumferentially at the femoral head taper (see Figure 7b). This lower wear depth, compared with the femoral head coupled with micro-grooved trunnion stem, is mainly due to having more area in contact and subsequently a larger interface. The larger interface allows better fixation which could maintain the relatively small amounts of micromotion for a larger number of load cycles.

As discussed, due to the Ti hardening *in-vivo*, which increases its hardness over the CoCr alloy, the CoCr alloy wears significantly more (Moharrami et al., 2013). In this study, the algorithm is able to consider the hardening of the Ti during the wearing analysis. As such, the harder micro-grooved trunnion stem imprints into the femoral surface as shown in Figure 7. Although this hardening happens for the smooth Ti trunnion stem as well, the surface damage is less extensive (see Figure 7).

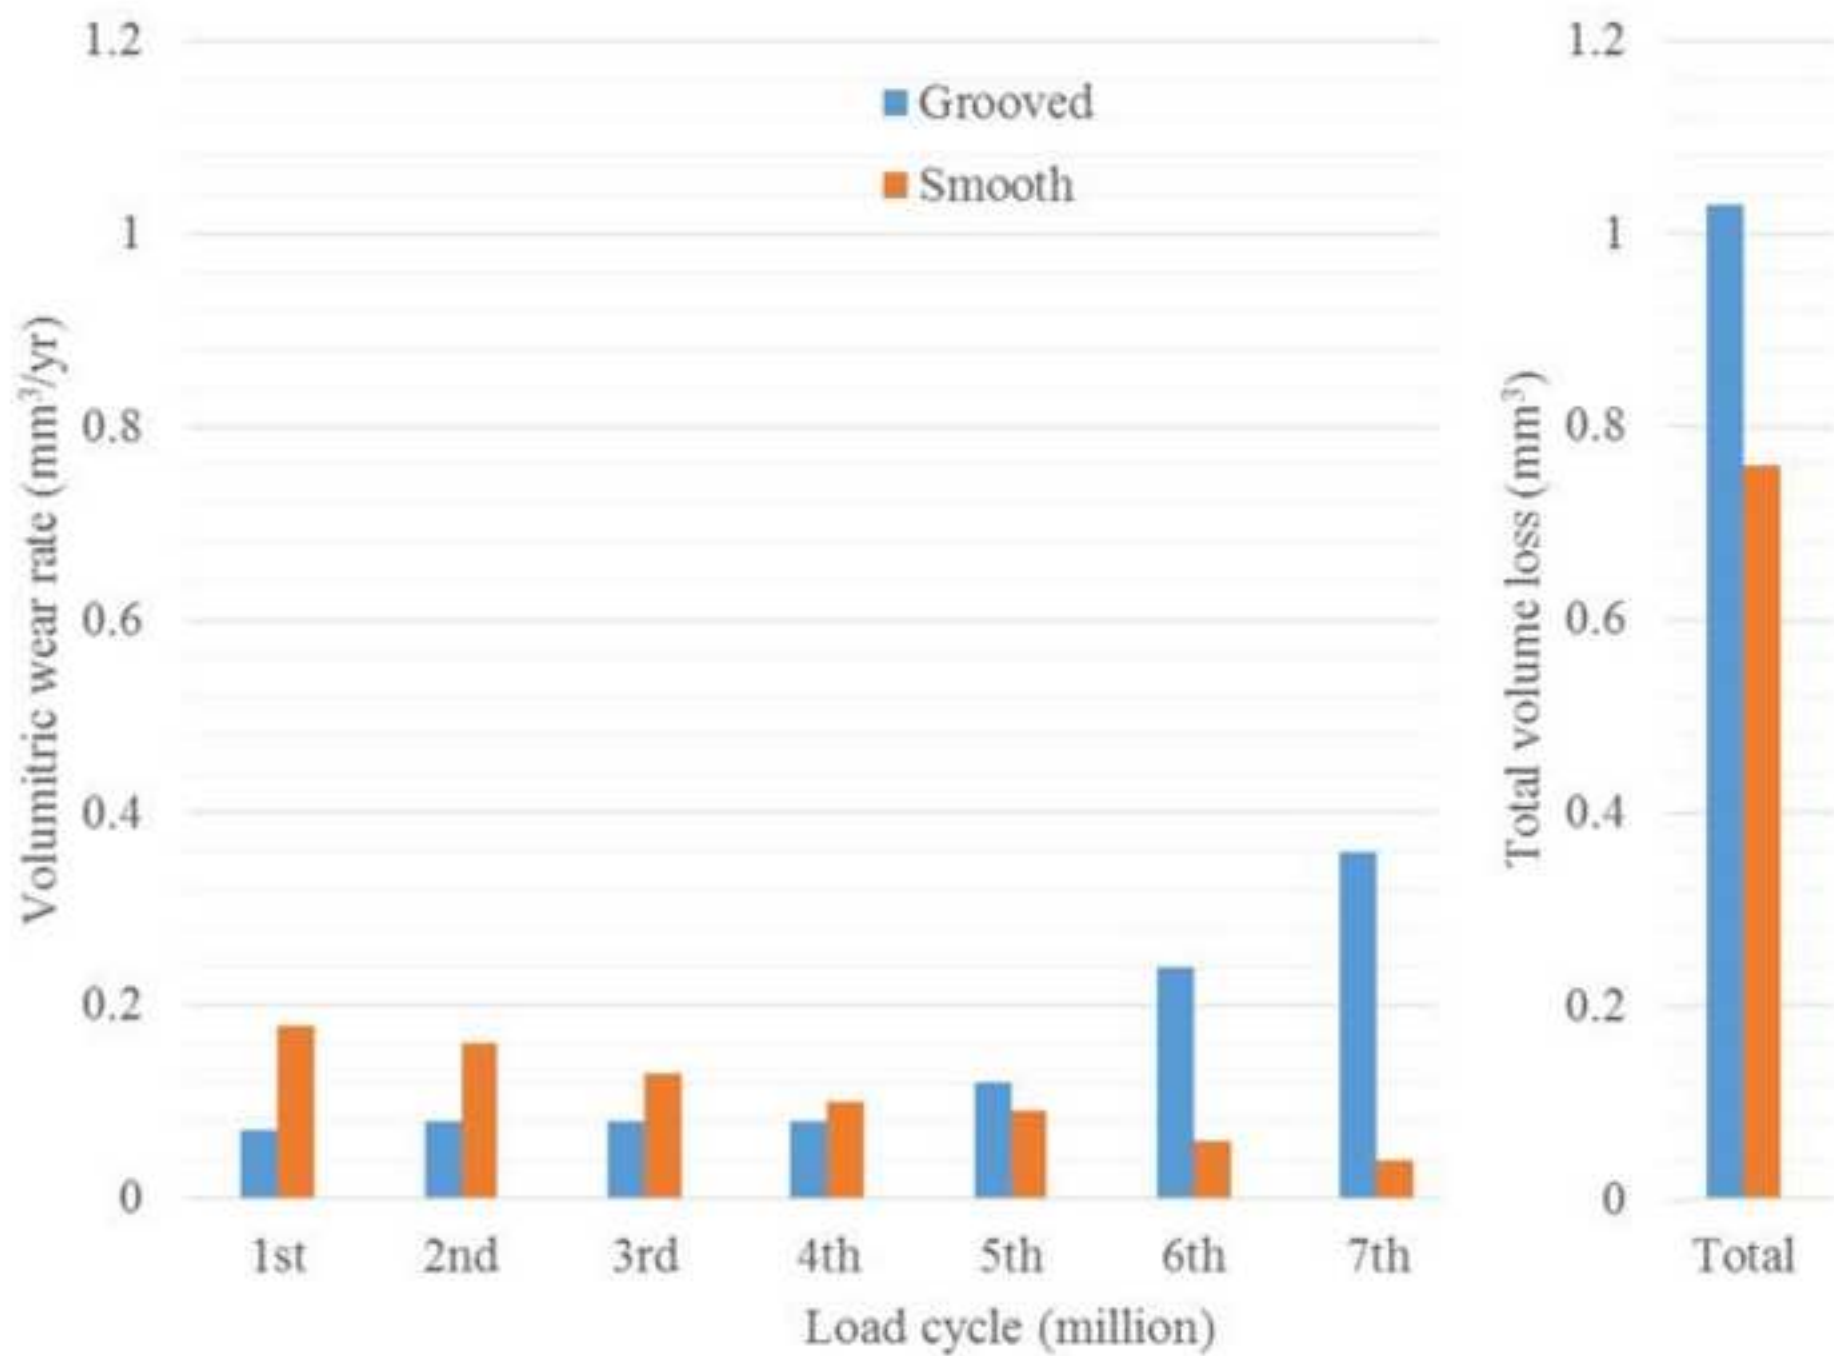
Figure 8: Volumetric wear rates and total volume loss over and after 7 million load cycles respectively

The volumetric wear rate over 7 million load cycles and the total volume loss are compared for both cases and are shown in Figure 8. For the head coupled with a micro-grooved stem trunnion, the volumetric wear rate is relatively constant over 4 million load cycles (approximately $0.08\text{ mm}^3/\text{yr}$) and then rapidly increases to 0.12 , 0.24 and $0.36\text{ mm}^3/\text{yr}$ over years 5, 6 and 7 respectively. This increase in the volumetric wear rate is due to the effect of loss of fixation which leads to a rapid increase in the relative micromotion and thus the material loss. The total volume loss is around 1.03 mm^3 over 7 million load cycles. It can be seen in Figure 8 that the initial wear rates for the head coupled with a smooth trunnion surface are slightly higher than the head coupled with a micro-grooved trunnion surface ($0.19\text{ mm}^3/\text{yr}$) as a smooth taper-trunnion coupling provides a greater surface contact area. Although these initial wear rates are higher, the fixation is better maintained over time at the

taper junction. As the micromotion is maintained at its lower extent over a longer period of time the contact stress at the interface reduces slightly and this causes a reduction in the wear rates gradually over time (to around $0.04 \text{ mm}^3/\text{yr}$ at 7 million load cycle). The total volume loss over 7 million load cycle is 0.76 mm^3 .

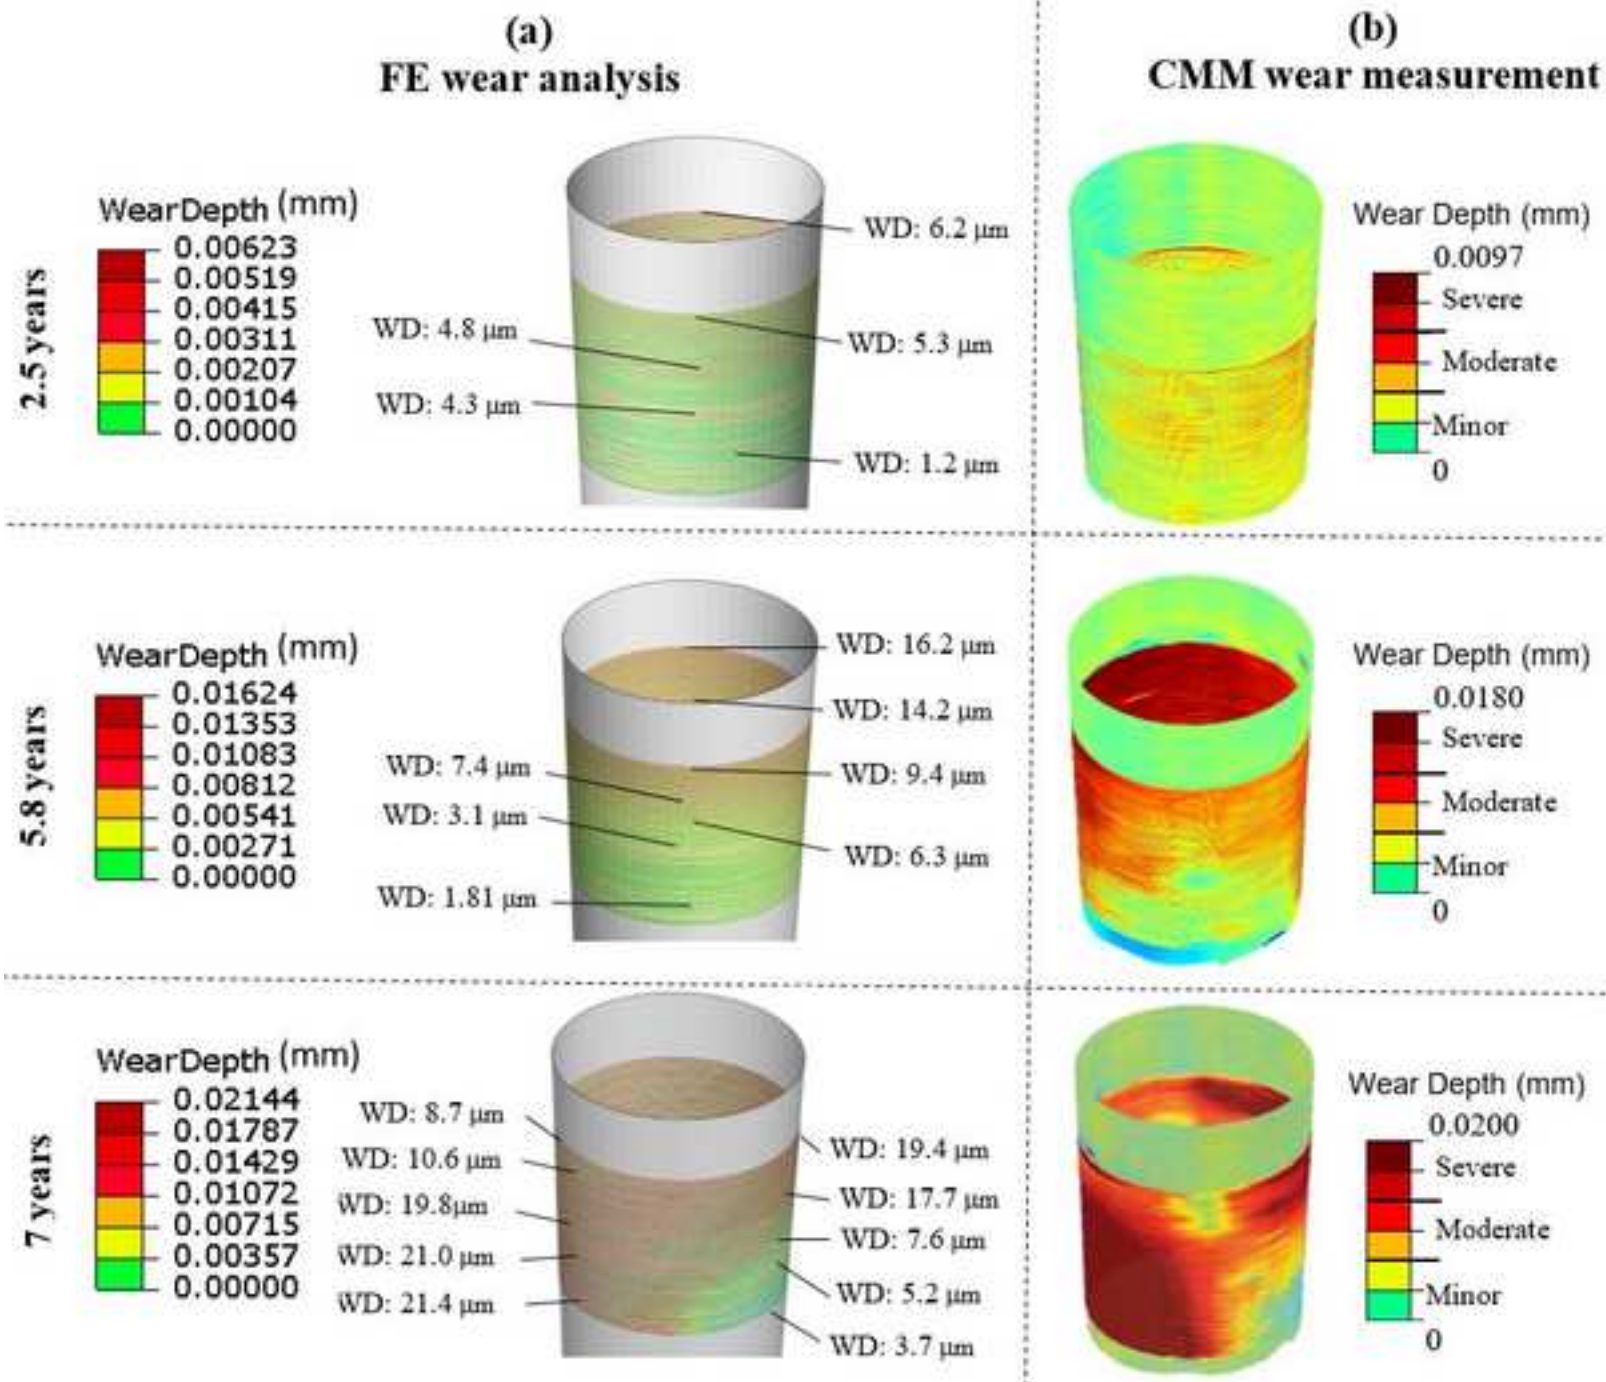
Figure 9: 36mm CoCr femoral head taper mated with Corail micro-grooved stem trunnion; (a) Finite Element analysis and (b) CMM wear measurement. Note that, the specific wear depth (WD) values have been added to help show the similarity in wear results between the FEA and CMM analyses.

Figure 9 compares the computational FE wear pattern damage obtained in this study with CMM measurements of wear damage at the retrieved femoral taper surfaces. The FE wear model could be analysed at specific points (i.e. 2.5 million cycles) to allow a direct comparison with a specific hip implant's time *in vivo* (i.e. 2.5 years). It can be seen in Figure 9 that the wear depths obtained computationally compare favourably with the CMM measurements for explants retrieved at 2.5, 5.8 and 7.0 years. Once again, note that due to the fine mesh size (0.012mm) of the FEA model, and the localised material removal from microgrooves, once the image is scaled up to show an entire taper, so areas of red (maximum wear depth) become difficult to discern on the FEA image. The average volumetric wear rate for the hip explants obtained from the CMM was $0.28 \text{ mm}^3/\text{yr}$, (range 0.04 to $1.67 \text{ mm}^3/\text{yr}$), while that from the FEA model was $0.26 \text{ mm}^3/\text{million cycles}$ (figure 8). The close similarities shown between the numerical analysis and measured wear damage of retrieved prostheses

demonstrates the effectiveness of the 3D FE wear model, the chosen loading and boundary conditions, and the wear algorithm; therefore, the computational analysis is validated.
