GIS technology for enhancing pavement maintenance and condition assessment: Case study

GIS technology for enhancing pavement maintenance and condition assessment: case study

Tariq Al-Mansoori [1]✉ ⓘ*, Noorance Al-Mukaram* [1] ⓘ*, and Ali Shubbar* [2] ⓘ

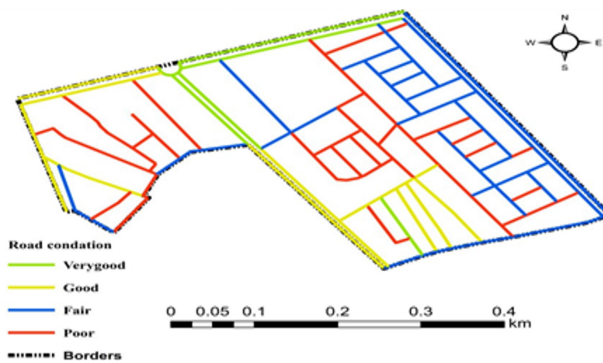
(OCI) to assess the road conditions in the study area. Figure 5 shows the current conditions of road sections based on the OCI principles, which are usually subjective and depending on the engineering expertise and judgement. It is evident that a significant number of roads are in fair condition, and most of these roads are very close to being in poor condition or out of service soon. The lack of an adopted maintenance strategy might be the reason for this situation. This case of roads is prevalent in most of the Iraqi roads, where different condition states ranging from excellent conditions through good and fair to poor in any study area, whether it was large or small. A legend indicating the Overall Condition Index (OCI) values are also included in the figure. It can be seen that there is no legend for the excellent condition, and the reason for that is that there is no condition of excellent condition has been found during

visual inspection. Therefore, the excellent condition is not present in the map of the study area. The map shows that the roads inside the residential areas are more prone to degrade faster than those on outer edges of such areas. This could be attributed to the deficient drainage system of roads near the houses as the sewage water could be higher.

**Figure 5.** Current pavement conditions in the study area according to OCI.

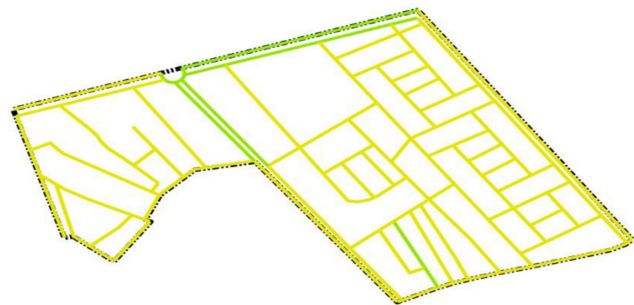
Figure 7. Strategy 2 that involves maintaining all lower condition roads to become good except the very good.

their maintenance infeasible. It can be noted that this strategy does not involve full rehabilitation or reconstruction of the roads in poor conditions. This could be due to the lack of budget, which is usually divided among all roads equally. This strategy could not be feasible in the long-term. The second strategy is shown in Figure 7. This strategy requires higher expenditure for maintaining all roads of conditions less than very good. The types of maintenance may vary from seals of small cracks to major rehabilitation or reconstruction depending on the state of the road and the type of defect. An example of this type of maintenance strategy was performed in the southern Iraqi city of Al-Basrah, during the Gulf Football Cup tournament in 2022, where Al-Basrah was the host of this tournament. This strategy could be feasible in the long-term, if a maintenance plan is implemented properly. Figure 8 presents the third strategy. This strategy involves some kind of emergent maintenance, where only fair and poor conditions are maintained to an acceptable state without spending too much amount of money for full rehabilitation or reconstruction. This strategy is not a long-term one and does not require a proper maintenance plan or staff. In the long-term process, road networks maintained with strategy could be degraded because the roads with conditions of good and more are neglected until their defect becomes visible and dysfunctional, which would need an emergent intrusion and that could be a major rehabilitation or reconstruction.

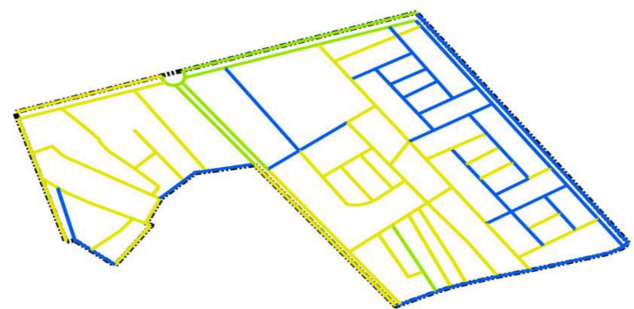
Figure 8. Strategy 3 that only roads in poor condition are turned into good.
