Study on the single-event burnout mechanism of GaN MMIC power amplifiers

Zhang, H, Zheng, X, Lin, D, Lv, L, Cao, Y, Hong, Y, Zhang, F, Wang, X, Wang, Y, Zhang, W, Zhang, J, Ma, X and Hao, Y (2024) Study on the single-event burnout mechanism of GaN MMIC power amplifiers. Applied Physics Letters. 124 (8). ISSN 0003-6951

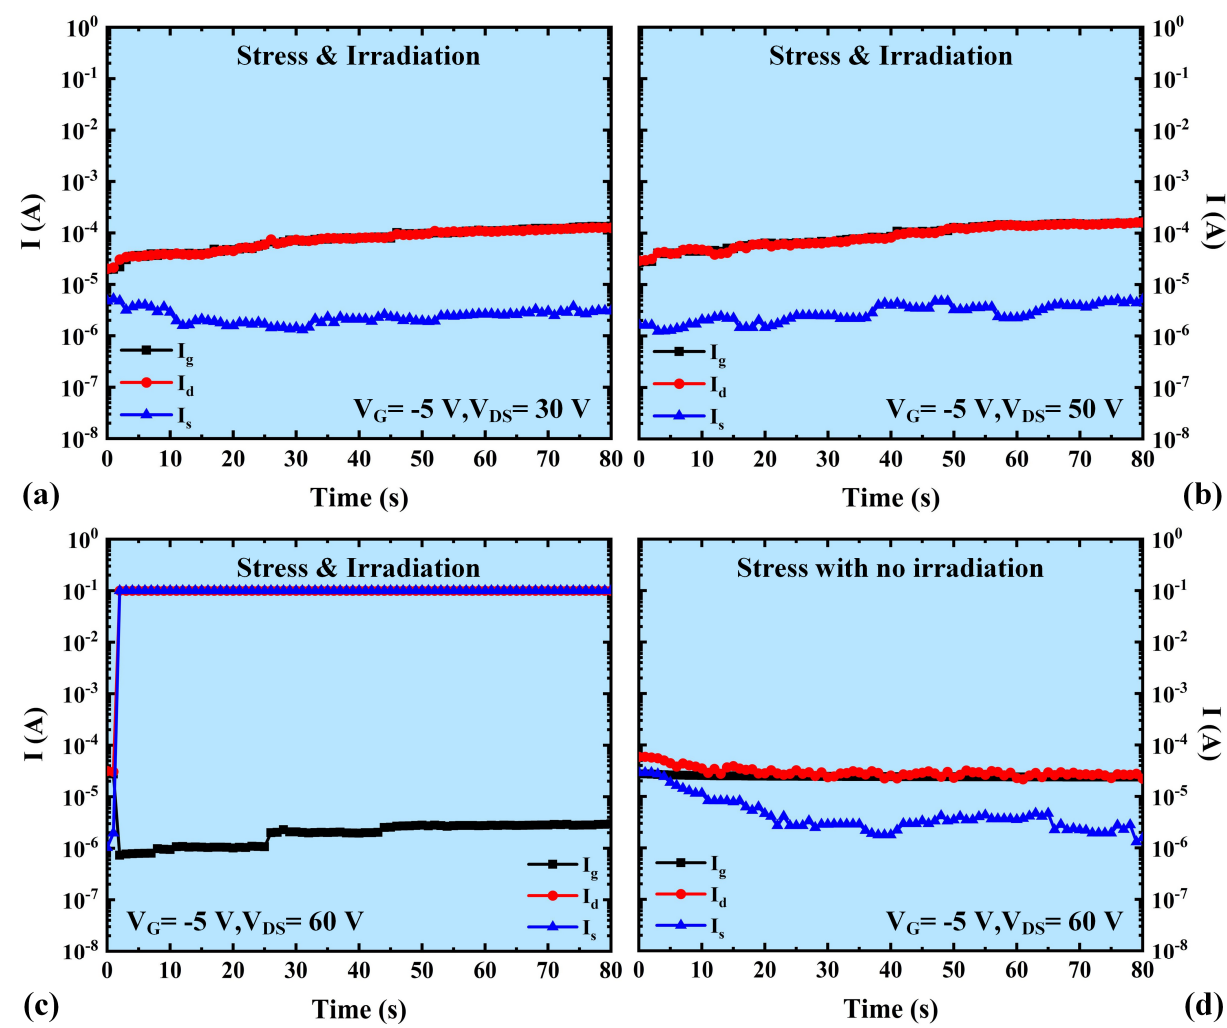
In order to accurately determine the SEB process, the gate, source, and drain currents during the irradiation were monitored, respectively. FIG. 1(a) shows the different leakage current components during irradiation with $V_{DS\text{-}Stress}$ = 30 V. It is observed that both the gate and drain leakage currents have a slight increase and agree well with each other. And the source leakage current is more than one order of magnitude lower than both of them. When the drain bias increases to 50 V, a similar procedure occurs, which is shown in FIG. 1(b).

In order to determine the burnout voltage under heavy ions irradiation, the drain bias is further increased to 60 V, which is shown in FIG. 1(c). It is clearly observed that both the drain and the source leakage current have a sudden increase and reach the preset current limit value soon, which indicates that the SEB is triggered and a leakage path is formed between the source and drain. In order to verify it, the leakage currents under the identical bias conditions without irradiation are also given in FIG. 1(d). It shows that no increase is observed for all leakage currents from different electrodes. It confirms that the failure of GaN MMICs under irradiation is mainly attributed to SEB rather than the applied electrical stress.

FIG. 1. Currents measured during the heavy ion irradiation with (a) $V_{DS\text{-}Stress}$ = 30 V, (b) $V_{DS\text{-}Stress}$ = 50 V, and (c) $V_{DS\text{-}Stress}$ = 60 V. (d) The currents of the reference MMICs under $V_{DS\text{-}Stress}$ = 60 V without irradiation. During the irradiation, the gate bias is kept at -5 V.

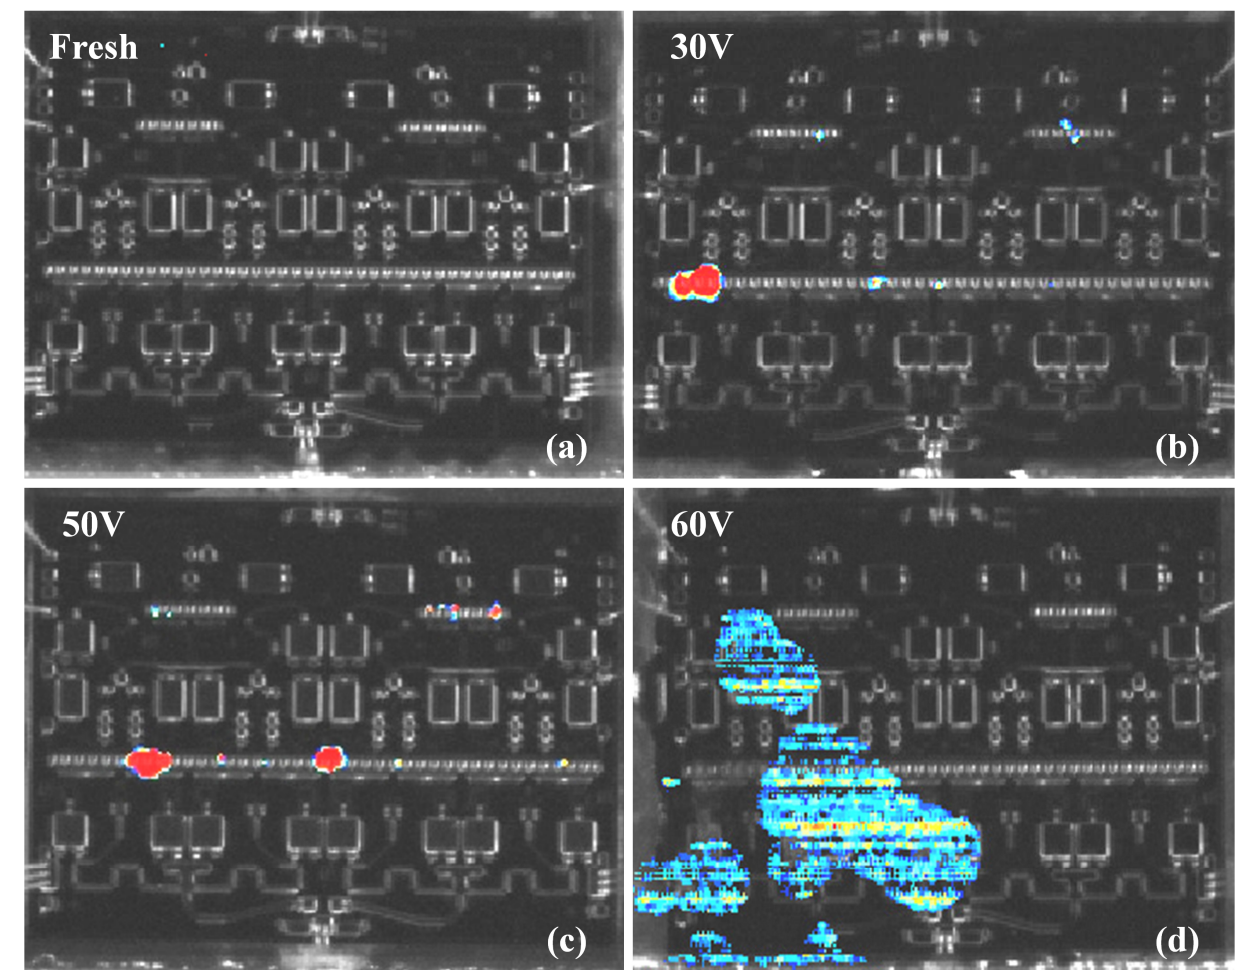
In order to have an in-depth study, the photon emission measurements (PEM) technique was utilized in this work to locate the failure point. FIG. 2(a) shows the photoemission signature of the fresh MMIC. It is clearly observed that there are few hotspots, indicating the absence of leakage paths. FIG. 2(b) shows some photoemission signature occurs in the irradiated MMIC with the drain bias of 30 V, which indicates that some faint local damages were generated. These damages are located in the GaN HEMTs rather than passive devices. When the drain bias increases to 50 V, more light distributions are observed, and the light emission intensities become stronger in FIG. 2(c), which indicates that the damage induced by heavy ions becomes more obvious. When the drain bias increases further to 60 V, a large range of photoemission signatures are observed in FIG. 2(d). It reveals a significant rise in the leakage current of the MMIC after triggering SEB. There are two features that should be noted. First, nearly all hotspots are observed in the power-stage HEMTs instead of driver-stage ones in the MMICs, which demonstrates that the power-stage suffers more severe stress. Second, photoemission signatures are also observed in the MIM capacitor region, which indicates that some leakage paths are generated within the insulated dielectric in MIM capacitors. The above results indicate that the heavy ions irradiation under 60 V induced not only the power-stage HEMTs burnout but also the dielectric damage in MIM capacitors within GaN MMICs.

FIG. 2. PEM images of the fresh and irradiated GaN MMICs with different drain bias. (a) Fresh, (b) $V_{DS\text{-}Stress}$ = 30 V, (c) $V_{DS\text{-}Stress}$ = 50 V, and (d) $V_{DS\text{-}Stress}$ = 60 V.

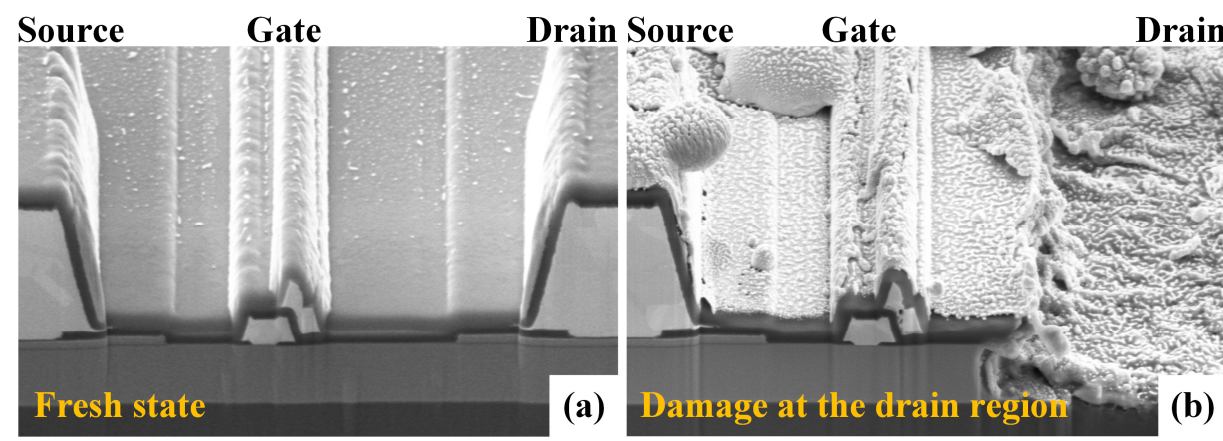
In order to further investigate the physical origin of these leakage paths, the focused ion beam (FIB) and scanning electron microscopy (SEM) analysis were performed in this work. FIG. 3 shows the SEM photos for GaN HEMTs within the MMIC. As shown in FIG. 3(a), no damage is observed in the fresh device. However, a significant burnout was observed between the drain electrode and the substrate in the irradiated device with the drain bias of 60 V, as illustrated in FIG. 3(b). It should be noted that the other regions away from the drain electrode remain a relatively complete structure with little damage.

FIG. 3. SEM images show the morphology of GaN HEMTs in the MMICs under $V_{DS\text{-}Stress}$ = 60 V. (a) Fresh state. (b) The SEB damage at the drain region.

With the electron trapping within the buffer layer accumulates, the longitudinal electric field near the drain electrode will be modulated. The simulation results in FIG. 6(b) present it. It is observed that the electric field near the drain electrode increases dramatically after the heavy ion strike. When a critical longitudinal electric field (E_{Cr}) is achieved, a catastrophic burnout occurs near the drain region, which agrees well with the result observed in FIG. 3(b).

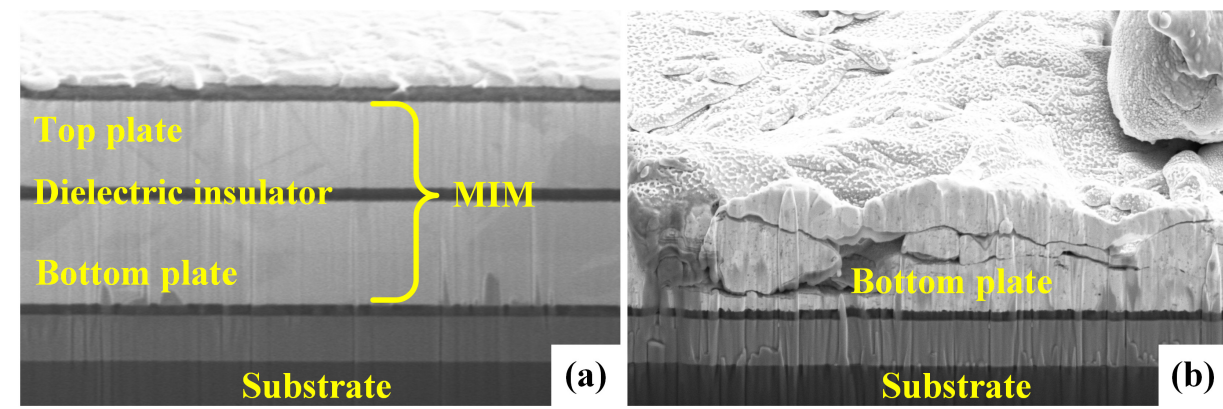
FIG. 4 shows the SEM photos for MIM capacitors within the MMIC. FIG. 4(a) shows the initial state of MIM capacitors, indicating it is almost free of any intrinsic crystal defects. FIG. 4(b) shows the morphology of the MIM capacitor after triggering SEB with the drain bias of 60 V. It can be seen that the dielectric layer and the top plate of the

capacitor are entirely burned out. In comparison, there is almost no damage or degradation was observed on MIM capacitors without irradiation at the identical bias voltage, which confirms the breakdown of MIM capacitors is attributed to single-event dielectric rupture.[28-30] When heavy ions irradiate MIM capacitors, dense electron-hole pairs can be induced in dielectric along the ion track. Under the influence of the high electric field across the MIM capacitor, the generated electrons and holes will be accelerated and become high-energy carriers. These high-energy carriers may induce significant leakage current via severe impact ionization, which can trigger the eventual burnout of the device. It is also possible that the latent tracks induced by the heavy ions strike induce leakage paths between the top plate and bottom plate, which leads to the final destruction of the dielectric.

FIG. 4. SEM images show the morphology of MIM capacitors in the MMICs under $V_{DS\text{-}Stress}$ = 60 V. (a) Fresh state. (b) The morphology after SEB.

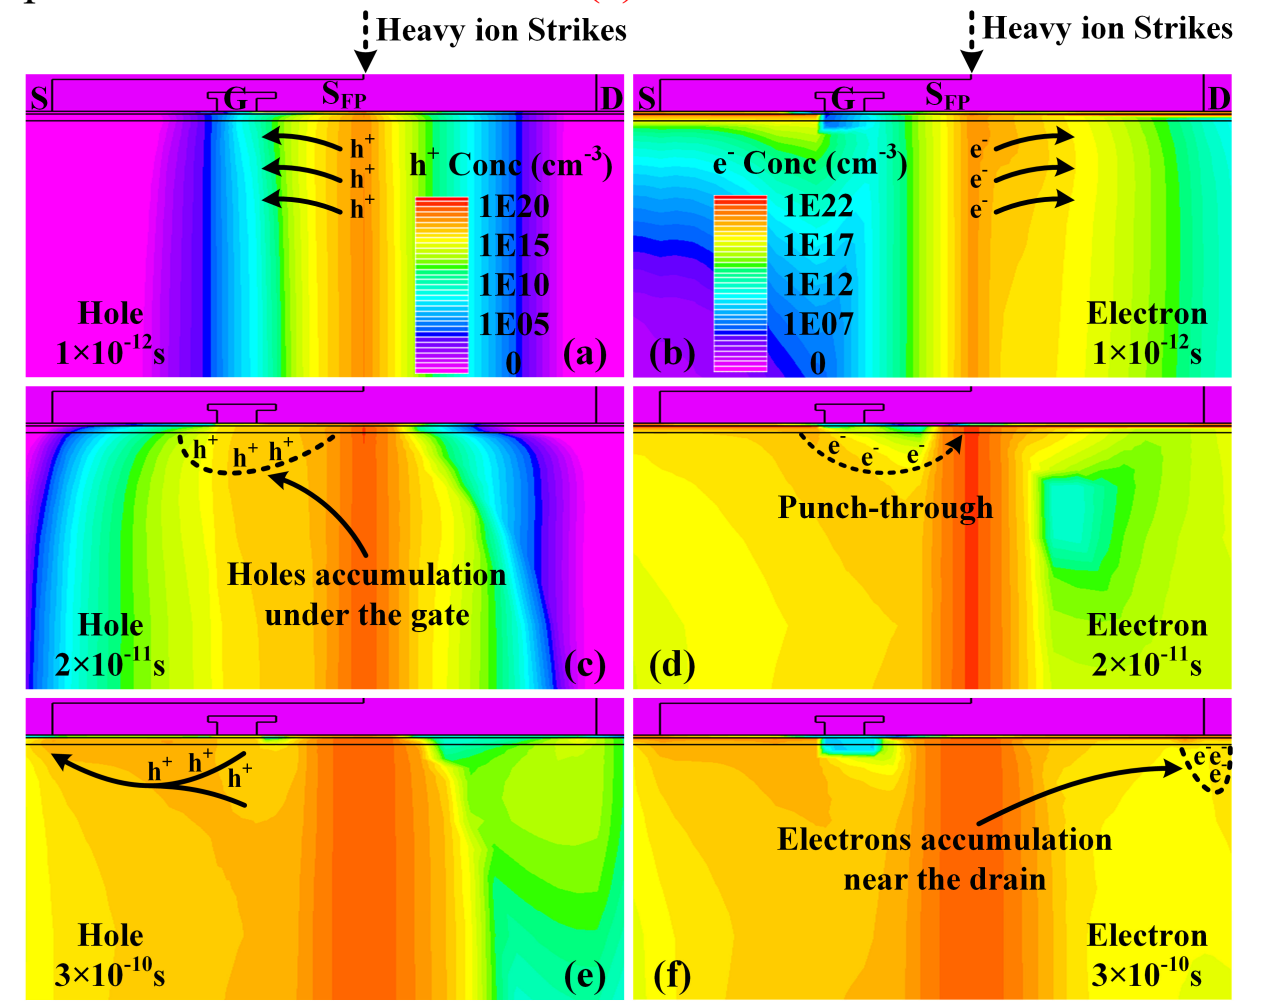
In order to have an in-depth understanding on the SEB mechanism in GaN HEMTs, TCAD simulation was carried out in this work. By simulating heavy ions striking at different positions from the source to the drain, it was found that SEB can be triggered more easily when heavy ions strike from the field plate edge. FIG. 5 demonstrates the hole and electron density distributions in GaN HEMT at different times after an ion strike at the field plate edge with the drain bias of 60 V. It can be seen that at 1×10^{-12} s, dense electron-hole pairs were induced along the ion track, as shown in FIG. 5(a) and (b). Then, these electrons and holes move towards the drain and gate electrodes driven by the transverse high electric field, respectively. Holes will accumulate below the gate due to the negative gate voltage, which can reduce the potential barrier between the source and the buffer, as shown in FIG. 5(c). As a result, electrons gradually begin to inject from the source to the drain at 2×10^{-11} s, as shown in FIG. 5(d). It will form an electron punch-through path and lead to the HEMT unexpectedly turning on, resulting in the leakage current from the drain to the source. In FIG. 5(e), when the time reaches 3×10^{-10} s, holes start to flow further towards the source. Meanwhile, more electrons are injected from the source to the drain, as shown in FIG. 5(f). Considering the significant transverse high electric field between the gate and drain, these injected electrons can be accelerated towards the drain electrode and become high-energy electrons, which can impact out more electron-hole pairs along the 2DEG channel, especially near the drain region. Most of electrons can be collected by the drain electrode and form drain current. The others will collide with the lattice in the GaN buffer layer near the drain region and generate new defects. Sequently, these electrons can get trapped within the newly generated defects and cause significant electron trapping. It is also possible that some of the high-energy electrons can surmount the interface barrier and inject into the AlGaN layer, which can form leakage current paths and cause potential damage. The above procedure is shown in FIG. 6(a).

FIG. 5. (a), (c), (e) Hole and (b), (d), (f) Electron density distributions of HEMTs in GaN MMICs at various times after a heavy ion strike at the field plate edge.

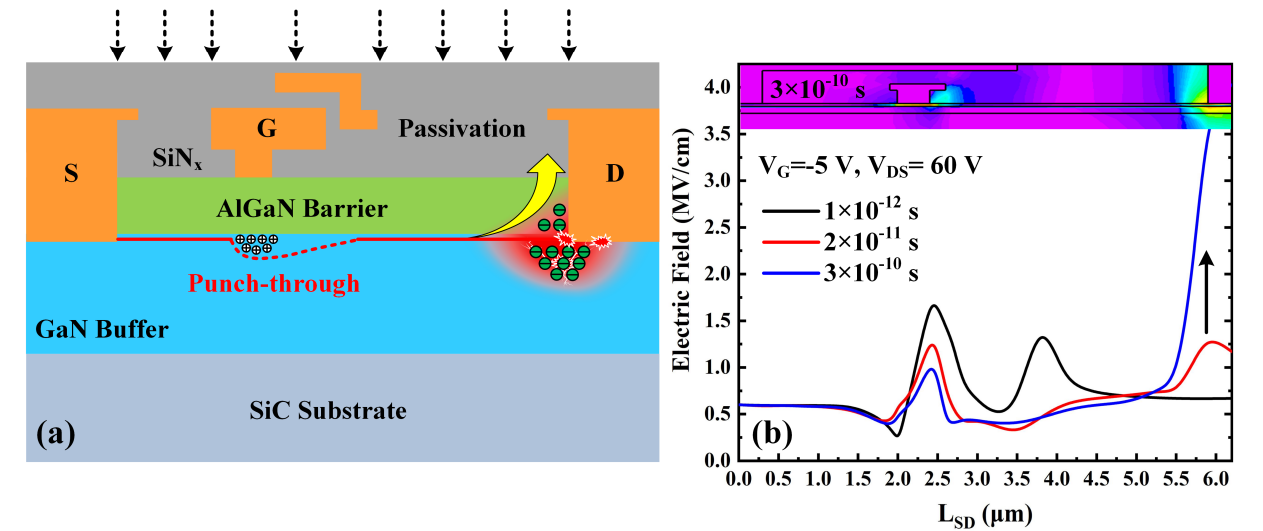
FIG. 6. (a) Schematic cross sections of GaN HEMTs in the MMICs show the electron trapping (Green solid symbols), and current leakage paths (Yellow arrow). (b) The simulated electric field in buffer layer at various times during heavy ion irradiation.
