Study on the Degradation Mechanism of GaN MMIC Power Amplifiers under on-state with High Drain Bias

***Abstract*—In this work, the electrical performance degradation and circuit burnout in gallium nitride (GaN) based microwave monolithic integrated circuit (MMIC) power amplifiers under on-state with high drain bias have been studied in-depth. It is found that when the drain bias increases from 30 V to 90 V, the saturation drain current decreases by 16%, and the output power drops significantly by 4.5 dB. With the aid of photon emission measurements (PEM) and scanning electron microscopy (SEM), it is found that catastrophic burnout occurs in the power-stage GaN HEMTs and the MIM capacitors, respectively. For the GaN HEMT, electrons in the channel can gain enough energy with the transverse high electric field to become hot electrons. One part of hot electrons can surmount the AlGaN/GaN interface barrier and then induce leakage paths in the AlGaN layer, resulting in a significant leakage current. The other part of hot electrons will collide with the lattice near the drain edge and induce significant electron trapping, which will result in a significant longitudinal local electric fie

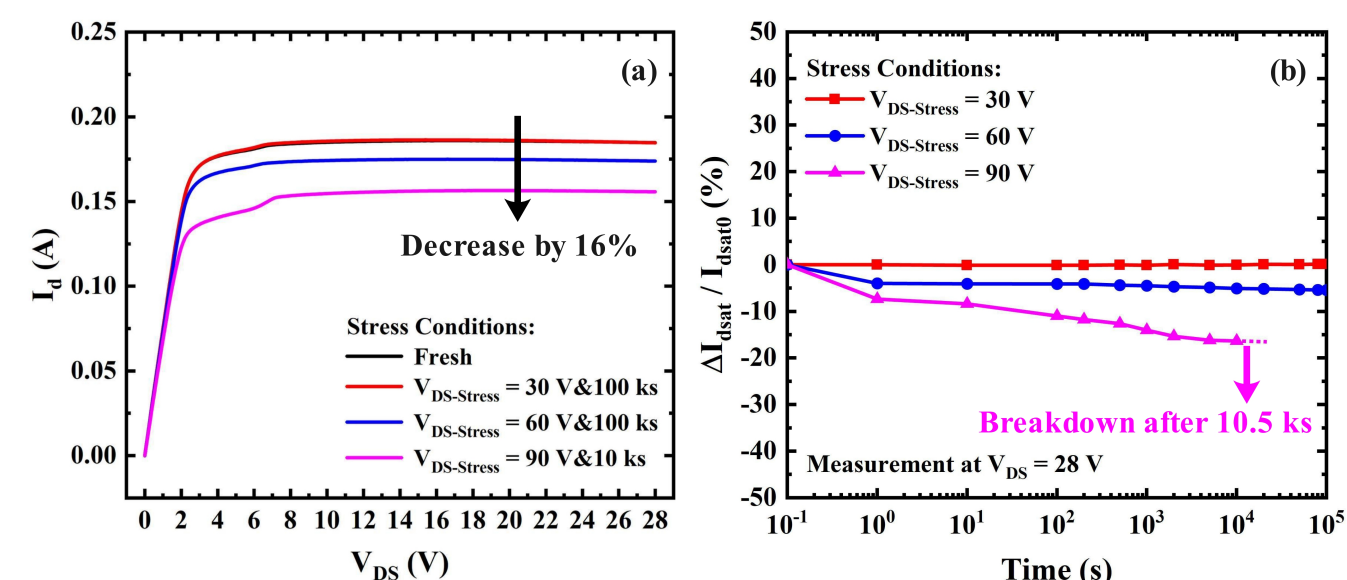
The electrical characteristics of the stressed GaN MMIC PAs were measured and compared. Fig. 2(a) depicts the DC output characteristic of GaN MMIC PAs under different $V_{DS\text{-}Stress}$. It is clearly observed that DC output performance degrades as $V_{DS\text{-}Stress}$ increases and the maximum reduction of the saturation drain current (I_{dsat}) reaches 16% under $V_{DS\text{-}Stress}$ = 90 V. Fig. 2(b) shows the degradation of I_{dsat} with stress time under different $V_{DS\text{-}Stress}$. It is found that the degradation of I_{dsat} under $V_{DS\text{-}Stress}$ = 30 V is negligible. With the increasing $V_{DS\text{-}Stress}$, obvious degradation occurs. Especially when $V_{DS\text{-}Stress}$= 90 V, I_{dsat} decreases dramatically with increasing stress time, and breakdown occurs eventually when the stress time reaches 10.5 ks. It should be noted that RF parameters are more important for PA's performance evaluation in most cases. Fig. 3 depicts PAs' RF performance degradation. As shown in Fig. 3(a), it is observed that the P_{out} degradation under $V_{DS\text{-}Stress}$ = 30 V is negligible. With the increasing $V_{DS\text{-}Stress}$, however, the degradation becomes more and more significant. It should also be noted that self-oscillation occurs with a lower P_{in} (less than -2 dBm) when $V_{DS\text{-}Stress}$ achieves 60 V, and it becomes more severe as $V_{DS\text{-}Stress}$ increases to 90 V. It may be explained by circuit mismatches caused by the degradation of the active devices and bias network [19]-[23]. Fig. 3(b) shows the RF performance degradation against $V_{DS\text{-}Stress}$ at P_{in}= 10 dBm. It is evidently observed that both P_{out} and gain significantly decrease by 4.5 dB and the power-added efficiency (PAE) is reduced by 10% under $V_{DS\text{-}Stress}$ = 90 V.

Fig. 2. The DC performance under on-state stress with different drain bias: (a) I_d-V_{DS} characteristics. (b) The normalized saturation drain current variation versus stress time.

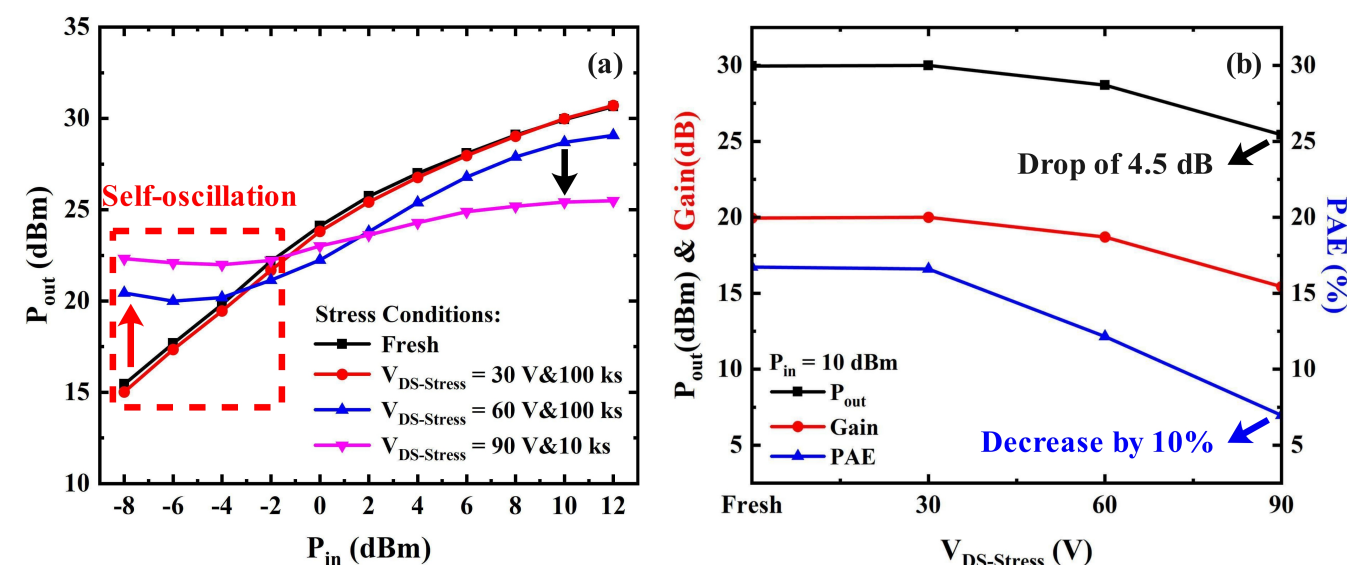
Fig. 3. The RF performances under on-state stress with different drain bias: (a) The output power vs. the input power at 10 GHz. (b) The output power, gain, and power-added efficiency (PAE) at P_{in} = 10 dBm as a function of $V_{DS\text{-}Stress}$.

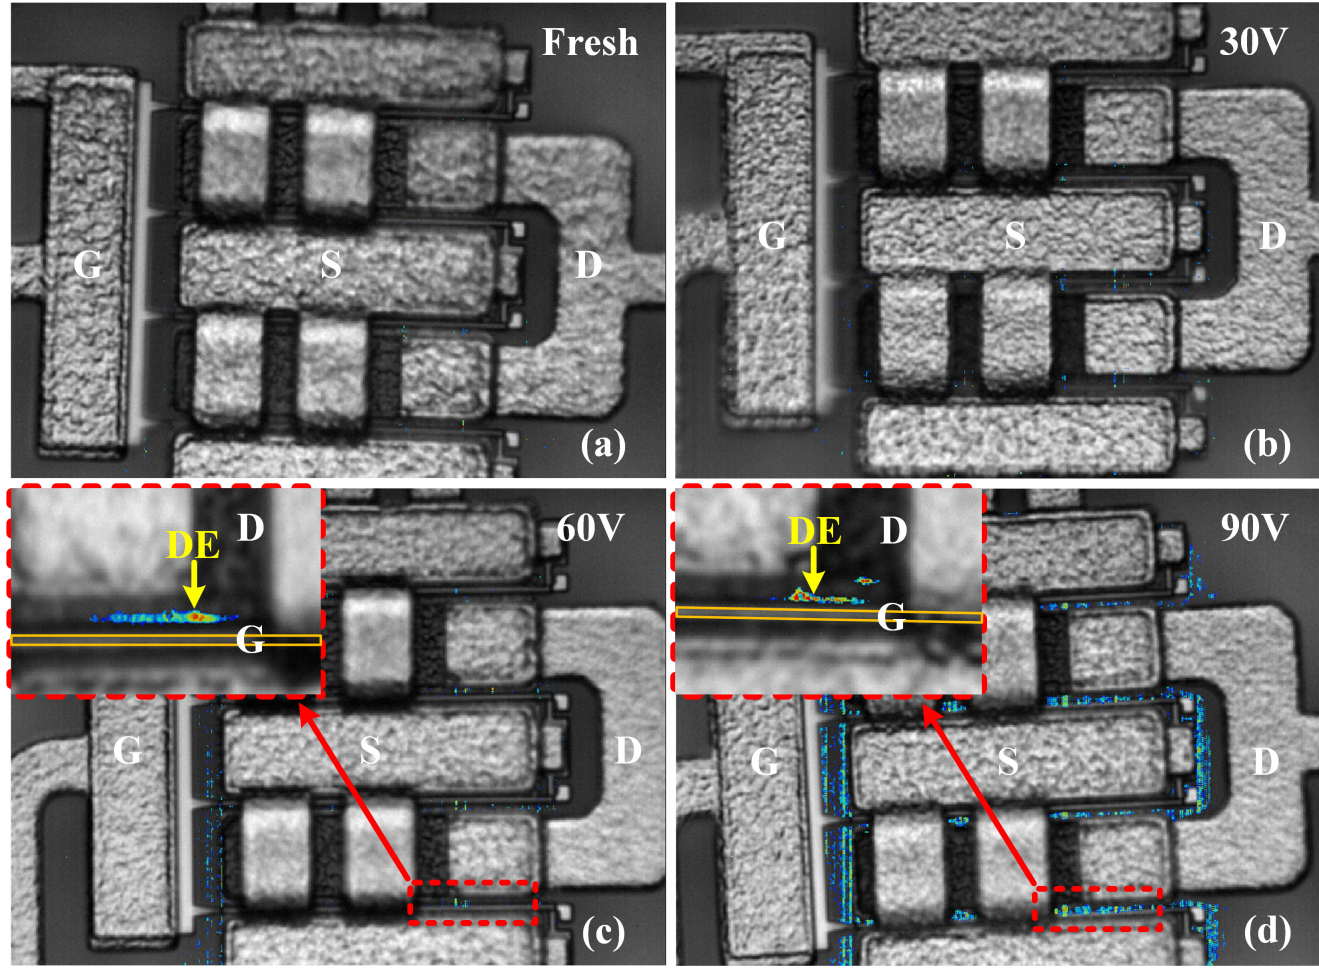
In order to gain more information about the possible physical degradation, PEM analysis was carried out on fresh and stressed GaN MMIC PAs to localize the leakage paths that were produced during the stress. Fig. 4(a) shows that the photoemission signature of the fresh device over the entire structure is insignificant, indicating the absence of leakage paths. Compared to the reference fresh device, Fig. 4(b) shows

a slight photoemission signature, indicating that insignificant damages were generated under $V_{DS\text{-}Stress} = 30$ V. In Fig. 4(c), the hotspots start to be well visible, in agreement with the onset of electrical degradation under $V_{DS\text{-}Stress} = 60$ V. In Fig. 4(d), stronger light emission intensities and more extensive light distributions are observed under $V_{DS\text{-}Stress} = 90$ V. It reveals a significant rise in leakage current, which is considered one of the reasons for the degradation of electrical performance [8], [9], [16]. Two aspects should be noted in this work. First, nearly all hotspots are observed in the power-stage HEMTs instead of driver-stage ones in GaN MMIC PAs. It is because that the power-stage HEMTs suffered the worst damage due to the presence of the highest power output during stress. Second, the strongest hotspot signal appears at the drain edge (DE) of the HEMTs, as illustrated by the insets in Fig. 4(c) and (d). The above results suggest that the drain edge of the power-stage HEMTs in GaN MMIC PAs may be the most sensitive and vulnerable area under on-state with high drain bias.

Fig. 4. PEM images of HEMTs in the power stage in on-state mode (V_{DS} =28 V) after different stress. (a) Fresh, (b) $V_{DS\text{-}Stress} = 30$ V, (c) $V_{DS\text{-}Stress} = 60$ V, and (d) $V_{DS\text{-}Stress} = 90$ V. The insets show a higher magnification (×100) of the marked hotspots.

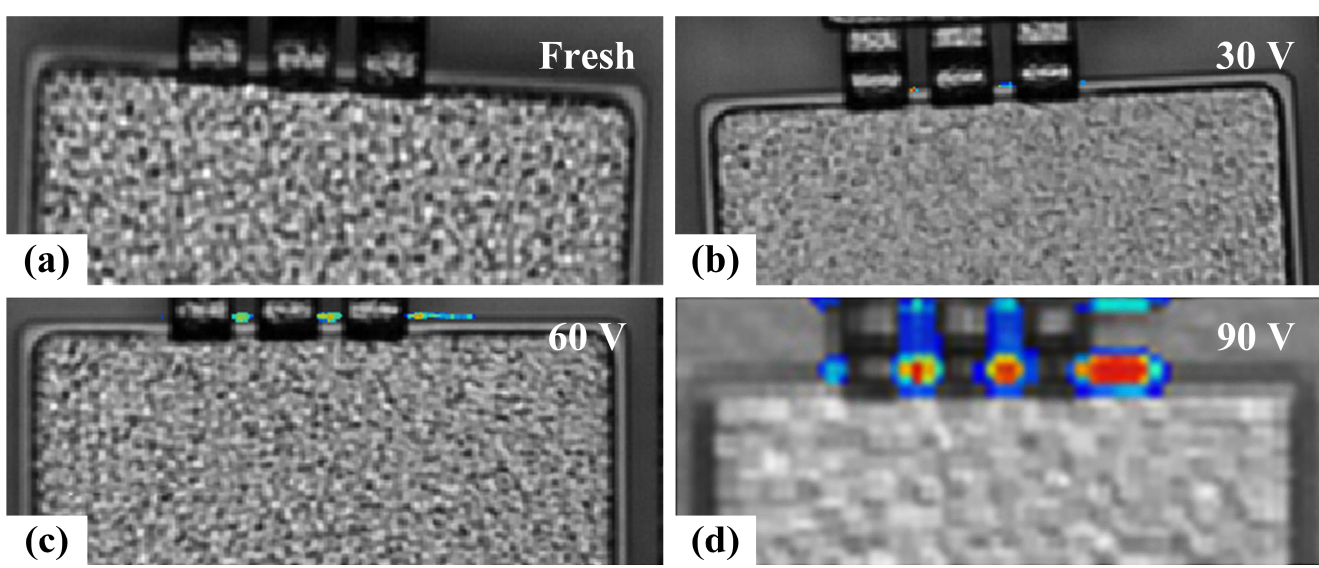
Fig. 5. PEM images of MIM capacitors in the power stage in on-state mode (V_{DS}= 28 V) after different stress. (a) Fresh, (b) $V_{DS\text{-}Stress} = 30$ V, (c) $V_{DS\text{-}Stress} = 60$ V, and (d) $V_{DS\text{-}Stress} = 90$ V.

In addition to the leakage current in GaN HEMTs, failures were also observed in MIM capacitors in the power stage, as illustrated by Fig. 5. Fig. 5(a) shows the initial state of MIM capacitors. It is almost free of any leakage paths. Compared to the reference fresh capacitor, slight emission intensity was observed in Fig. 5(b), indicating that insignificant damages were generated under $V_{DS\text{-}Stress} = 30$ V. In Fig. 5(c), the hotspots start to be well visible, in agreement with the onset of self-oscillation under $V_{DS\text{-}Stress} = 60$ V. In Fig. 5(d), a stronger photoemission signature is observed under $V_{DS\text{-}Stress} = 90$ V. It indicates that a significant leakage path is formed in the capacitor, which can seriously affect the stability of the bias network, leading to more severe self-oscillation even burnout. It should be noted that nearly all leakage paths are observed at the edge of MIM capacitors. This is because the electric field peak at the edge of the capacitor is denser than that in the bulk of the capacitor due to the electric field concentration effect, which will lead to dielectric breakdown at the edge. In addition, the local temperature near the power stage is higher, which can accelerate the degradation of capacitors here. The above results suggest that the failure of MIM capacitors also plays an important role in circuit deterioration, which should also be considered during the MMIC circuits assessment.

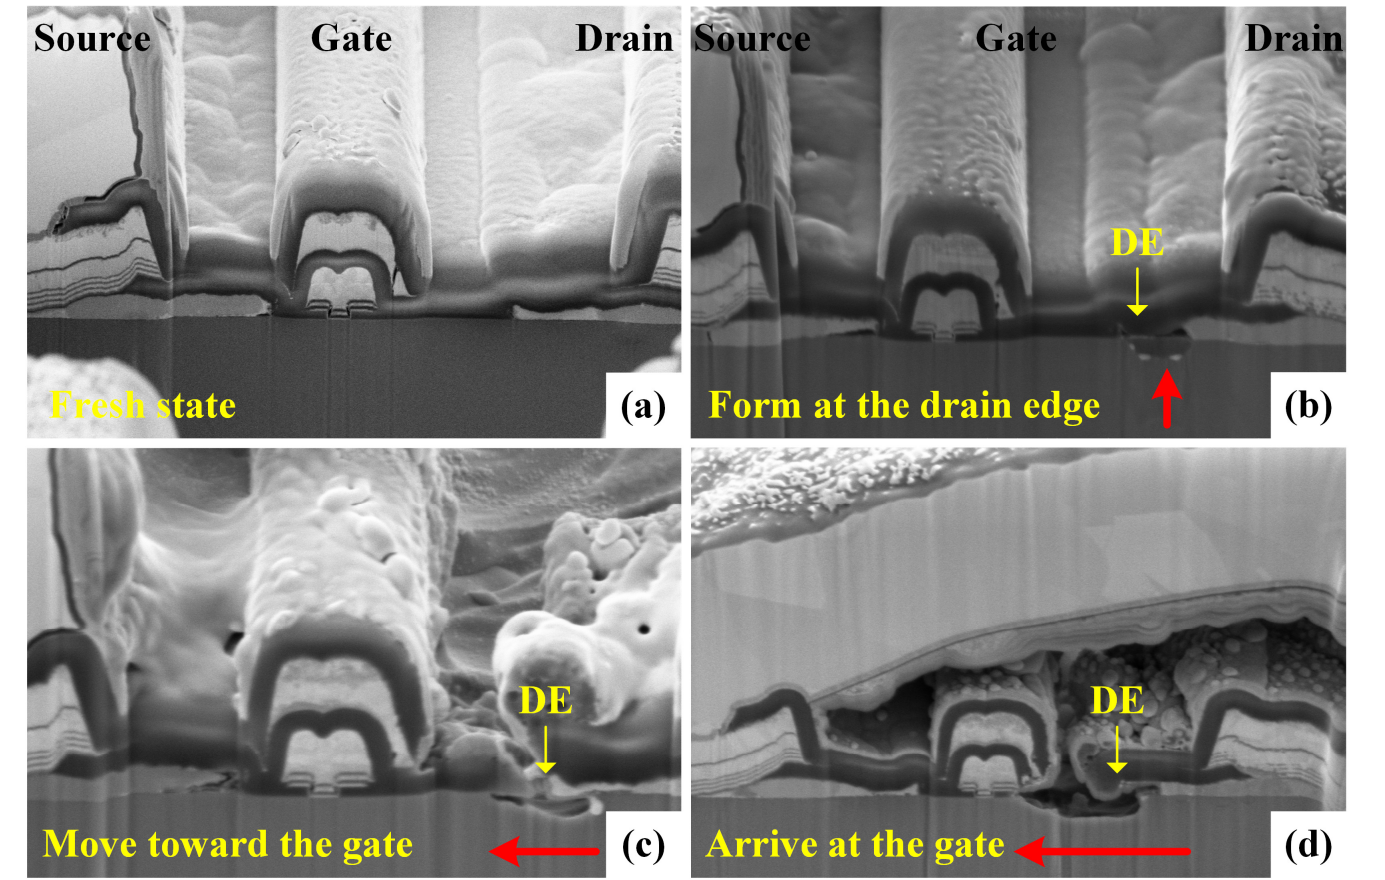
In order to further investigate the physical origin of these leakage paths, the SEM analysis was performed on the degraded GaN MMIC PAs, which are shown in Fig. 6. The images were collected from the hotspots observed by PEM and the failure points in the burned GaN MMIC PAs. Fig. 6(a) shows the initial state of the device structure. It is clear that there is almost free of any intrinsic visible crystal defects. In Fig. 6(b), it is obviously observed that the cracks and pits start to appear around the drain edge, which is consistent with the result observed in Fig. 4. Furthermore, Fig. 6(c) and (d) show the evolution process of cracks and pits traveling from the drain edge toward the gate during the stress.

Fig. 6. FIB-SEM images show the evolution process of catastrophic failure under $V_{DS\text{-}Stress} = 90$ V. (a) Fresh state. (b) Cracks and pits form at the drain edge (DE), (c) traveling from the drain edge toward the gate, (d) arriving at the gate. Traces of cracks and pits are marked with red arrows and explained with yellow texts.

Based on the above procedure, the following side effects will be induced: 1) The density and mobility of electrons within the 2DEG channel will be reduced due to the depletion and the coulomb scattering effect of electron trapping within the buffer layer, which will decrease the DC and RF output performance. 2) With the stress time increasing, the electron trapping within the GaN layer will increase, which induces a higher electric field. The simulation results in Fig. 9 verified it. Fig. 9 shows the electric field for the devices with different amounts of buffer acceptor trap concentrations under $V_{DS\text{-}Stress}$= 90 V. It is clearly observed that the electric field near the drain electrode increases dramatically with the increasing electron trapping within the GaN buffer layer. When a critical longitudinal electric field (E_{Cr}) is achieved, a catastrophic burnout occurs near the drain edge, which can be observed as that in Fig. 6.

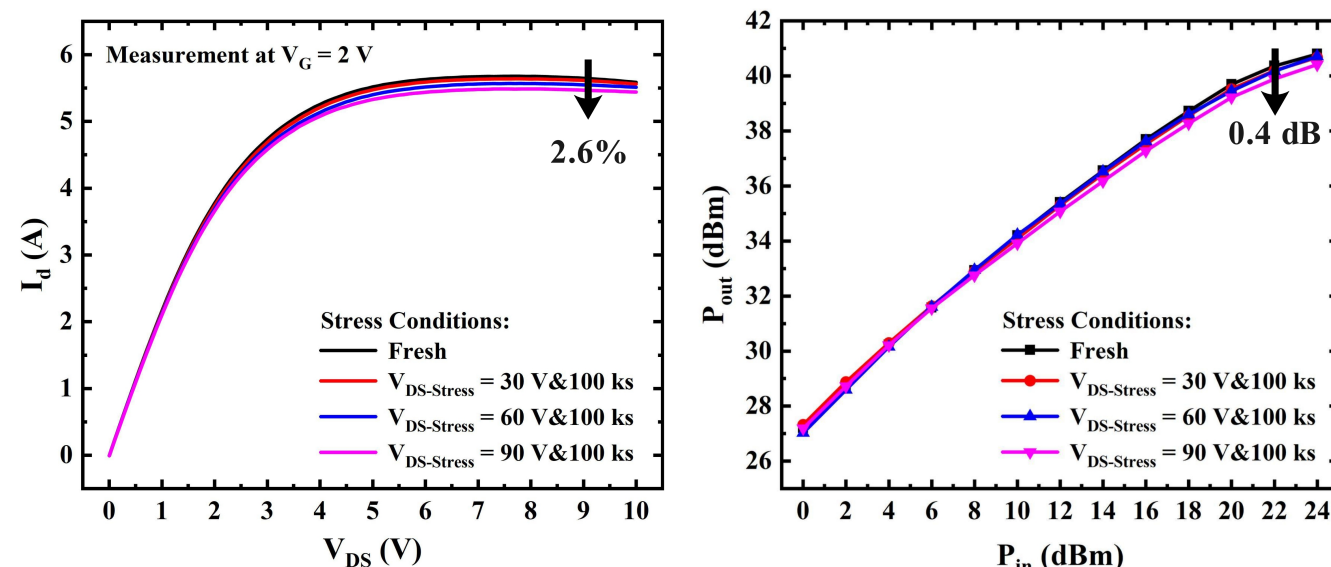
One may suspect that the degradation and catastrophic burnout under high drain bias may be attributed to the inverse piezoelectric effect. In order to verify it, off-state stress with identical drain bias was performed on discrete GaN HEMTs fabricated in the same wafer with the identical process. In Fig. 7(a), it can be seen that the DC output performance degrades slightly as $V_{DS\text{-}Stress}$ increases. Even under $V_{DS\text{-}Stress} = 90$ V, the maximum reduction of the saturation drain current is just 2.6%. Fig. 7(b) depicts the HEMT's RF performance degradation. It is observed that the P_{out} degradation is insignificant and only decreases by 0.4 dB even at $V_{DS\text{-}Stress}$= 90 V, which is much

lower than that in GaN MMIC PAs. The above results suggest that the electrical performance degradation caused by the off-state high drain bias is insignificant. It confirmed that the origin of electrical degradation of GaN MMIC PAs under on-state with high drain bias is not due to the inverse piezoelectric effect but rather closely related to the channel hot electrons.

Fig. 7. The electrical performances of discrete GaN HEMTs under off-state stress with different drain bias: (a) The DC output characteristics. (d) The output power vs. the input power at 10 GHz. The static operating point is V_{DS} = 28 V, I_{dq}= 180 mA.

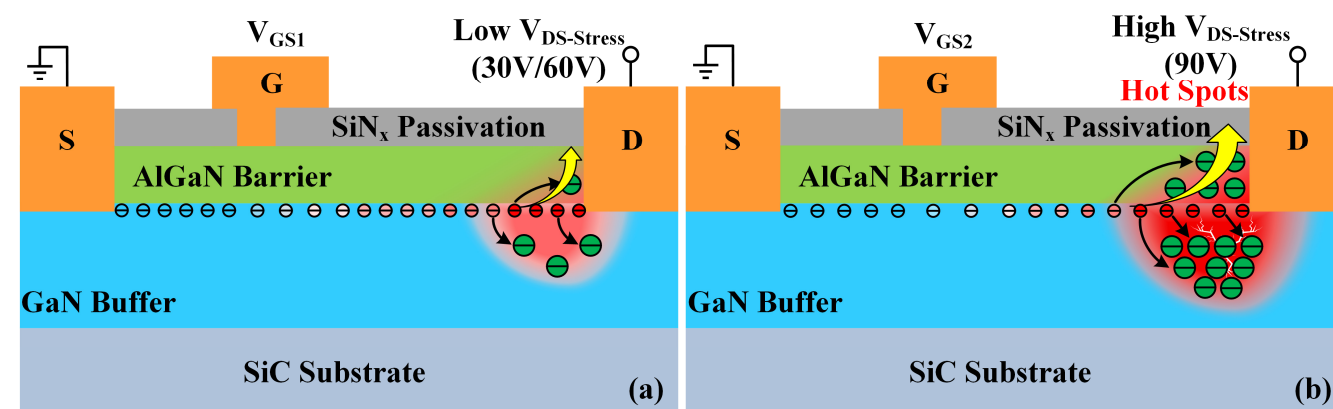
In order to obtain an in-depth insight into this degradation, a hot electrons-based mechanism is proposed in this work. In Fig. 8, the schematic cross sections of HEMTs in GaN MMIC PAs are presented to understand the dynamic behavior during the stress. As shown in Fig. 8(a), when the GaN MMIC PA is biased at low $V_{DS\text{-}Stress}$ with on-state, electrons in the channel are accelerated by the transverse high electric field and then gain energy to become hot electrons accordingly. Especially, when the drain bias increases, more hot electrons with higher energy will be formed near the drain electrode, as illustrated in Fig. 8(b). Most of hot electrons can be collected by the drain electrode and form drain current. The other hot electrons are divided into two parts. One part of hot electrons with enough energy can surmount the AlGaN/GaN interface barrier and pass through the AlGaN layer. It then causes damage and induces leakage paths across it, which induces hotspots as that can be observed by PEM in Fig. 4. The other part of hot electrons will collide with the lattice in GaN buffer layer, especially near the drain edge and generate new defects. Meanwhile, these electrons can get trapped within the newly generated defects and cause significant electron trapping.

Fig. 8. Schematic cross sections of the HEMTs in the GaN MMIC PAs show channel electrons, electron trapping (Green symbols), and current leakage path (Yellow arrow) under (a) Low $V_{DS\text{-}Stress}$ and (b) High $V_{DS\text{-}Stress}$, respectively.

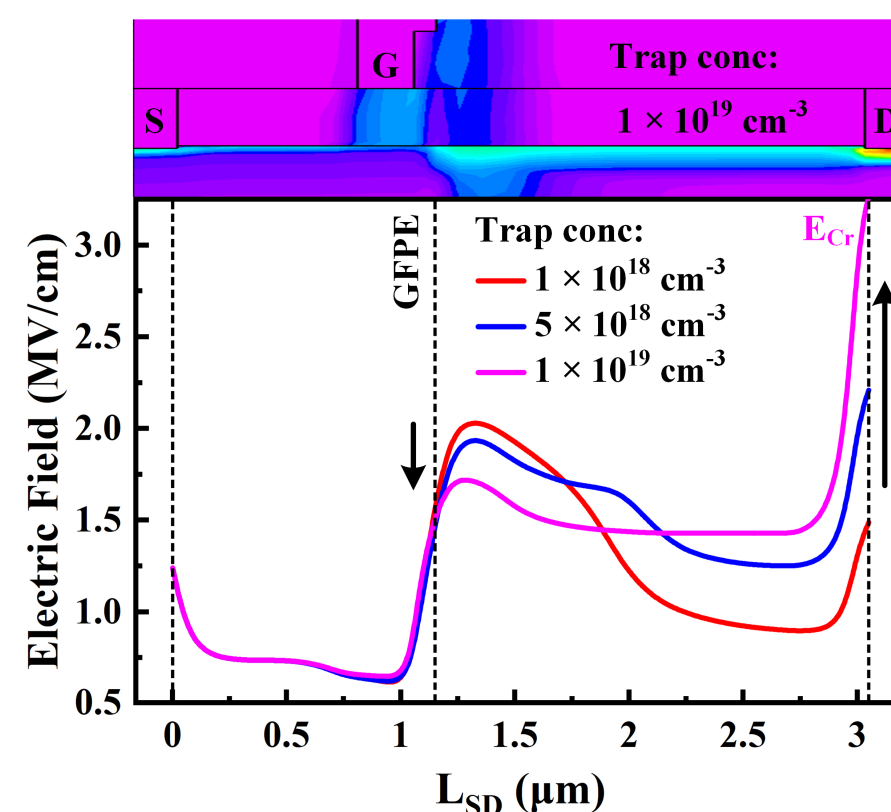
Fig. 9. The simulated electric field from the source edge to the drain edge with different acceptor trap concentrations in the buffer at $V_{DS\text{-}Stress}$ = 90 V.
