Fragility assessment of traditional wooden houses in Madagascar subjected to extreme wind loads

<https://doi.org/10.1016/j.engstruct.2023.116220>

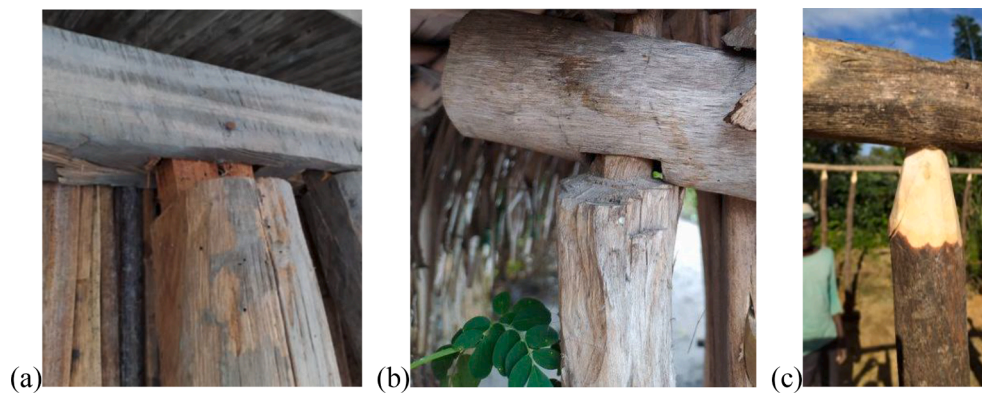
MT connections are nailed or pegged using a single nail or dowel. However, different geometrical configurations for the mortises and the tenons are commonly used, and those seen in the study sites were rectangular, circular, or conical (Fig. 7). MT joints of inferior quality, notably with a loose tenon that is not well fitting into the mortise, were commonly seen. These different connection configurations were considered in the subsequent experimental and field-testing campaigns to assess their strengths.

Fig. 7. Identified types of MT joints in the study sites: (a) rectangular tenon; (b) circular tenon; (c) and conical tenon.

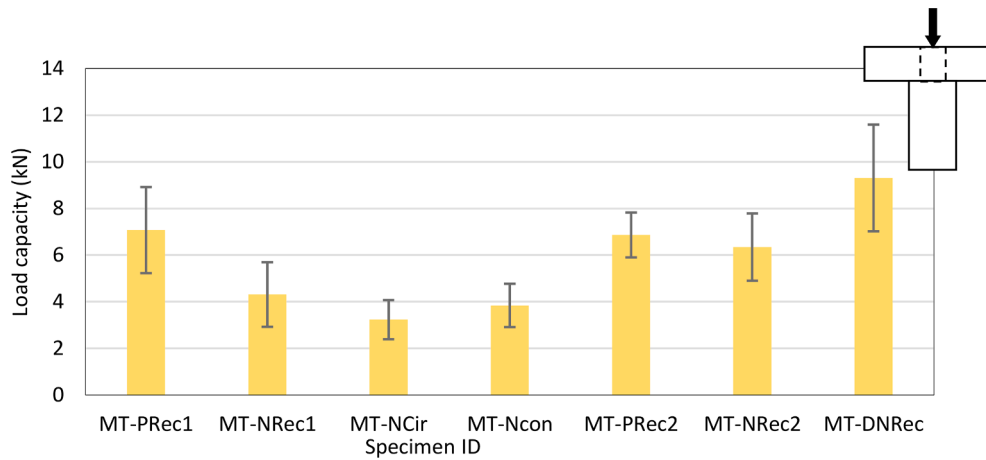
Two types of failure modes were observed for axially loaded MT joints. The first category of failure was due to grain tension splitting of the mortise, observed for pegged MT joints. The second was observed for single nailed MT joints and was due to the splitting failure of the tenon member driven by the bending deformation of the nails. For double nailed MT joints, both failure modes due to splitting of the mortise member and the tenon were observed (Fig. 20). Table 3 and Fig. 21 gives

Fig. 21. Load capacity of Mortise-Tenon joints for tested specimens under axial load.

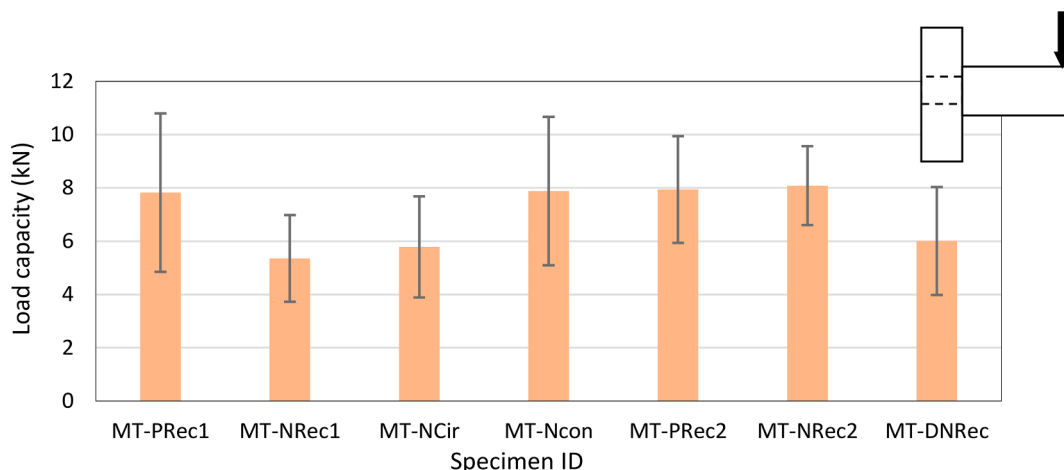
Table 4 and Fig. 22 gives the mean and the standard deviation of the load capacity for each test configuration. Three categories of failure mode were observed for laterally loaded MT joints. The first was due to grain tension splitting of the mortise member (observed for pegged MT joints, which were similar to failures observed for axially loaded pegged MT joints), and the second was due to the splitting failure of the tenon at the contact line with the nail, driven by the bending deformation of the nails (Fig. 23). The third category of failure mode was observed for double nailed MT joints and was due to the tension splitting of the tenon.

Fig. 22. Load capacity of Mortise-Tenon joints for tested specimens under lateral load.

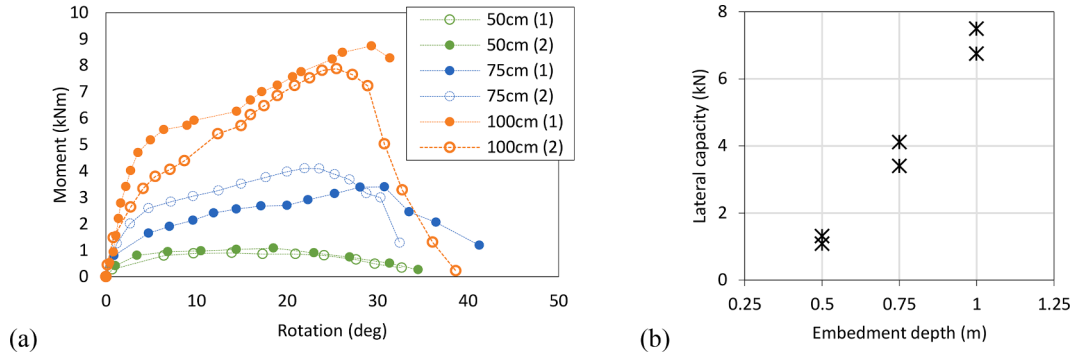
The response curves for moment versus rotation is shown in Fig. 24a. The moments and rotations were evaluated around a centre of rotation at two third of the embedment depth based on Bowling simplified model [36]. It is notable that lateral strength is significantly reduced by

reducing the embedment depth of the columns. By reference to 50 cm embedment depth as the common construction practice for wooden traditional houses, increasing the embedment to 75 cm and 100 cm increase the lateral capacity by 3 times and 6 times, respectively. The lateral capacity versus embedment depth for each test are plotted in Fig. 24b.

Fig. 24. Embedded column lateral test response (a) load-displacement response curves and (b) lateral capacities for the different considered embedment depths.

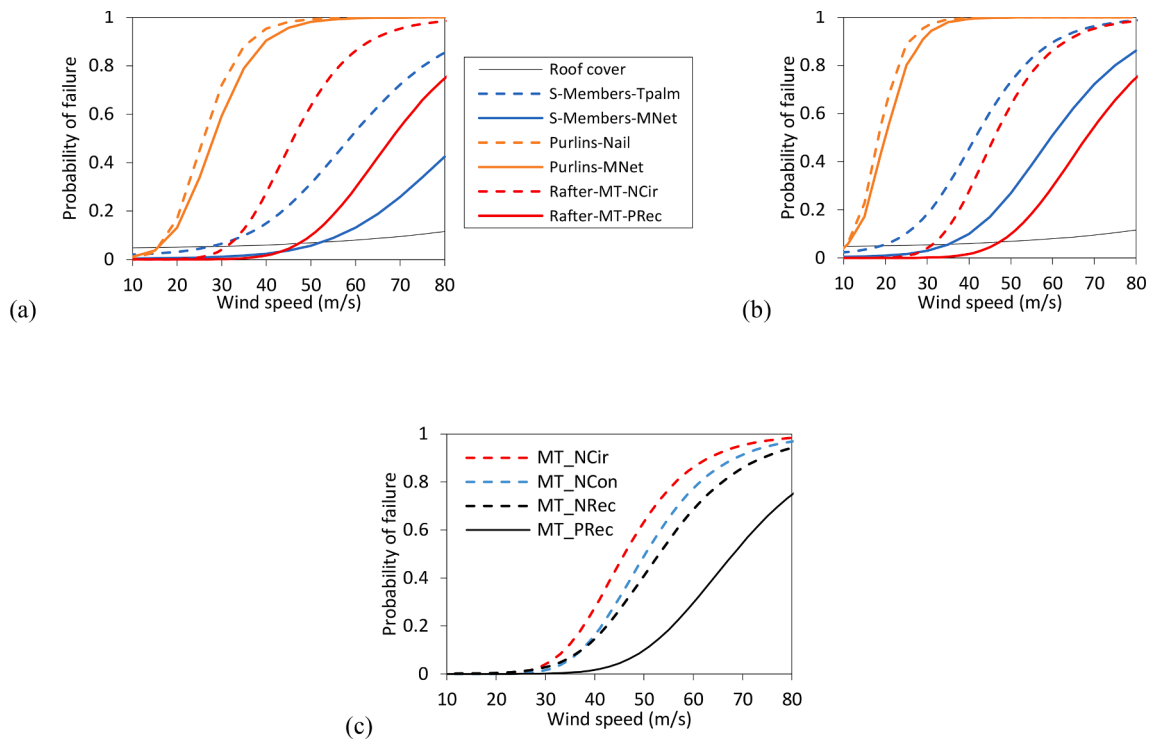
Fig. 27 shows fragility curves for the different components constituting the roof system for the trigger of damage corresponding to the most loaded roof zone. The curves are presented for roof cover-secondary members, secondary members-purlins, and purlins-rafter connections. For each type of these connections, fragilities were assessed for the weakest and the strongest strengths, that is traveller's palm leaves and mosquito net wrapped connections for secondary members-purlins connections, nailed and mosquito net wrapped connections for purlin-rafter connections, pegged rectangular MT joint and nailed circular MT joint for rafter-tie beam connections.

As had been observed during the field survey, the use of the mid-purlin or roof truss at mid span of the tie beams were omitted in several cases; these presence of absence of the mid-purlin was therefore also considered when evaluating the fragility curves. Fig. 27a and b show the case of roof system with and without mid-purlin, respectively. It is shown in both cases that the purlin-rafter connections are the weakest links in the roof system that may lead to roof damage.

The presence of a mid-purlin has a considerable effect in reducing failure probability of secondary member-purlin connections due to the reduction in the corresponding tributary area. As shown in the figure, the presence or not of the mid-purlin may change the damage trigger from the secondary member-purlin connections to the rafter-tie beam connections. This later may lead a complete failure of the roof system as the example of the house shown on the right in Fig. 10.

Fig. 27. Fragility curves for (a) roof members wrapped connections for roof with mid-purlin, (b) roof members wrapped connections for roof without mid-purlin, and (c) Rafter-Tie beam MT connections.

rafter-tie beam MT joint types are shown in Fig. 27c. The median wind speeds for nailed circular, conical, rectangular, and pegged rectangular are 46, 50, 53, and 68 m/s, respectively. This clearly shows the advantage of pegged MT joint in resisting uplift of the roof structural system compared to the other considered MT joint types. The strength of the roof cover to secondary member connections means it is unlikely that damage appears at connections between these two members prior to other connections in the roof system.

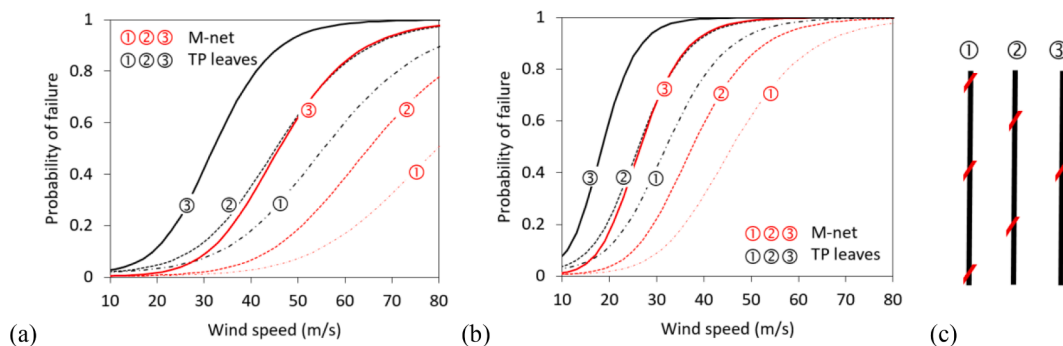
Fig. 28 shows fragility curves for wall cladding for three connection schemes to the columns using Traveller's palm leaves and mosquito net wrapped connections for the cases of columns spaced by 0.5 m and 1.5 m. These three connection schemes are schematically represented in Fig. 28c and considers the number of connections points of the wall cladding along the height of the columns. The strength of the Traveller's palm leaf wrapped connections is approximately half the strength of the mosquito net wrapped connection. For each of the wall cladding connection schemes, the median wind speeds for the case with Traveller's palm leaves wrapping materials is about 65–70% higher than the case using mosquito net. On the other hand, reducing column spacing from 1.5 m to 0.5 m, increases the median wind speeds required for damage by approximately 60%.

Fig. 28. Fragility curves for the cases of (a) 0.5 m columns spacing and (b) 1.5 m columns spacing (c) for the three wall cladding connection schemes to the columns.

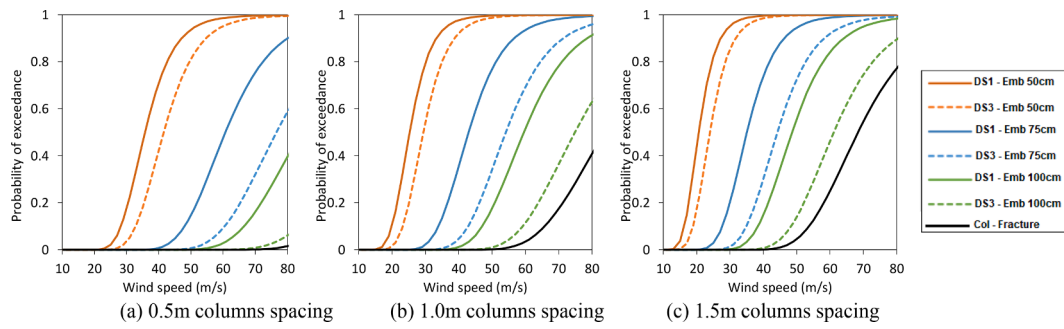
Fig. 29 shows fragility curves for column embedment of 50 cm, 75 cm, and 100 cm, considering columns spacing of 0.5 m, 0.75 m, and 1.0 m. For each combination of column embedment depth and spacing, fragility curves are drawn for yield (DS1) and ultimate (DS3) limit states, and for column fracture.

Fig. 29. Fragility curves for DS1 (yield), DS3 (ultimate), and column fracture limit states for embedded columns.
