# Ship/Platform Collision Incident Database (2015) for offshore oil and gas installations

Prepared by **Liverpool John Moores University**  
for the Health and Safety Executive

**RR1154**

Research Report

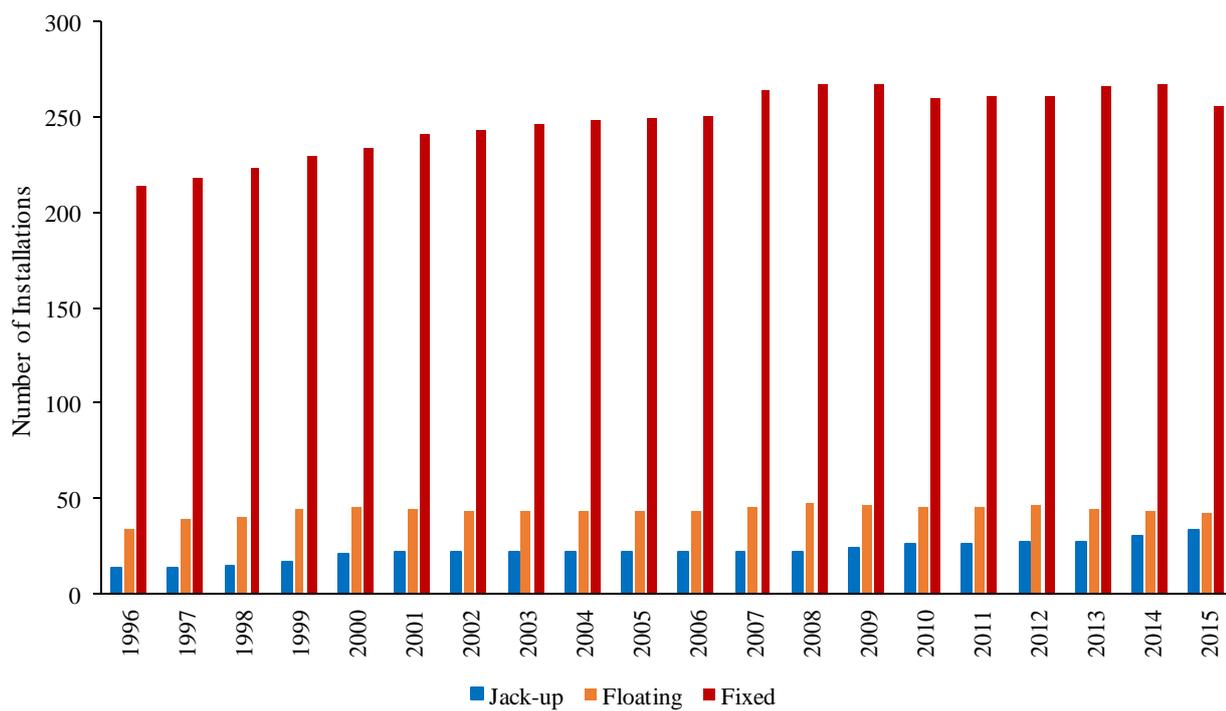
Figure 1: Number of Fixed, Floating and Jack-up installations operating per year between 1996 and 2015

A summary of operating experience for fixed installations, floating installations and jack-up rigs over the period of study (1996 – 2015), in the UKCS, is represented graphically in Table 1 and presented in Figure 1.

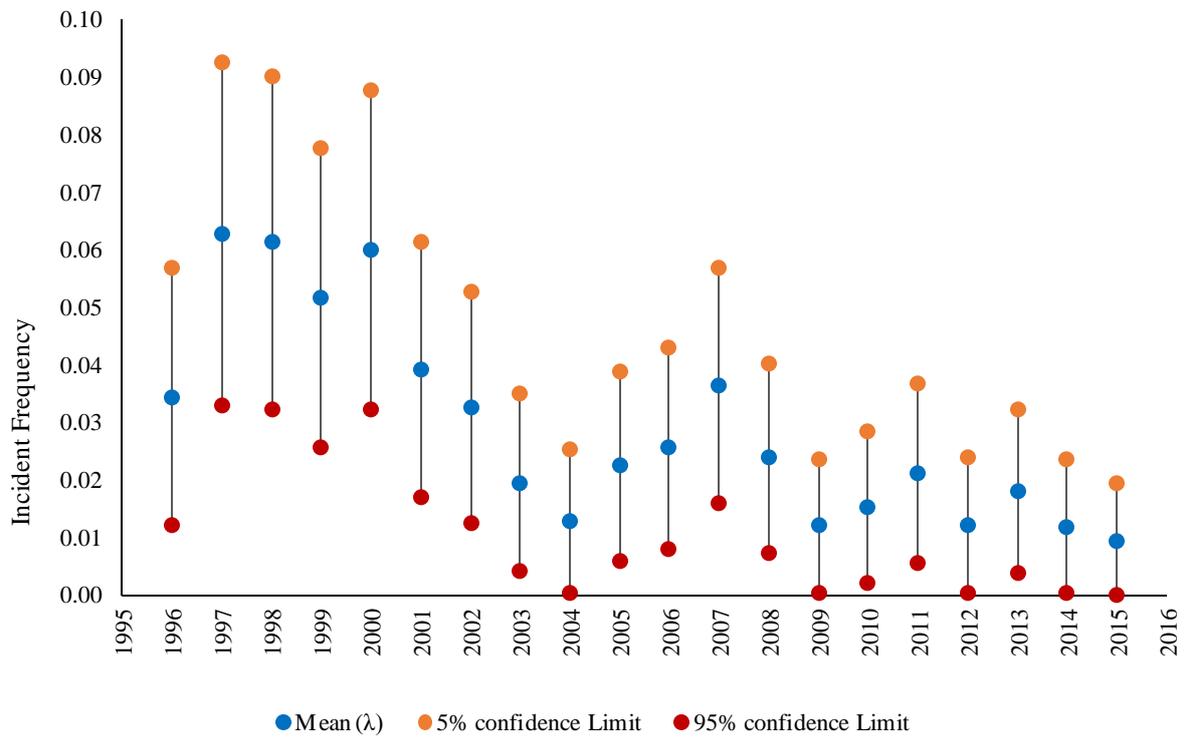
Figure 2: Frequency of all reported incidents to all installations per year

It can be seen from Figure 2 and Figure 3 that the general trend of ship to platform collisions is in decline. However, there are two key spikes within the data, firstly, in 1997 then again in 2007. These spikes could be attributed to the general increase in operational installations per year, or they could be anomalous spike. However, the data shows that there is a gradual increase and decrease within the trend. This could lead one to believe the situations may have occurred to account for some fluctuation. One possible explanation is that safety case regulations have been released in both 1996 and 2005. It is possible that an alteration in regulation can affect the operation and reporting when ship/platform incidents occur.

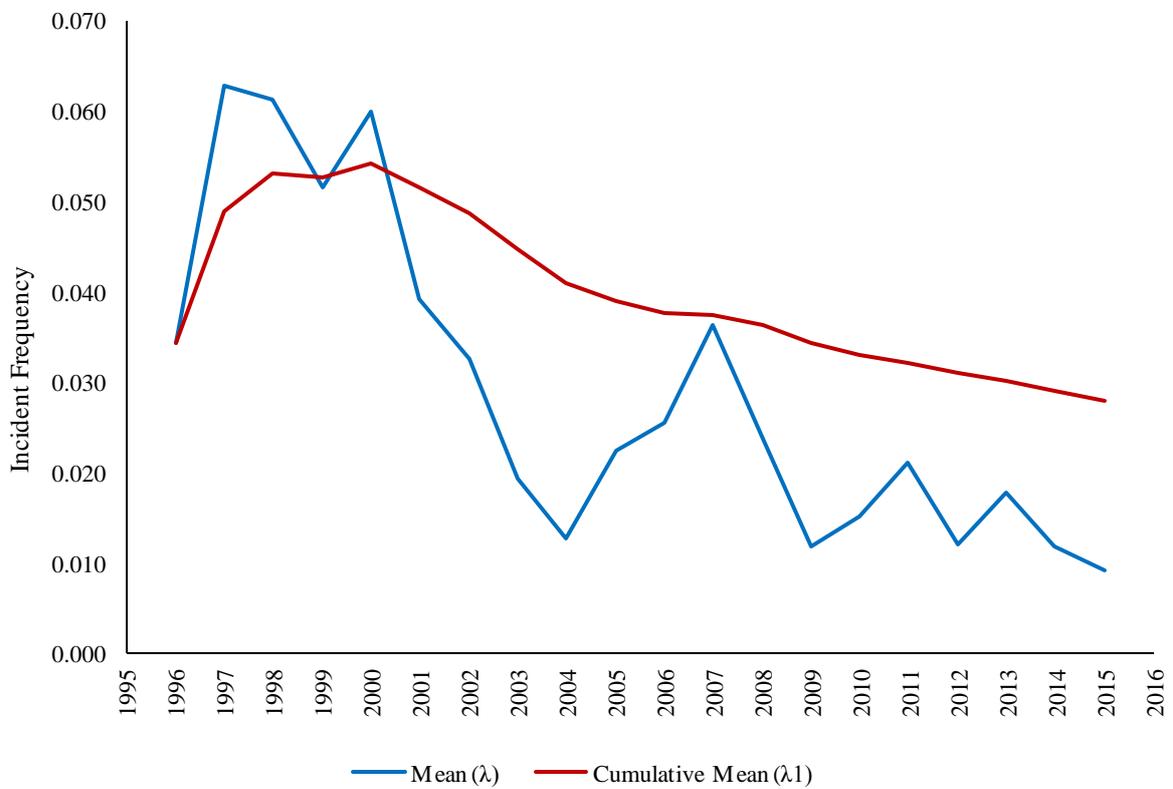
Figure 3: Mean and cumulative frequency of all reported incidents to all installations

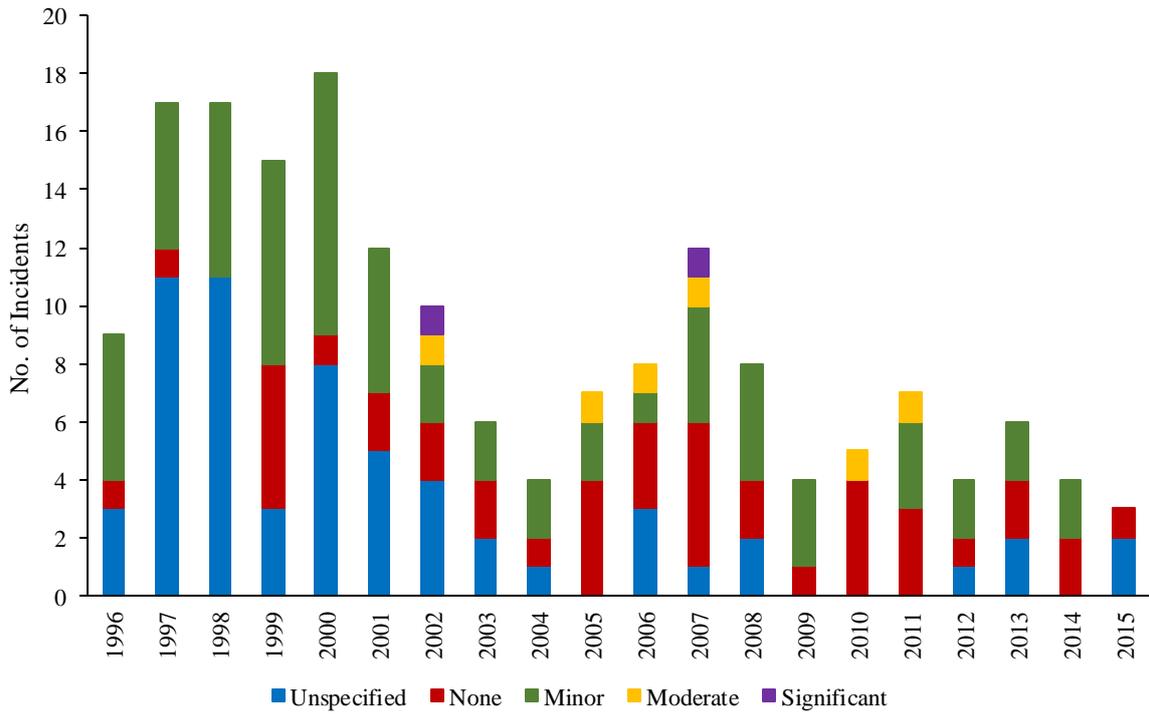
Figure 5: Damage classification of all reported incidents to all installations per year

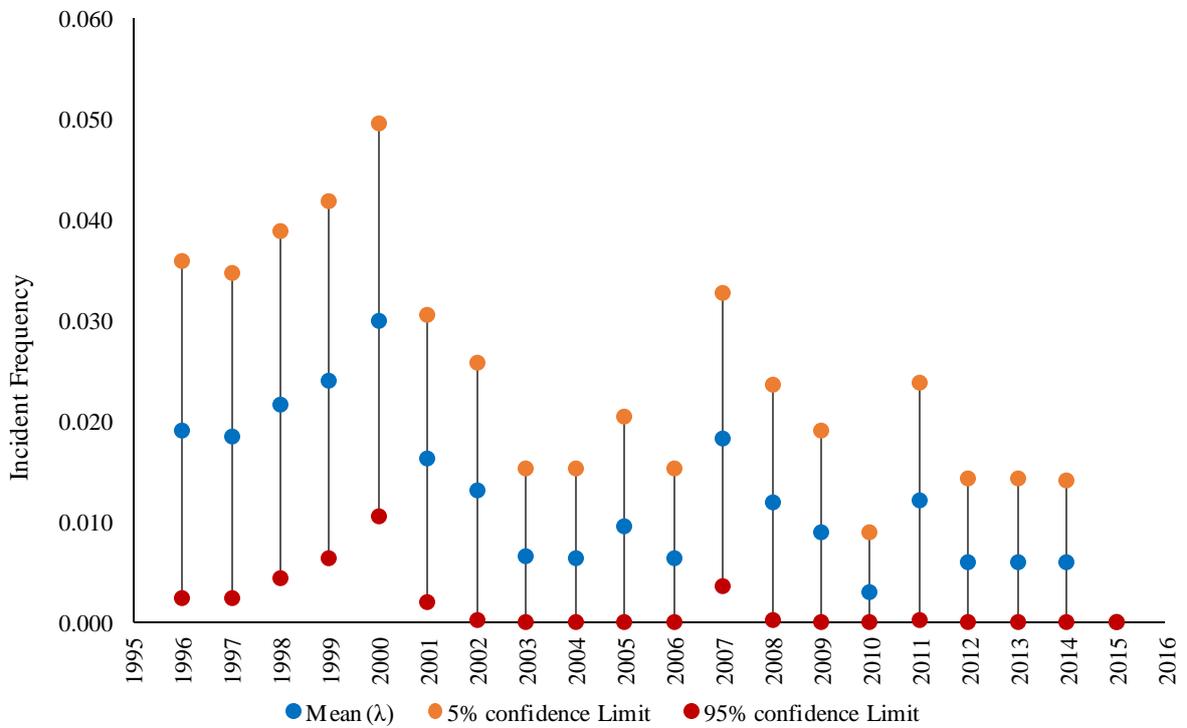
Figure 4: Frequency of incidents resulting in minor, moderate or significant damage for all installations per year

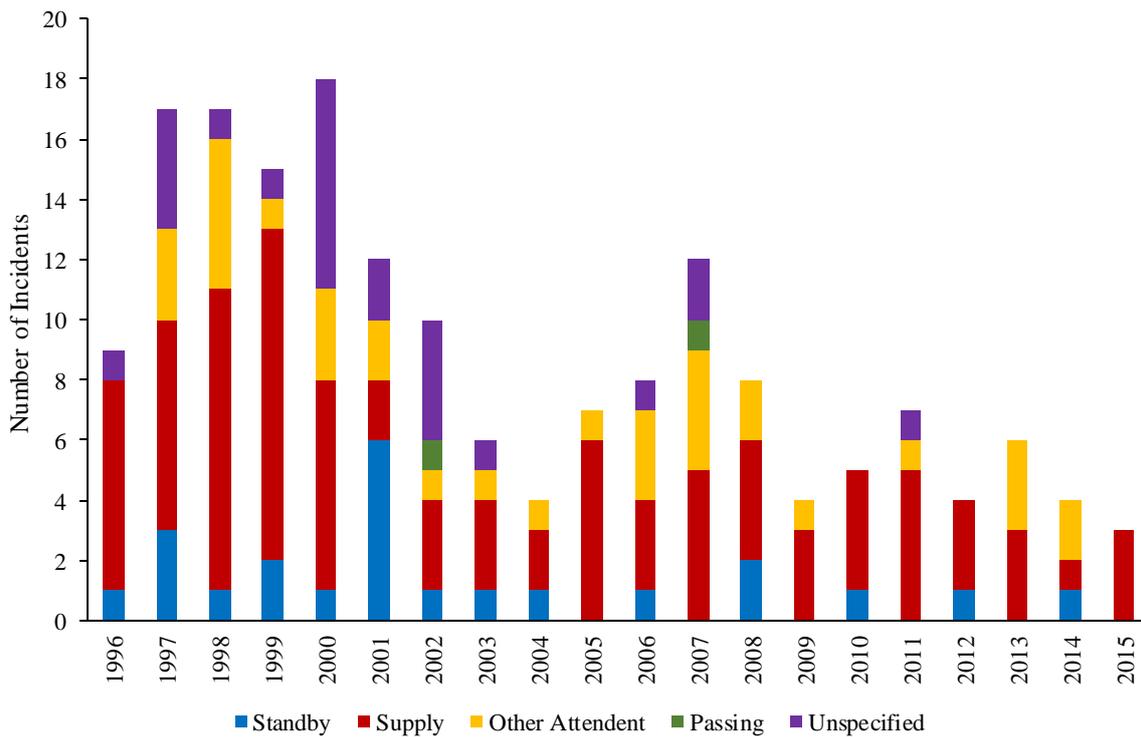
Figure 6: Number of reported incidents by all vessel types per year

A summary and graph of the types of vessels involved in collision incidents are demonstrated by Table 6 and Figure 6. These indicate that the majority of incidents are caused by attendant vessels. A breakdown of the attendant vessels shows that 23 incidents were caused by “*Stand-by*” vessels, 92 by “*Supply*” vessels, 34 were “*Other Attendant*” vessels, with the rest being “*Unspecified*”. It can also be seen that 2 incidents occurred due to “*Passing*” vessels (a merchant container and a trawler). The category of “*Other Attendant*” includes the following vessel types:

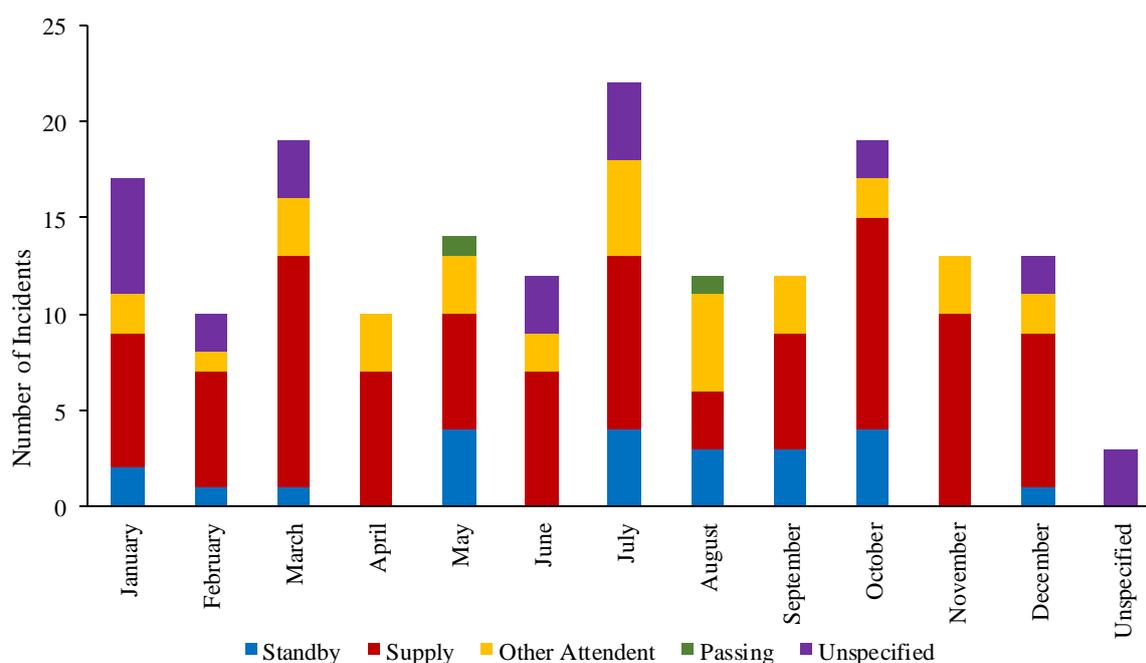
Figure 7: Number of incidents by vessel type per month

Table 7 and Figure 7 demonstrate the trend of incidents given the type of vessel and the month of occurrence. Given the data presented, most incidents have occurred in the 6 month period of October to March when compared to April to September. This can be attributed to an increase in the number of incidents involving supply vessels between October and March. In this time frame weather conditions are likely to be more adverse and hence increases the risks during cargo transfer. Similarly, there is a large spike of incidents in the month of July. This can also be attributed to the weather in the sense that the weather is generally better between May to September and so increased maintenance and close support work is carried out. This can be seen by the cumulative number of incidents between May to September where the majority of incidents involving standby vessels occur, as well as other attendant vessels. This is backed up further by the fact that the number of incidents related to other attendant vessels increases as the months between May and October is usually when annual inspections and repairs take place. This can be seen also by the number of Diver support incidents, where 4 of the 5 incidents occur between May to August.

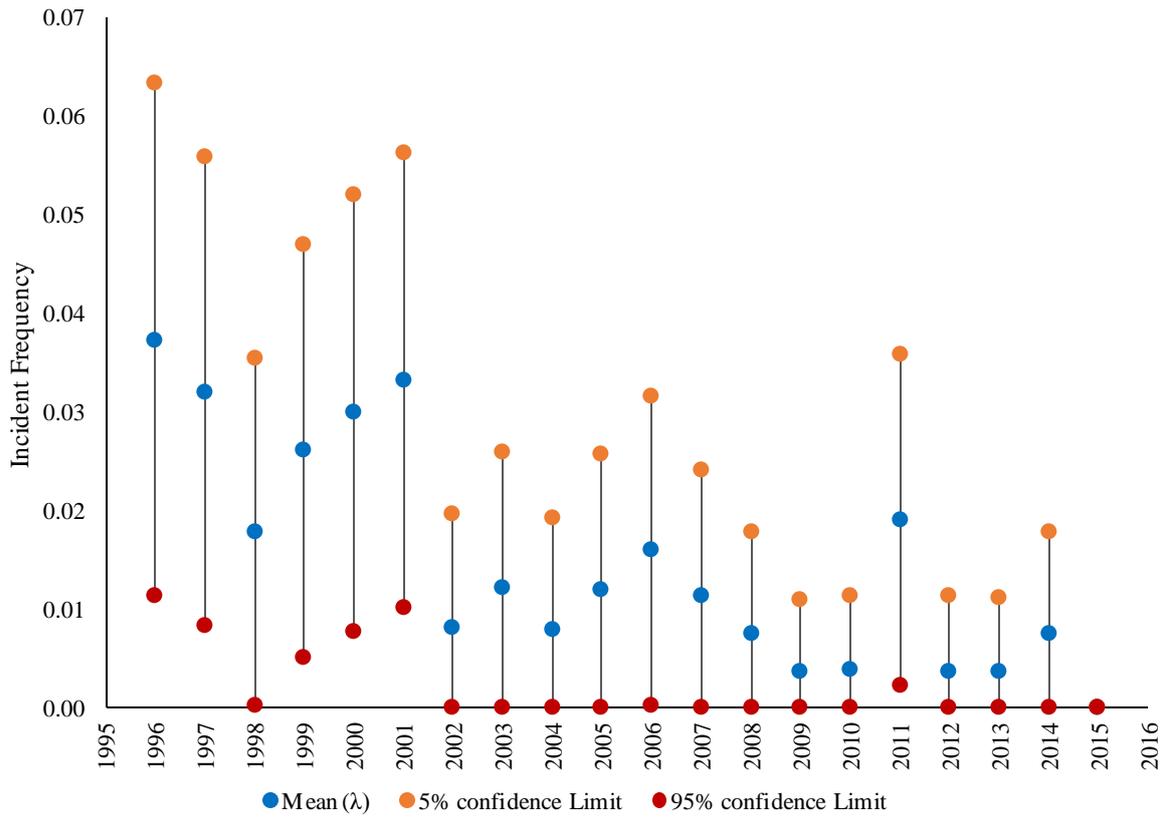
Figure 9: Frequency of all reported incidents to fixed installations per year

Tables 8 and 9 demonstrate the mean frequency and cumulative frequency of all reported incidents to all fixed installations on the UKCS between 1996 and 2015. Figures 8 and 9 graphically represent the information demonstrated in Tables 8 and 9.

Within the initial years of the study (1996-2001) the frequency of incidents remained at a consistently high level until a large decrease in 2002. The incident frequency fluctuated very little with a small spike in 2006 – 2007, which is in concurrence with the spike for incidents across all installations. There is one anomalous data point in 2011 where the frequency of incidents rapidly increases and instantly decreases in 2012. Generally the mean frequency displays a consistent decrease over the 19 year period.

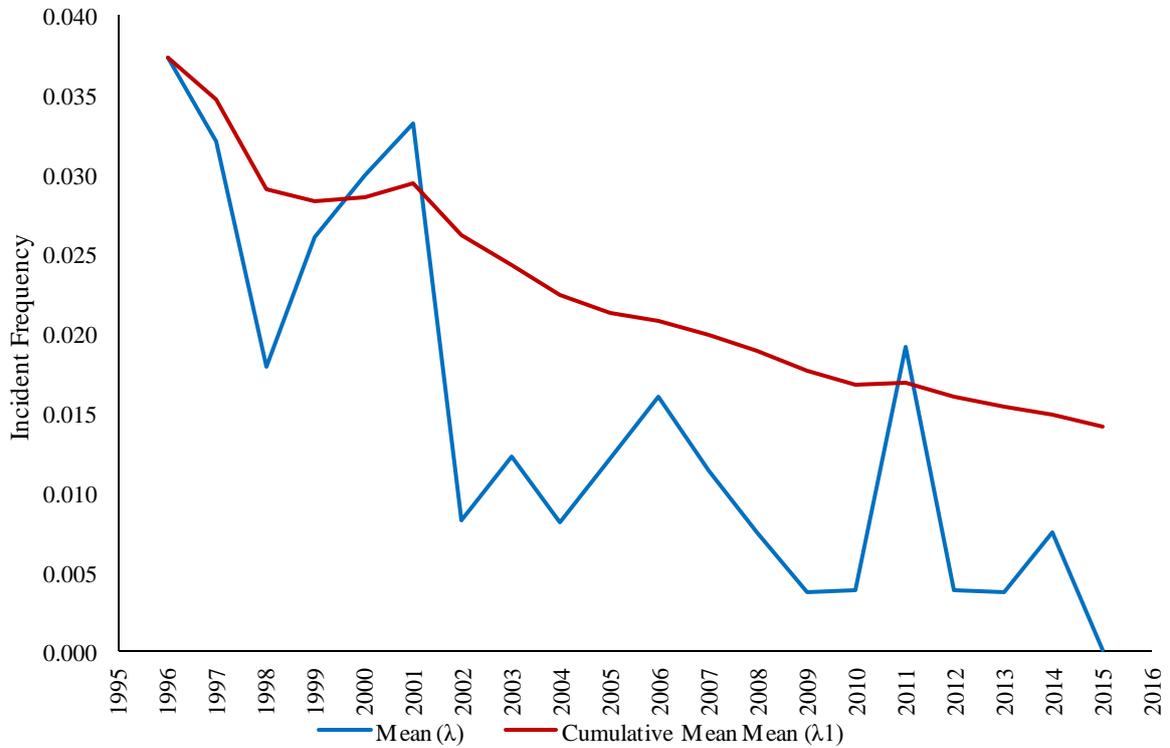
Figure 8: Mean and cumulative frequency of all reported incidents to fixed installations per year

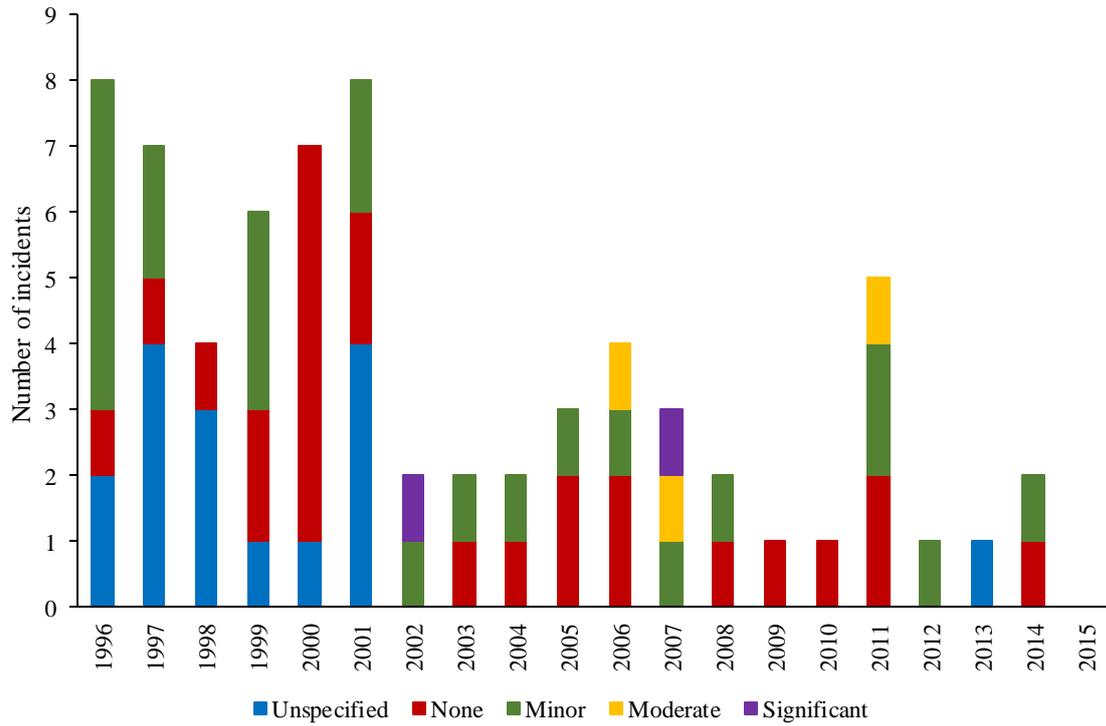
Figure 10: Damage classification of all reported incidents to fixed installations per year

Tables 10 and 11 summarise the number and damage classification of all incidents relating to fixed installations as well as those categorised as resulting in “*minor*”, “*moderate*” or “*significant*” damage. The data presented in Tables 10 and 11 is represented graphically in Figures 10 and 11. 23 incidents were classed as minor, with 3 moderate and 2 significant incidents.

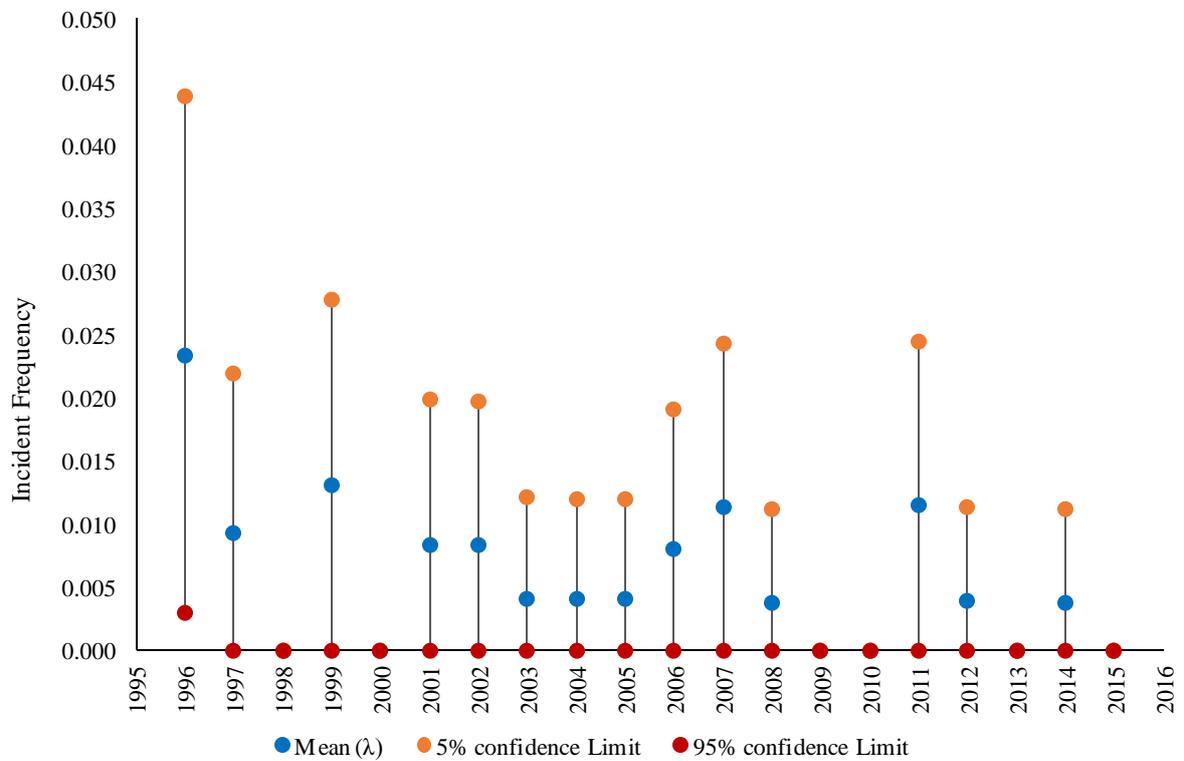
Figure 11: Frequency of incidents resulting in minor, moderate or significant damage for fixed installations per year

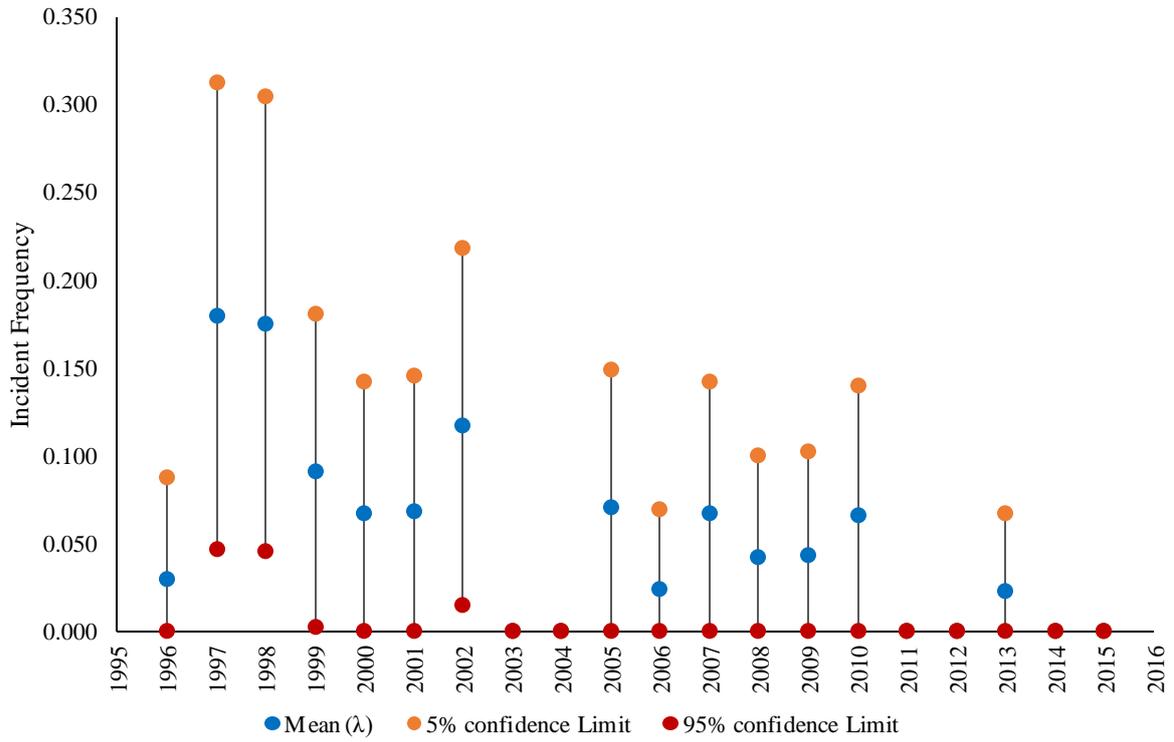
Figure 12: Frequency of all reported incidents to floating installations per year

Tables 12 and 13 demonstrate the mean frequency and cumulative frequency of all reported incidents to all floating installations on the UKCS between 1996 and 2015. Figures 12 and 13 graphically represent the information demonstrated in Tables 12 and 13.

The trend of collision incidents regarding floating installations on average decreases over the 19 year period, however, there is an element of fluctuation. A peak in the number of incidents is reached in 1997 and 1998. This eventually decreases to zero in 2003 and 2004 and the frequency of incidents remains consistent until 2011 at which point the number of incidents decreases to zero again through to 2015, with the exception of 1 incident in 2013.

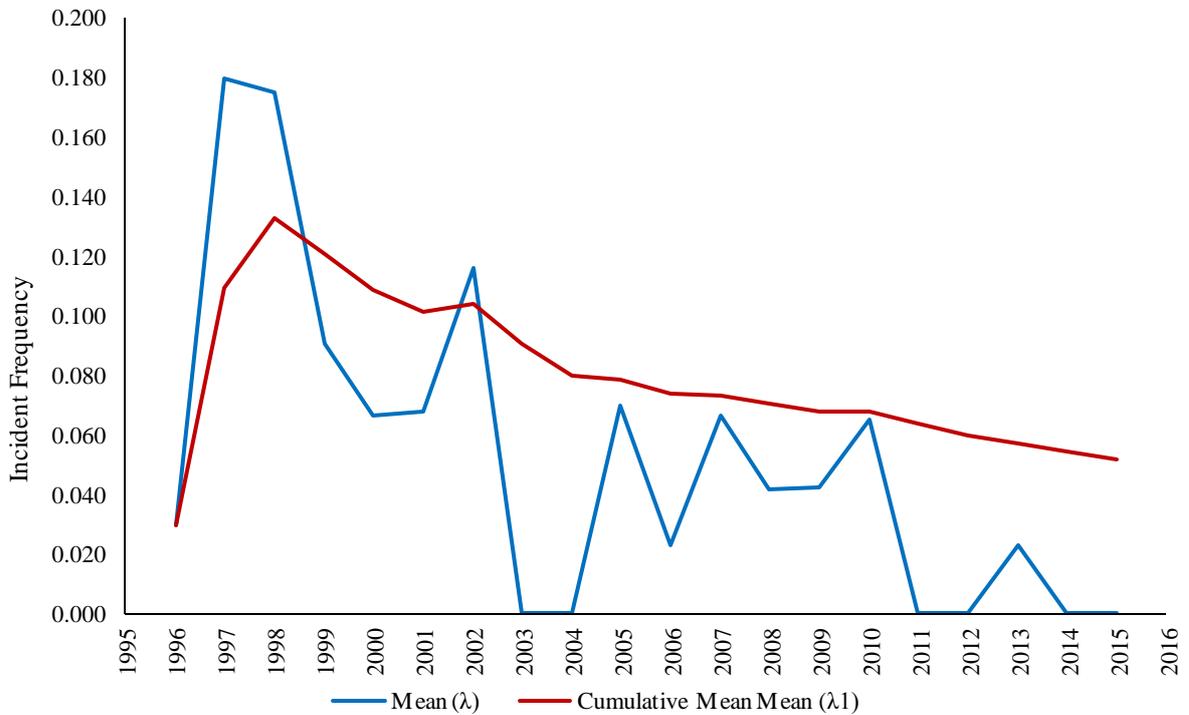
Figure 13: mean and cumulative frequency of all reported incidents to floating installations per year

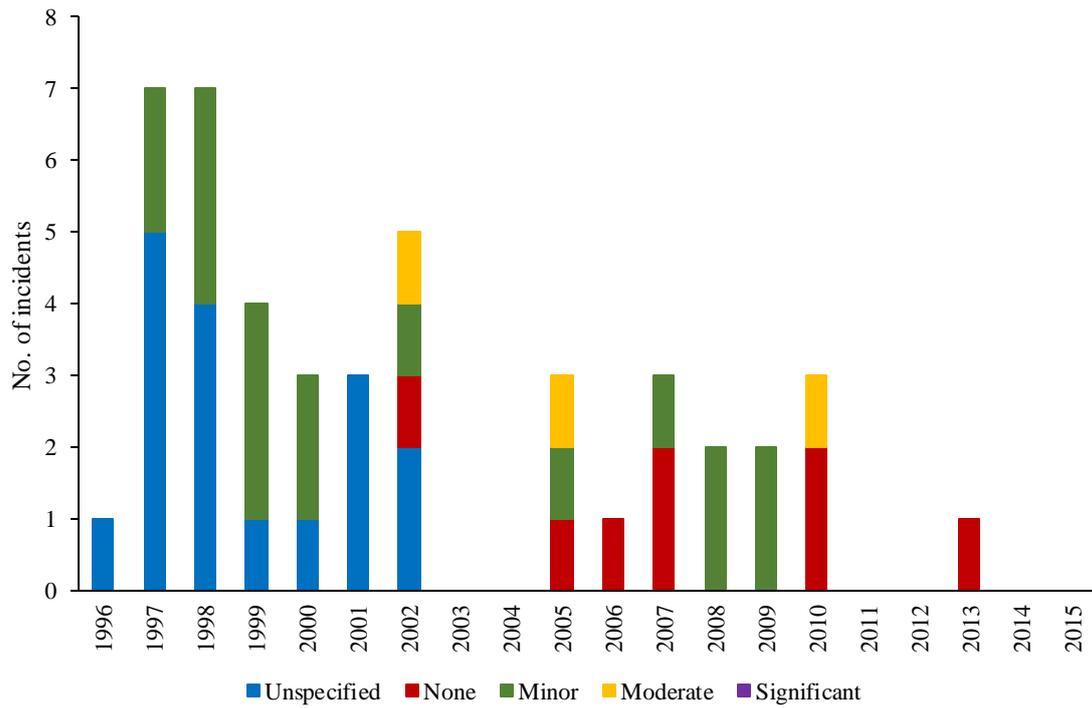
Figure 14: Damage classification of all reported incidents to fixed installations per year

Tables 14 and 15 summarise the damage classification of the reported incidents to floating installations as well as a breakdown of the number of incidents that cause minor, moderate and significant damage. In total, 16 incidents were classified as minor, 3 as moderate and none were deemed to be significant. Similarly, 26 incidents were found have suffered no damage or the damage classification was unspecified.

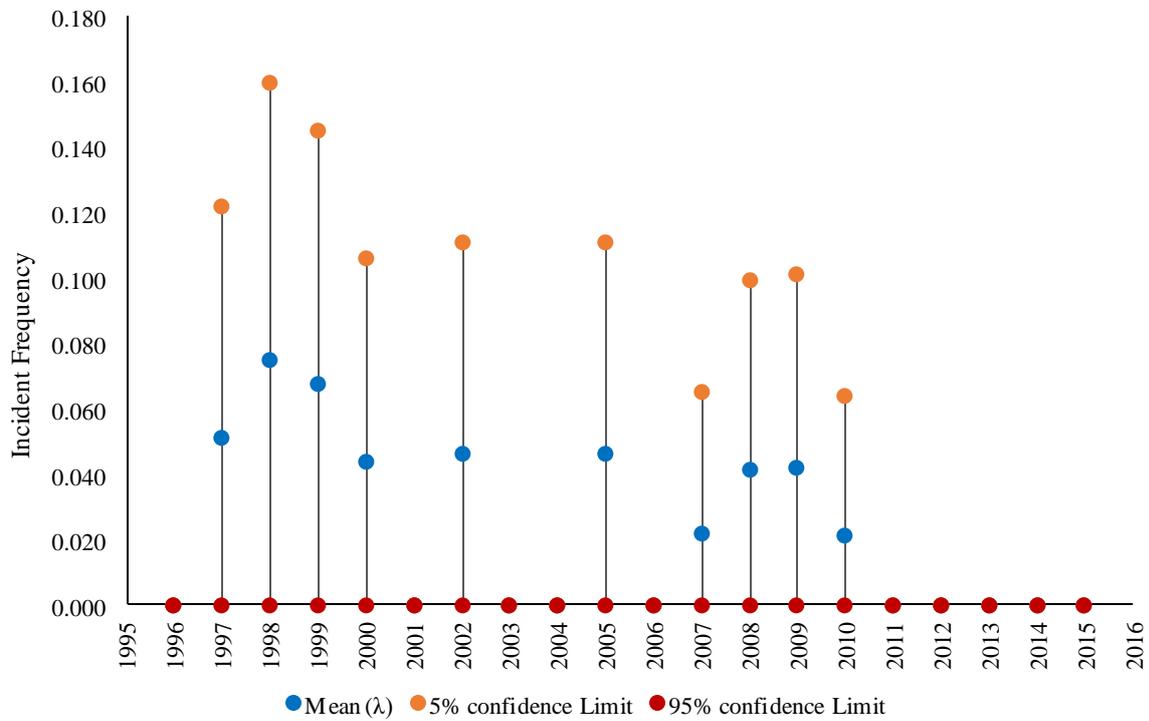
Figure 15: Frequency of incidents resulting in minor, moderate or significant damage for fixed installations per year

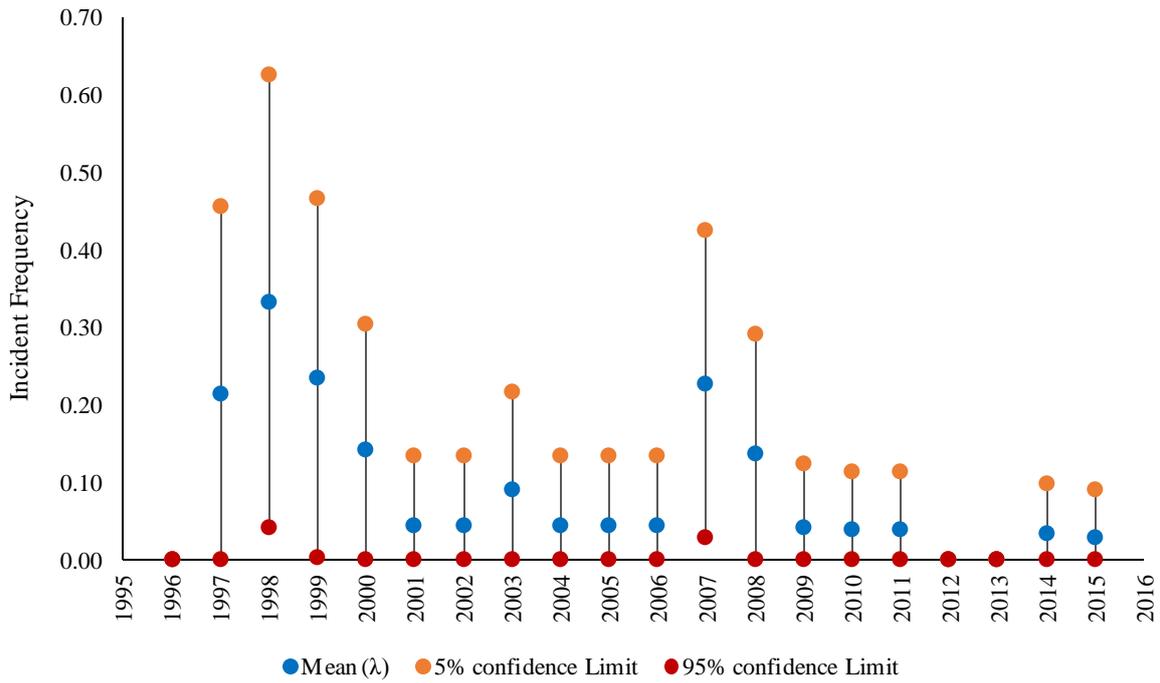
Figure 16: Frequency of all reported incidents to jack-up installations per year

A total of 35 reported incidents were identified involving collisions between vessels and jack-up installations between 1996 and 2015. Tables 16 and 17 demonstrate the mean and cumulative frequency of all reported incidents to all jack-up installations on the UKCS between. Figures 16 and 17 graphically represent the information demonstrated in Tables 16 and 17.

The incident frequency in the earlier part of the study for jack-up installations is relatively high given the small population of operating installations compared with the number of incidents, with a peak frequency in 1998. The trend in incident frequency decreases and remains consistent from 2001 onwards. There is one key spike in the incident frequency in 2007 where a significant number of incidents occurred. A key issue with the jack-up operating data compared to fixed and floating data is that the number of platforms that have been decommissioned or taken out of service in the 19 year period was not known accurately. Hence the number of jack-up installations operating on the UKCS steadily increases, and potentially devalues the data presented.

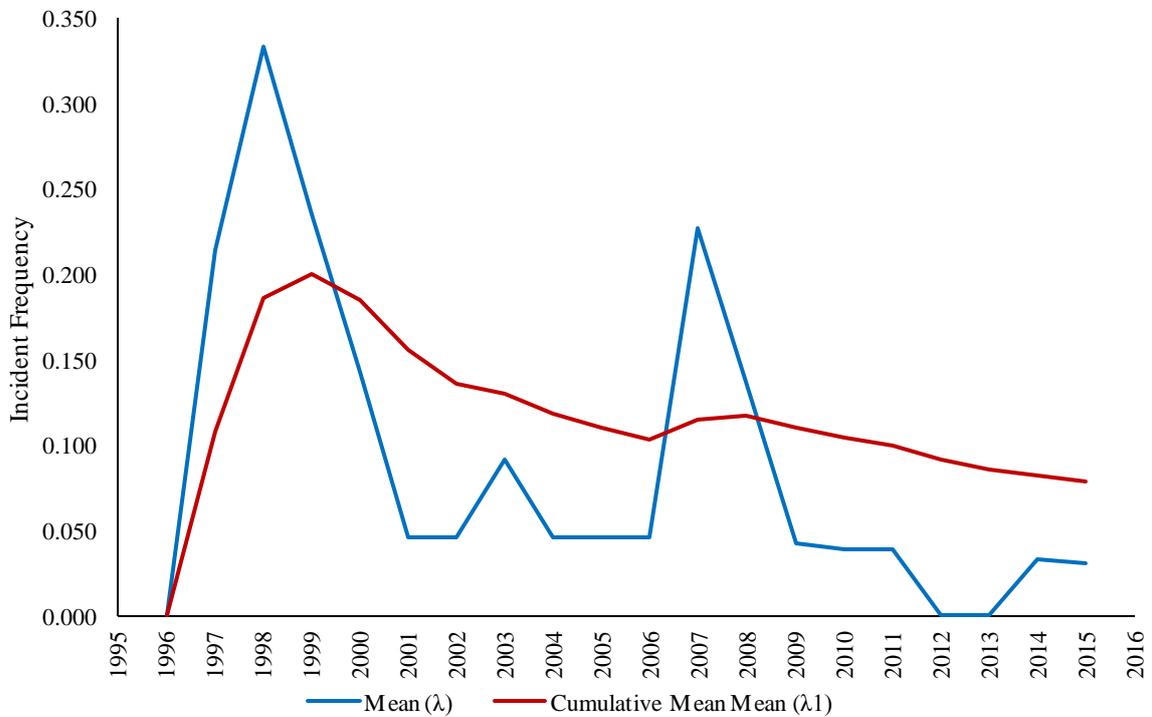
Figure 17: Mean and cumulative frequency of all reported incidents to jack-up installations per year

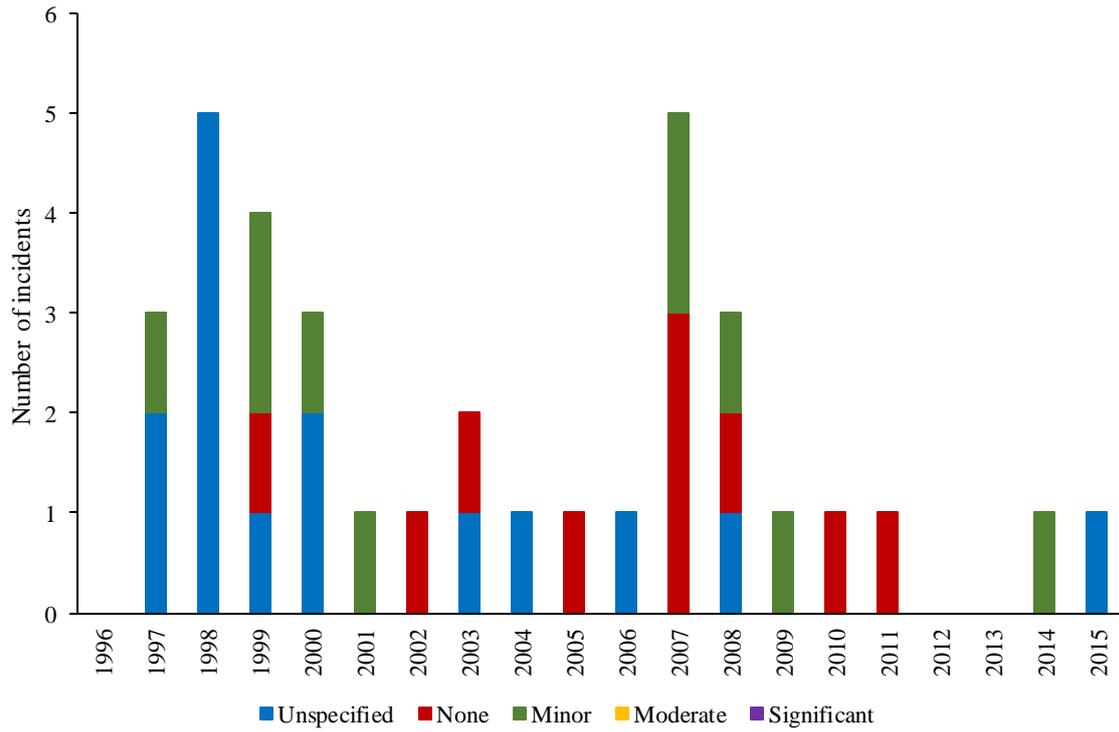
Figure 18: Damage classification of all reported incidents to jack-up installations per year

Tables 18 and 19 summarise the damage classification of the reported incidents to Jack-up installations as well as a breakdown of the number of incidents that cause minor, moderate and significant damage. In total, 10 incidents were classified as minor, and none were deemed to be moderate or significant. Similarly, 25 incidents were found have suffered no damage or the damage classification was unspecified. Figures 18 and 19 graphically demonstrate the data presented in Tables 18 and 19.

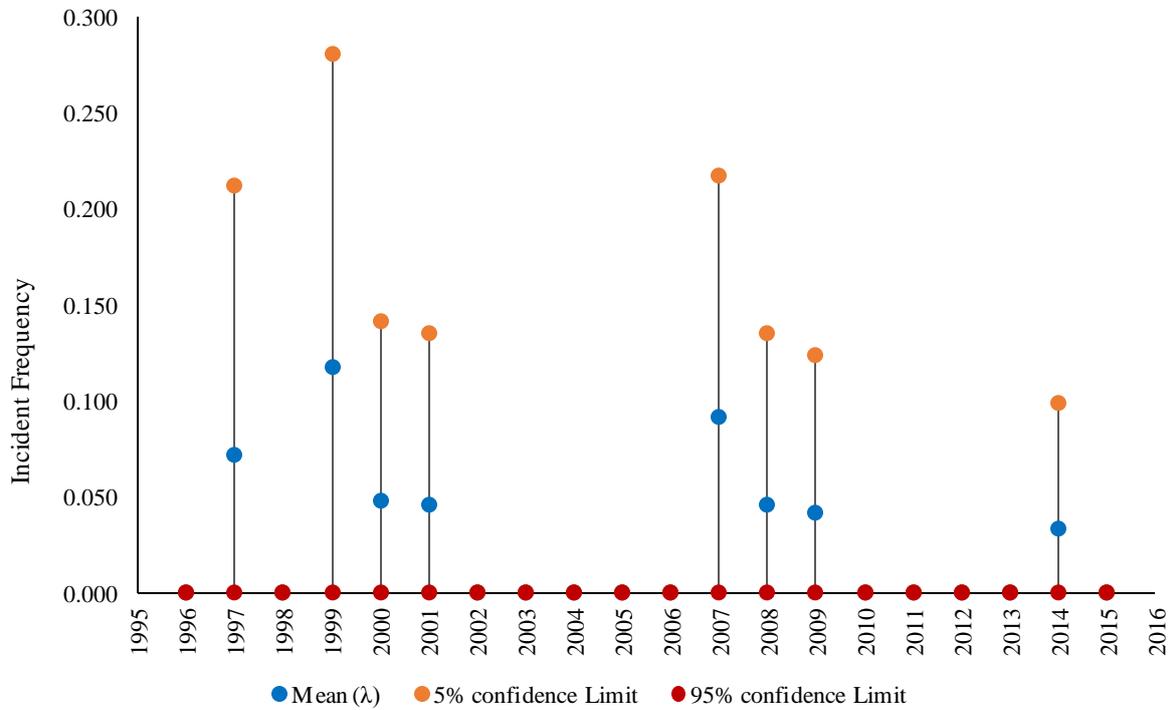
Figure 19: Frequency of minor, moderate and significant damage to jack-up installations per year

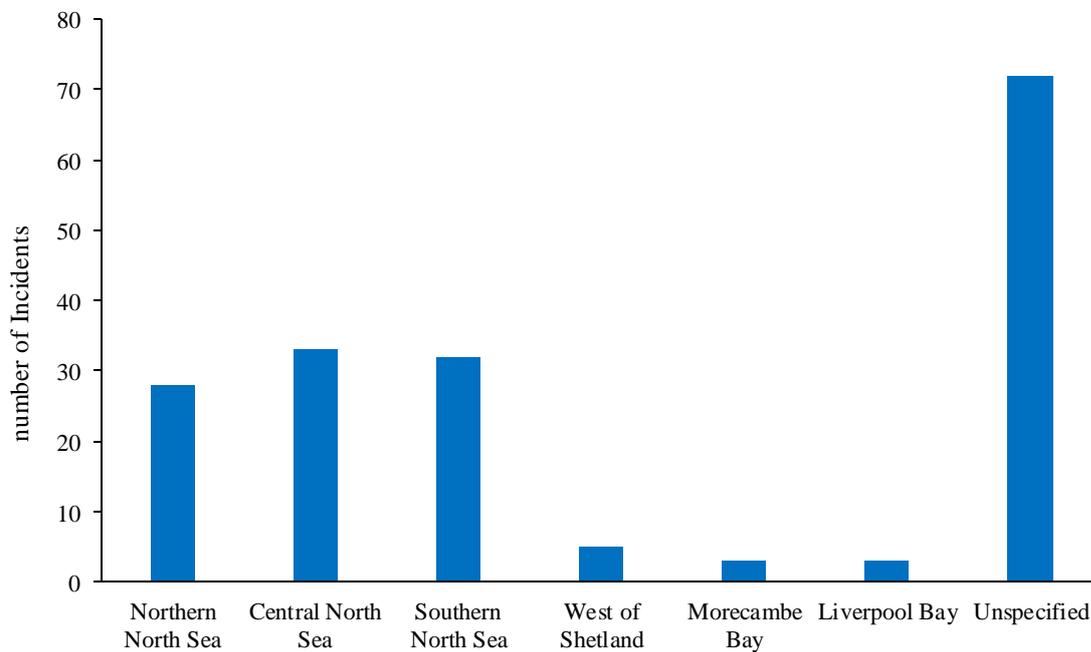
Figure 20: Geographical distribution of all reported incident on the UKCS

A straightforward comparison of the reported incidents by region is demonstrated by Table 21 and Figure 20. The information shows areas that have endured more incidents than others, yet the data should be viewed against the varying levels of activity between the North Sea sectors. Unless the number of incidents per region is cross referenced with the number of installations

All incidents outlined in the statistical analysis were attendant vessels with the exception of 2 incidents which were passing vessels, a trawler and a merchant container ship. Similarly, these 2 incidents occurred in the southern North Sea. This would be expected as this is deemed to be the most congested sector in terms of offshore operations and general shipping activity.

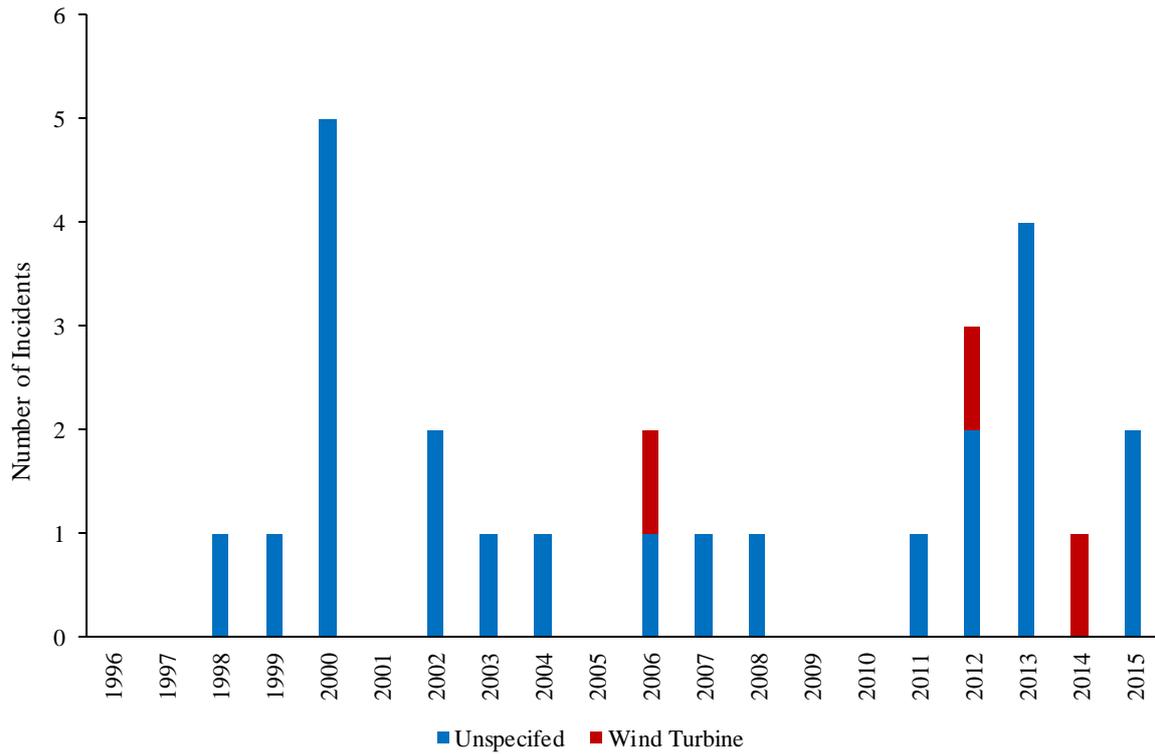
Figure 21: Number of incidents reported for other or unspecified installation types per year

Table 22 and Figure 21 demonstrate the number of incidents involving other or unspecified installations types per year.

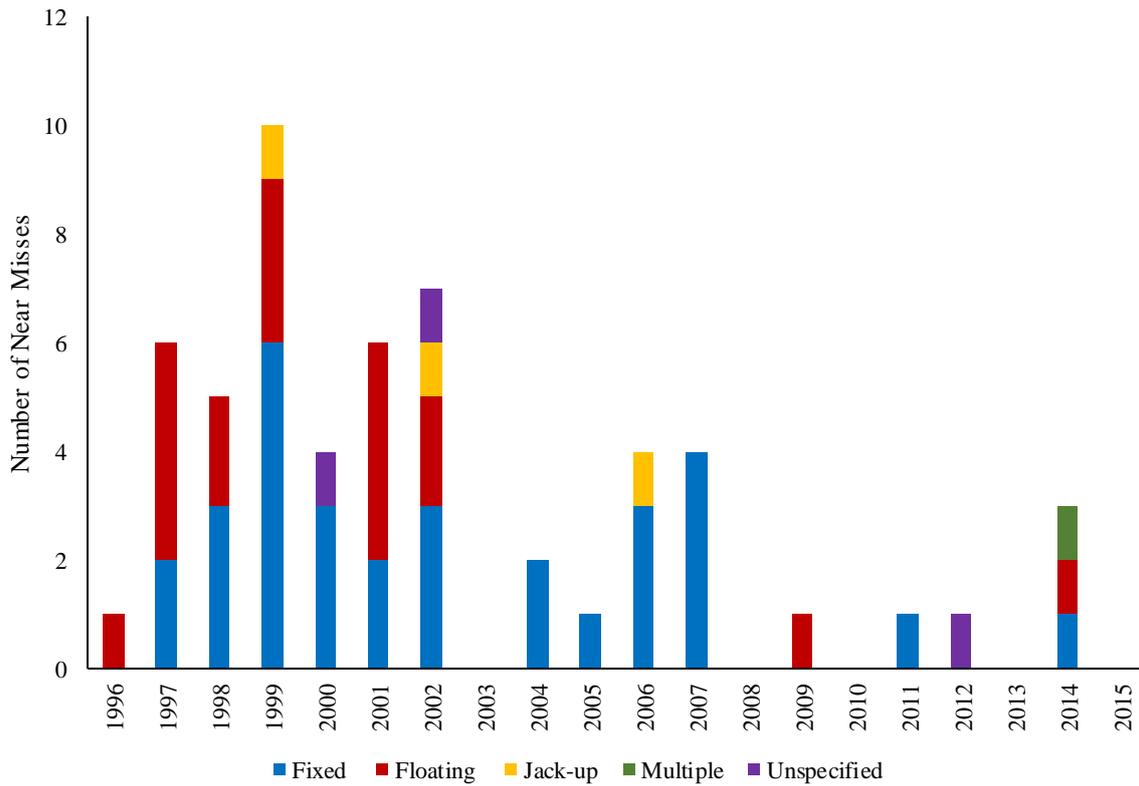
Figure 22: Number of near misses on the UKCS per installation type per year

Given the outlined definitions above, 56 incidents were determined to be classed as “near misses” in the 19 year period between 1996 and 2015. These incidents are outlined by installation type in Table 23 and Figure 22. These incidents are broken down by installation type, as follows:

It can be seen that the number of incidents directly correlates to the relative number of installations of a given type operating in the North Sea per year, i.e. there are more fixed installations operating on the UKCS, hence the number of near misses relating to fixed installations is much higher when compared to floating or jack-up installations.

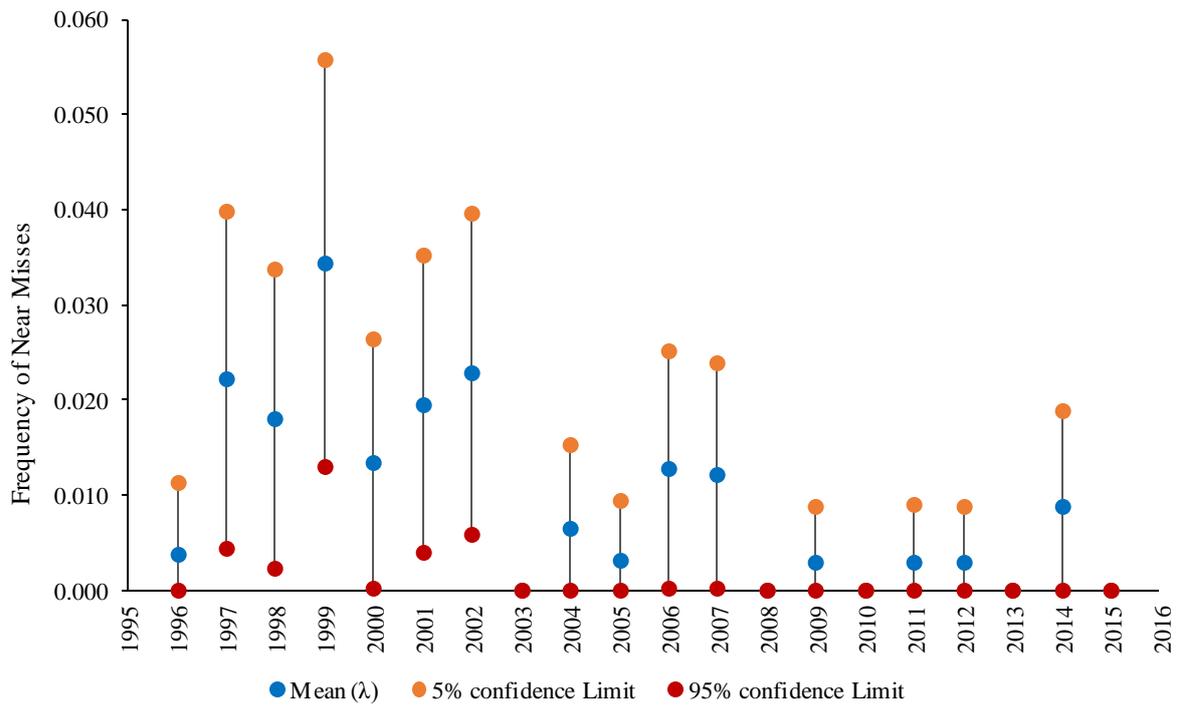
Figure 23: Frequency of all reported near misses per year

Tables 24 and 25 demonstrate the mean and cumulative frequencies of all reported “near misses” per year on the UKCS between 1996 and 2015. Similarly, Figures 23 and 24 demonstrate such frequencies information graphically.
