# Ship/Platform Collision Incident Database (2015) for offshore oil and gas installations

Prepared by **Liverpool John Moores University**  
for the Health and Safety Executive

**RR1154**

Research Report

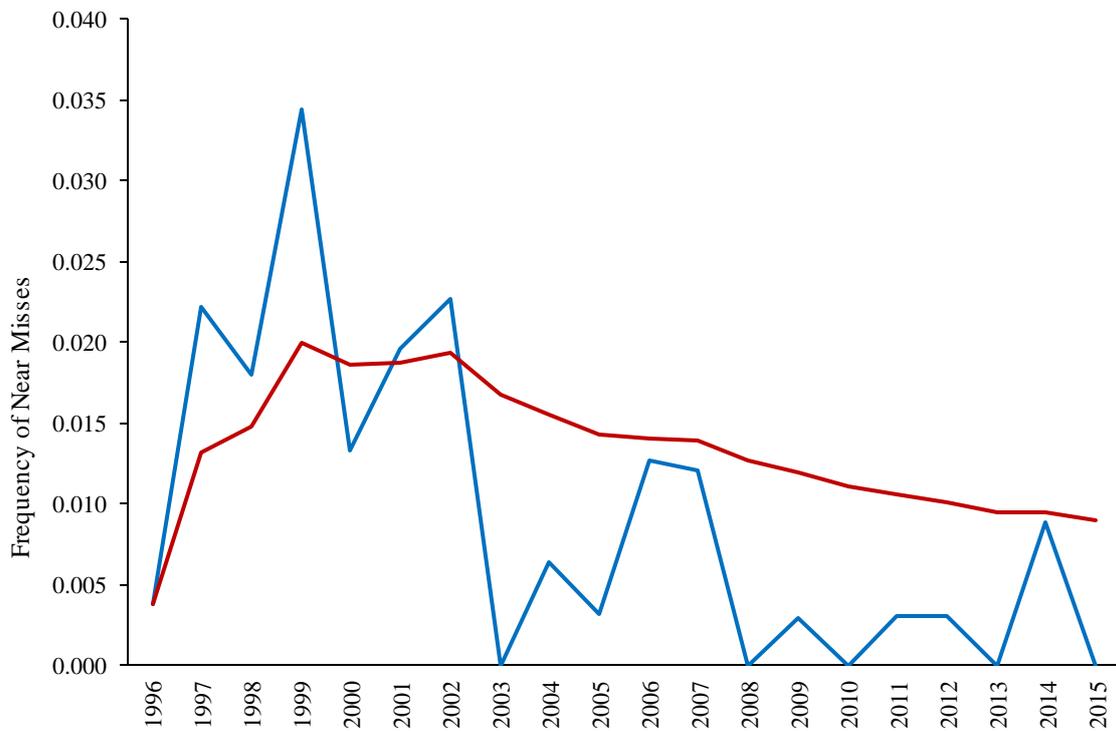
Figure 24: Mean and cumulative frequency of near misses per year

Tables 24 and 25 demonstrate the mean and cumulative frequencies of all reported “near misses” per year on the UKCS between 1996 and 2015. Similarly, Figures 23 and 24 demonstrate such frequencies information graphically.

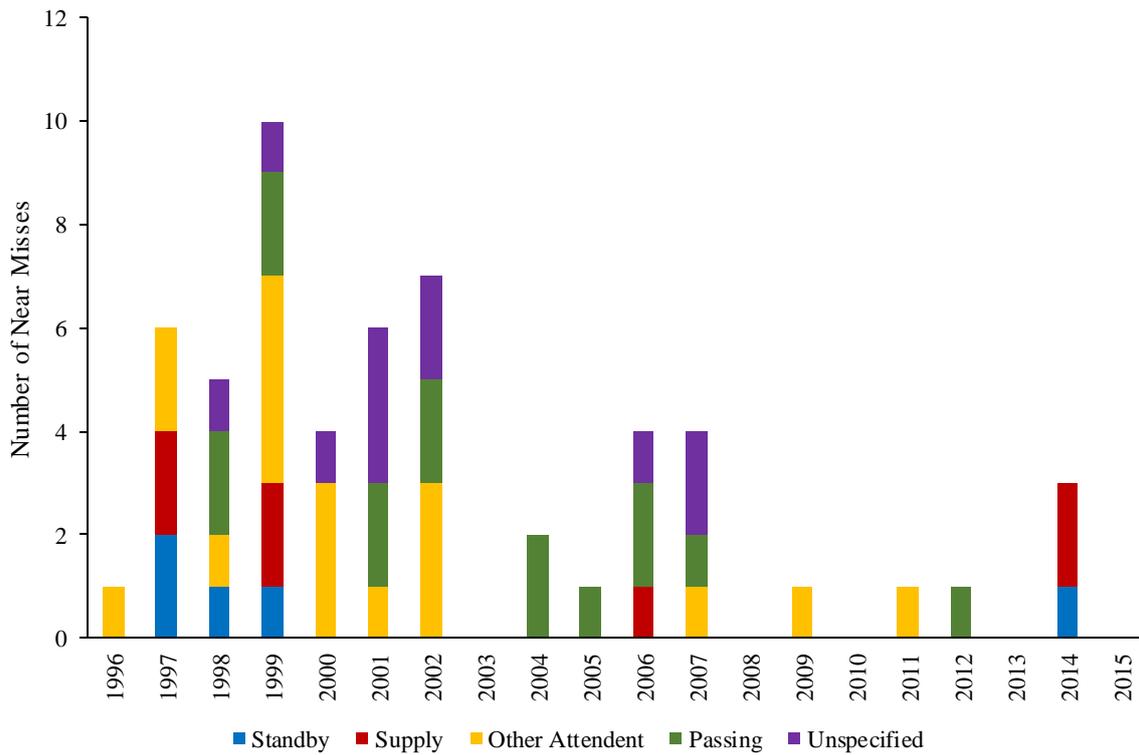
Figure 25: Number of near misses per vessel per year

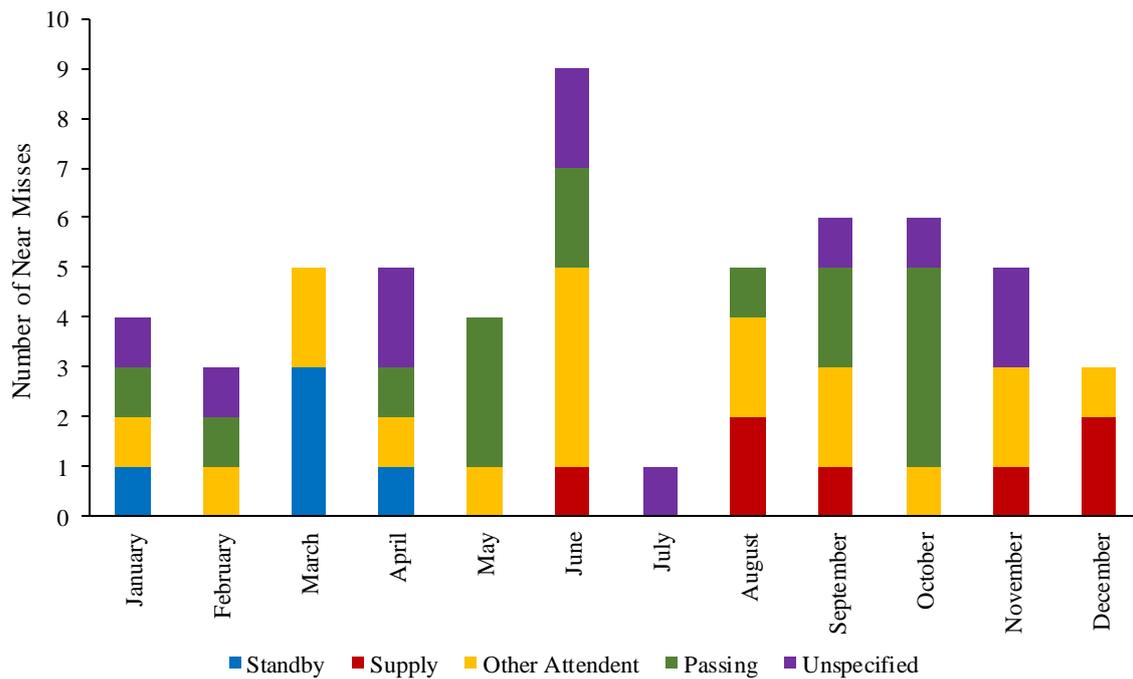
Figure 26: Number of near misses per vessel type per month

Given the data presented, slightly more incidents have occurred in the 6 month period of April to September as opposed to October to March, when most actual collisions occur. This can be attributed to two factors; firstly, the number of incidents involving attendant vessels increases in the summer months due to preferred weather conditions for maintenance and other operation; secondly, the increased number of incidents involving passing vessels. Most of the passing vessels involved in near misses in the summer months are fishing vessels and trawlers with 6 of 8 near misses involving these vessels occur between April and September. However, there are still a large number of incidents during the months October to March. Most of these incidents can be attributed to standby vessels and shuttle tankers, where 10 of the 13 incidents involving these vessels occurring in the winter months (October to March). A potential reason for this is the adverse weather conditions, and in the event of a vessel losing power or control, the weather plays a significant part in the uncontrolled direction in which the vessel will head.

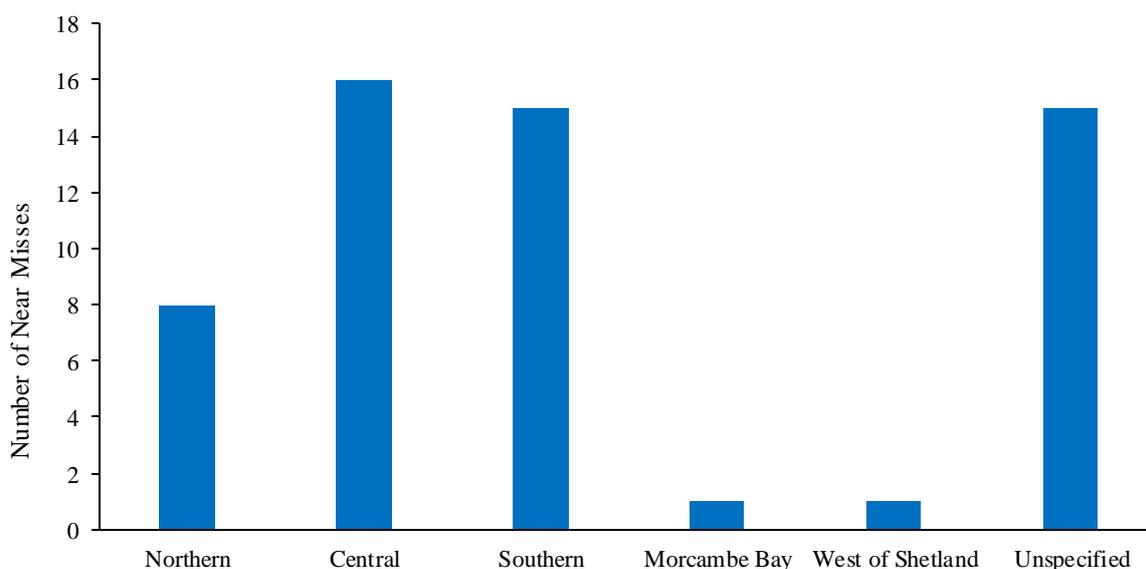
Figure 27: Geographical distribution of all reported near misses on the UKCS

Again a straightforward comparison of the reported “near misses” by region is demonstrated by Table 28 and Figure 27. The information shows areas that have endured more “near misses” than others, yet the data should be viewed against the varying levels of activity between the North Sea

All “near misses” in this analysis involve all vessel and installations types. The data would suggest that most incidents occur in the central and southern North Sea. This is a fairly accurate statement as these two sectors have the highest concentration of installations. Furthermore, the data in Table 28 demonstrates the number of incidents per region per vessel. The data implies that the majority of “near misses” involving “*passing vessels*” occur in the southern sector of the North Sea. This makes sense as the southern North Sea is heavily congested with both offshore platforms and commercial shipping. Similarly, the majority of the unspecified “near misses” occur in the southern sector. It would be reasonable to suggest that many of these unknown vessels would be “*passing vessels*”.
