Accidental damaged diamond-like carbon coating by prefabricated scratches: Experimental exploration on anticorrosion and tribological performances

Abstract: Accidental damage on the diamond-like carbon (DLC) coating can have a great influence on the anticorrosion and tribological performances. In this study, DLC coating was deposited by a DC unbalanced magnetron sputtering technique. The scratch tests with different damage loads of 2, 10, 20, 30, 40 and 50 N were used to imitate the different types of accidental damage. The influence of different types of surface damage states on anticorrosion performance and scratch damage structures on tribological performance were studied and compared with those of the coating without damage. Cracking or spalling of the coating promotes the corrosion failure of the coating system and pitting corrosion of the stainless steel substrate, resulting in the deterioration of the corrosion protection effectiveness. With the damage increases from fine crack to complete failure, the corrosion resistance decrease obviously and the corrosion rate increases from 1.796×10^{-9} to 2.880×10^{-8} (A/cm²). The coating with an appropriate scratch structure as the

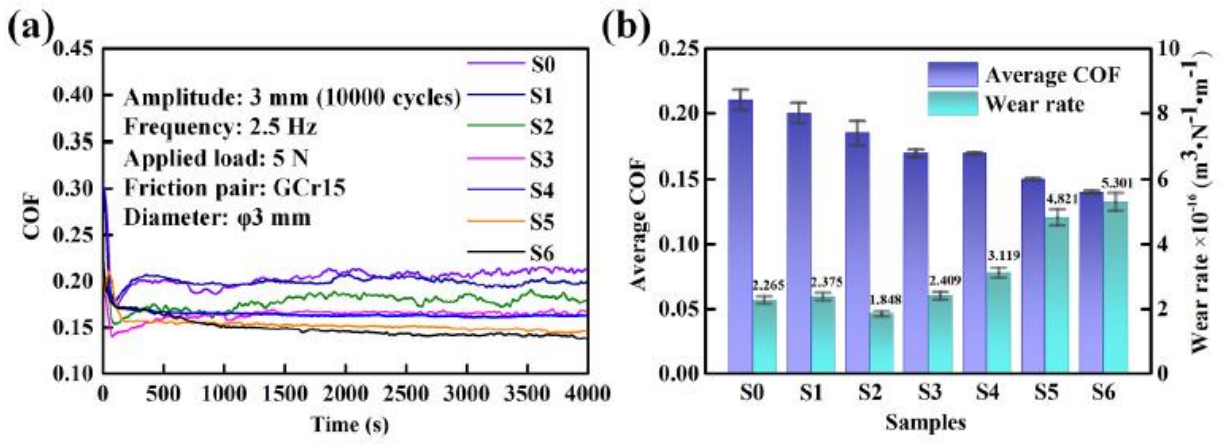
Fig. 7. Friction coefficients and wear rate results of the DLC coatings.

Fig. 7(a) shows the COF evolution of the DLC coatings during the reciprocating sliding process, and the average COF in the steady state (excluding the sliding process before 250 s) is provided in Fig. 7(b). During the short sliding process, the COF of the sample S1 is higher than that of the sample S0. After a sliding time of 1000 s, the COF of the sample S1 decreases and the average COF in the steady state is slightly lower than that of the sample S0. For the other samples, the COF is always lower than that of the sample S0, and the average COF decreases with the increasing accidental damage on the coating surface caused by the prefabricated scratches. The average COF of all the samples is stable between 0.14 and 0.21. The sample S0 shows the highest average COF of 0.21. Compared with that, the average COF of the samples S1–S6 are 0.2, 0.18, 0.17, 0.17, 0.15 and 0.14, respectively. The COF is the ratio of shear stress to contact stress, and the reduced shear property between the wear pairs is the main reason for improving the antifriction performance of the coating. Compared with the COF of the sample S0, the reduction in COF of the samples S1–S6 could be related with the microstructural evolution due to the GCr15 grinding pair reciprocated sliding across the prefabricated scratches. The wear rate of the DLC coatings after the reciprocating sliding process can also be seen in Fig. 7 (b). The wear rate of the sample S0 is $2.265 \times 10^{-16} \text{ m}^3/(\text{N} \cdot \text{m})$ and this increases slightly to $2.375 \times 10^{-16} \text{ m}^3/(\text{N} \cdot \text{m})$ and $2.409 \times 10^{-16} \text{ m}^3/(\text{N} \cdot \text{m})$ for the samples S1 and S3, respectively. The wear resistance of the samples S4–S6 obviously decreases and the wear rate of the sample S6 increases to $5.301 \times 10^{-16} \text{ m}^3/(\text{N} \cdot \text{m})$, which is twice as much as that of the sample S0. Meanwhile, the sample S2 shows excellent wear resistance with the lowest wear rate of $1.848 \times 10^{-16} \text{ m}^3/(\text{N} \cdot \text{m})$, which indicates that the wear resistance of the coating can be improved with an appropriate scratch damage structure acting on the surface.
