Comparison of Microbially Induced Healing Solutions for Crack Repairs of Cement-Based Infrastructure

Article

Citation: van der Bergh, J.M.; Miljević, B.; Vučetić, S.; Šovljanski, O.; Markov, S.; Riley, M.; Ranogajec, J.; Bras, A. Comparison of Microbially Induced Healing Solutions for Crack Repairs of Cement-Based Infrastructure. *Sustainability* **2021**, *13*, 4287. <https://doi.org/10.3390/su13084287>

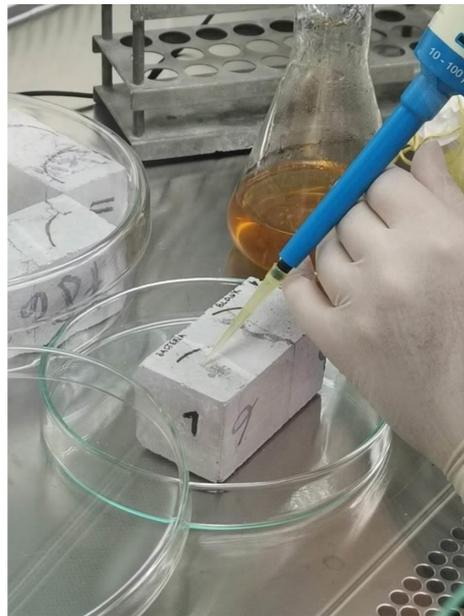
Figure 3. Application of bacteria-based repair agent onto an artificially generated crack on cement mortar beam (authors' image).
