The feasibility of using electromagnetic waves in determining membrane failure through concrete

Kot, P, Shaw, A, Ali, A, Cotgrave, A and Riley, ML (2017) The feasibility of using electromagnetic waves in determining membrane failure through concrete. International Journal of Civil Engineering, 15 (2). pp. 355-362. ISSN 1735-0522

1 **The feasibility of using electromagnetic waves in determining membrane**
2 **failure through concrete**

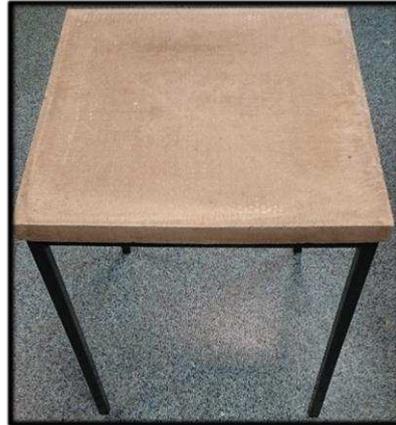
Figure 3: Concrete Paving Slab on Metal Structure

317 A preliminary roof structure for testing is made from a pre-cast concrete paving slab
318 (600x600x50mm), grade 20 without any reinforcement bar and with an applied rubber
319 membrane. A paving slab has been placed on a metal frame 620mm high as indicated in
320 Figure 3. This height is to ensure easy access for the sensor antenna during the experiment.

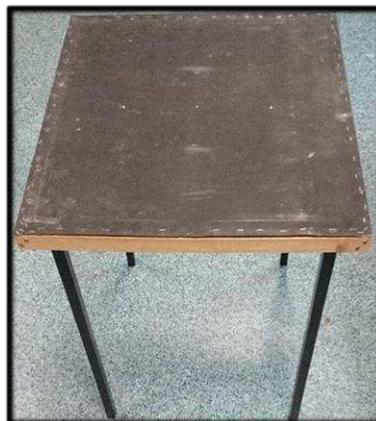
Figure 4: Concrete Paving Slab with a Membrane Layer

324 A typical waterproof rubber membrane is applied tight into a wooden frame above the slab to
325 imitate the flat roof membrane. The membrane is placed on the top of the slab as shown in
326 Figure 4.

347 An initial preliminary experiment was undertaken to identify differences between the
 348 membrane in different conditions and situated in different positions on the concrete (Figure
 349 4). Results are presented in Figure 8.
