Article

Behaviour of strengthened timber beams using near surface mounted Basalt Fibre Reinforced Polymer (BFRP) rebars

Alfred Kofi Gand^{a*}, David Yeboah^b, Morteza Khorami^a, Adegoke Omotayo Olubanwo^a and Richard Lumor^c

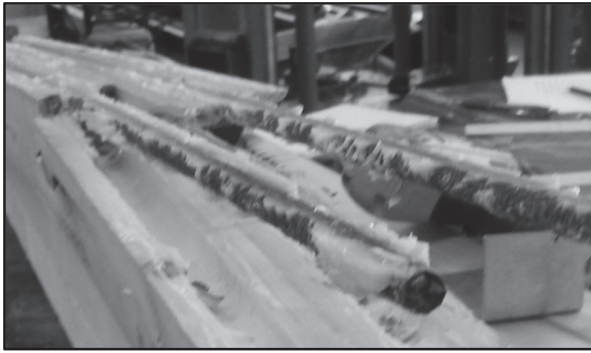
Fig. 9. Debonded rebar following ultimate failure

Beam TB-BFRP-01 suffered horizontal shear failure of the timber. Minor ruptures were observed at the tension zone and the rebar-adhesive was still intact. This mode of failure occurred due to splits and shakes located at the centre of the cross section shown in Fig. 7. TB-BFRP-01 was, therefore, unable to obtain ultimate load capacity and was consequently the weakest of all the beams tested. Cross-grained tensile failure of the timber occurred in beam TB-BFRP-02. Additionally, severe indentations were detected in the compression zone as the beam reached ultimate load capacity. Similar to TB-BFRP-02, beam TB-BFRP-03 suffered tension and compression failure of the timber. The beam was severely splintered at mid-span which resulted in the adhesive shattering whilst the beam failed. Observation of the adhesive interface showed that the epoxy was still marginally saturated resulting in the debonding of the rebar. Beam TB-BFRP-04 failed in simple tension of the timber. Prior to testing TB-BFRP-04, a large knot was prominent at mid-span. Horizontal shearing and de-bonding of the rebar-adhesive interface occurred shortly after the cracks formed in the tensile zone (see Fig. 8). For beam TB-BFRP-05, the timber suffered severe fractures at mid-span failing in compression and tension. The rebar in specimen TB-BFRP-05 debonded because of the timber splitting (see Fig. 9). Similar to TB-BFRP-05, beam TB-BFRP-06 failed due to splintering at the compression and tension zones. Subsequently, shearing in the timber transpired following the ultimate load capacity. TB-BFRP-07 failed as tensile cross-grained cracks had formed on the timber. Indentations were also detected in the compression zone of TB-BFRP-07. The base of the specimen TB-BFRP-03 suffered moderate splitting at mid-span resulting in the epoxy resin cracking, with the Rockbar remaining unaffected (see Fig. 10).

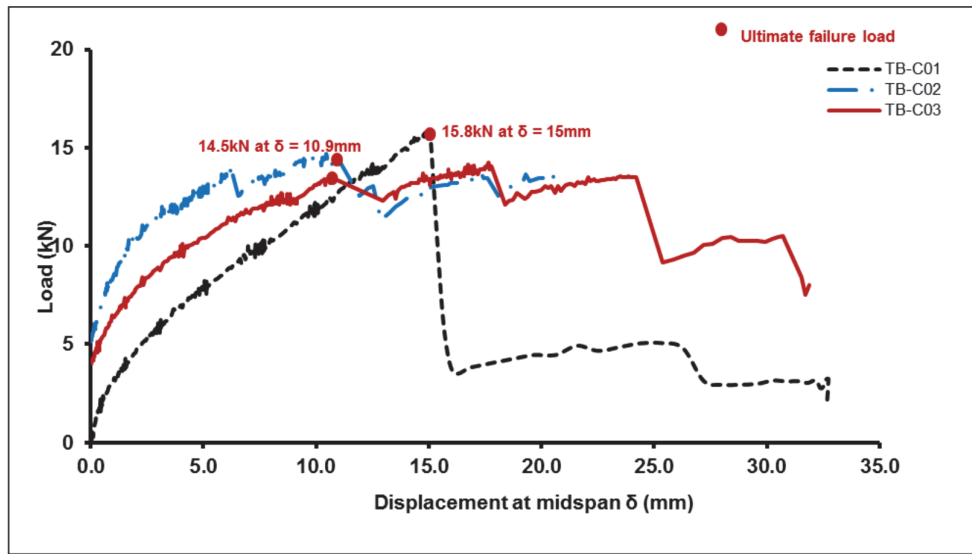
Fig. 12. Load-displacement plots for the unreinforced timber beams

The results for all the tested beams are shown in Figs. 11 and 12. Initially, all the beams demonstrated a linear elastic behaviour, and as the load capacity increased the graph plateaued until failure. Cracks were heard through acoustic emissions in the timber which often indicated where the non-linearity started to occur. The majority of the strengthened specimens exhibited higher ultimate load than that of the control specimens. While all the tested beams demonstrated a range of deflections of approximately 8 – 21 mm, these values do not satisfy the serviceability limit state. With reference to BS EN 1995, Eurocode 5, the deflection limit equals span/300 for a typical member between two supports. Therefore, for a beam with a clear span (L) of 1000 mm, the allowable deflection is 3.3 mm. Though a member may have a high load capacity, a low stiffness means it will not satisfy the serviceability limit state which is an essential factor.
