The feasibility of using electromagnetic waves in determining membrane failure through concrete

Kot, P, Shaw, A, Ali, A, Cotgrave, A and Riley, ML (2017) The feasibility of using electromagnetic waves in determining membrane failure through concrete. International Journal of Civil Engineering, 15 (2). pp. 355-362. ISSN 1735-0522

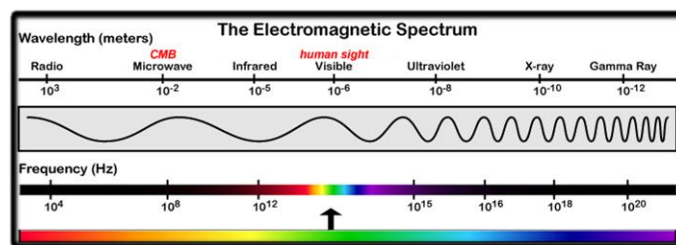
Figure 1: The electromagnetic spectrum

233 Microwaves are radio waves with wavelengths ranging from one meter to one millimeter, or
234 equivalently, with frequencies between 300 MHz (0.3 GHz) and 300 GHz [13]. Figure 1
235 depicts the full electromagnetic spectrum from long waves up to Gamma Rays [14].

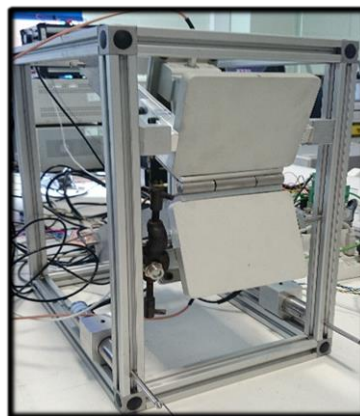
Figure 2: Sensor Design

308 The sensor has been designed to be able to carry out numerous measurements without concern
309 about displacement. Sensor parameters such as: Antenna angle, distance to object and
310 temperature can be monitored in real time. The sensor frame has two calibrated displacement
311 transducers attached, which enable clarification of the distance between the antennae and the
312 roof. A third displacement transducer is located between the antennae to calculate their angle.
313 A temperature sensor is also placed in front of the sensor frame. The sensor design as
314 presented in Figure 2.

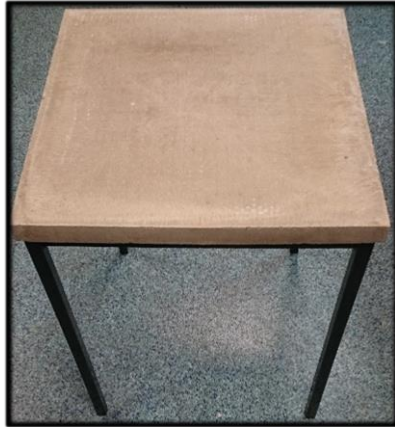
Figure 3: Concrete Paving Slab on Metal Structure

317 A preliminary roof structure for testing is made from a pre-cast concrete paving slab
318 (600x600x50mm), grade 20 without any reinforcement bar and with an applied rubber
319 membrane. A paving slab has been placed on a metal frame 620mm high as indicated in
320 Figure 3. This height is to ensure easy access for the sensor antenna during the experiment.

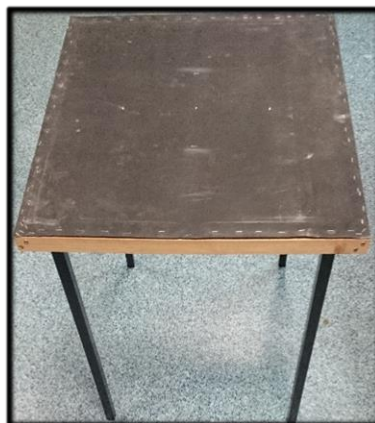
Figure 4: Concrete Paving Slab with a Membrane Layer

324 A typical waterproof rubber membrane is applied tight into a wooden frame above the slab to
325 imitate the flat roof membrane. The membrane is placed on the top of the slab as shown in
326 Figure 4.

347 An initial preliminary experiment was undertaken to identify differences between the
 348 membrane in different conditions and situated in different positions on the concrete (Figure
 349 4). Results are presented in Figure 8.

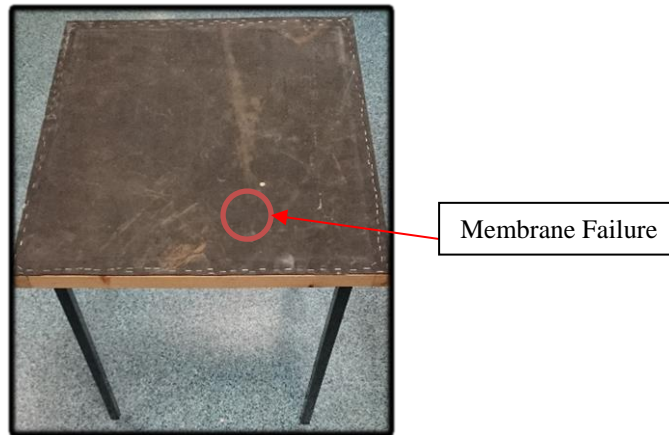
Figure 5: Membrane with a Fault

330 One of the membrane samples was subjected to penetration damage with the creation of a 10
331 mm diameter hole. This is to allow water ingress mimicking membrane failure to the concrete
332 roof as shown in Figure 5.

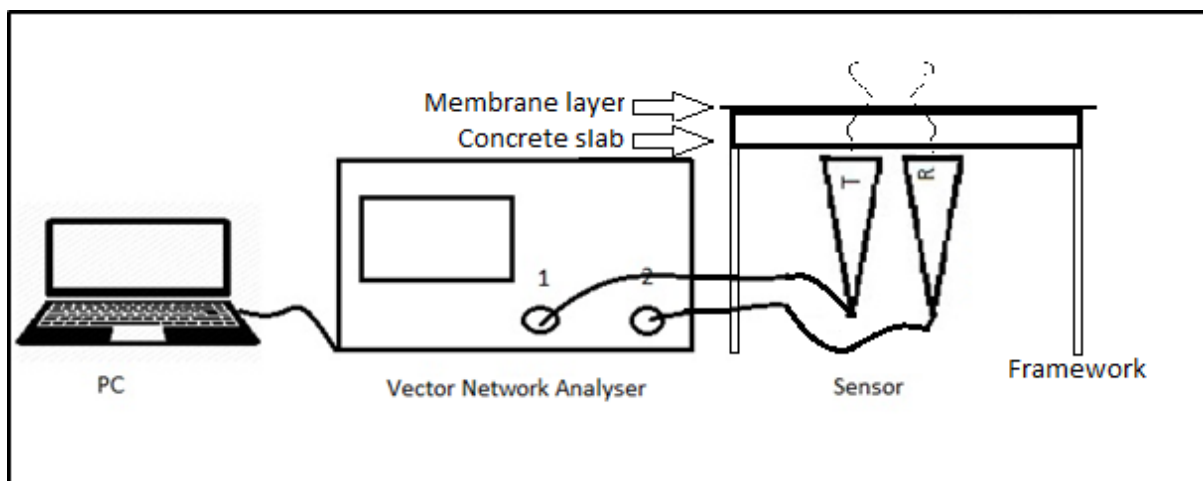
Figure 6. Schematic Diagram of the Test Setup

336 The microwave sensor was placed 20 mm beneath the concrete structure. A schematic
337 diagram of the test setup is presented in Figure 6. The sensor was connected to a Marconi
338 Microwave test set and laptop, which captured and stored data via software developed in
339 LabVIEW as indicated in Figure 7.

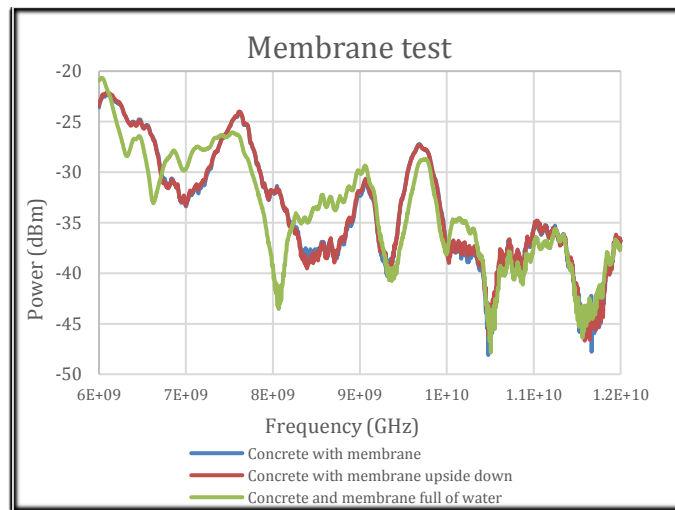
354 Figure 8: Membrane position experiment results

355 Figure 8 shows that the position of the membrane does not affect the results of experiment.
 356 Noticeable changes appeared after applying water on the top of the membrane, especially
 357 around 8GHz frequency range. Water absorbs electromagnetic waves very well because of

358 its dielectric properties, which enabled observation of changes in microwave spectrum. Data
359 analysis allows identification of the location of the water content.

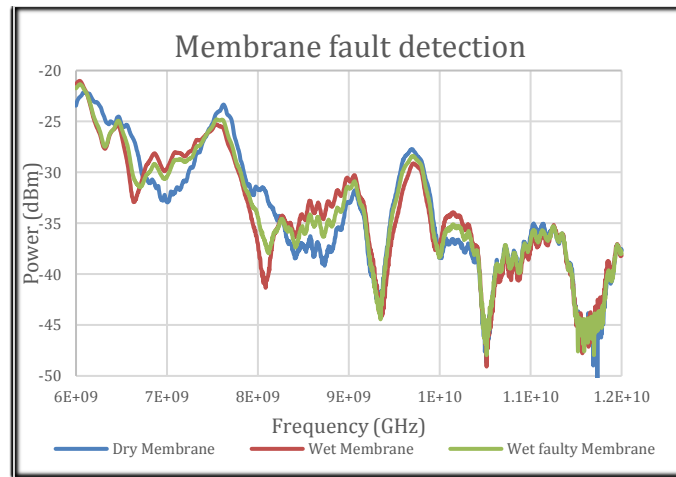
364 Figure 9: Membrane Fault Detection Experiment Results

365 Results from the second experiment proved the concept that it was possible to observe
366 changes in the spectrum between 8GHz to 9 GHz frequency ranges, when water leaked
367 through the damaged membrane and penetrated the paving slab as shown in Figure 9.

361 A second experiment was then undertaken to monitor spectrum changes with water ingress
362 thorough the damaged membrane.

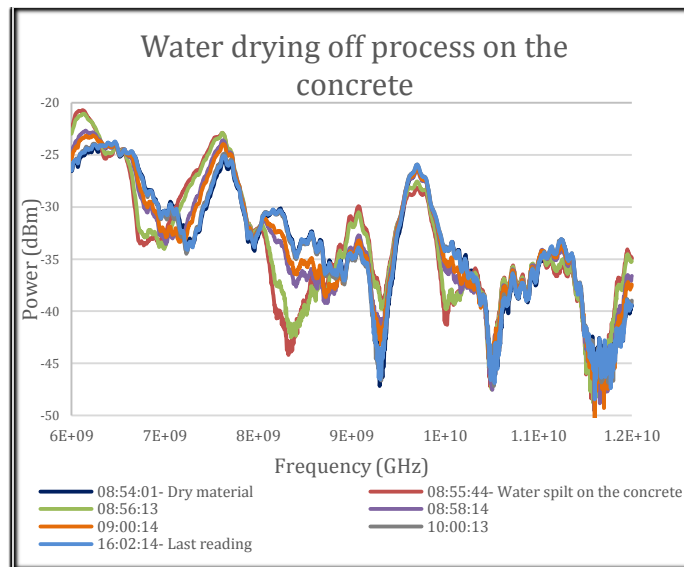
Figure 10: Water Drying Off Process on the Paving Slab Experiment Results

Results from the third experiment, as shown in Figure 10, enabled mapping of the drying off

process at the range of frequency between 8 GHz to 9 GHz. Changes in the spectrum were

caused by dielectric properties of the water, the reducing amount of water absorbs less EM

energy, which enabled identifying the stage of the water drying process. Data analysis

applied to the results can be used to identify the precise stage of the water drying process.

369 A third experiment has been undertaken to monitor the water drying off process in the paving
370 slab. The sensor recorded data every 30 seconds and stored them in a defined database
371 location.
