**Experimental investigation on the post-fire performance of reactive powder concrete columns**

**Kadhum, M, Mahdi, Z, Funfakh, Y, Mohammed, Z, Abdulraheem, M and Gkantou, M (2021) Experimental investigation on the post-fire performance of reactive powder concrete columns. Przegląd Naukowy Inżynieria i Kształtowanie Środowiska. 30 (2). pp. 315-326. ISSN 1732-9353**

## **Experimental investigation on the post-fire performance of reactive powder concrete columns**

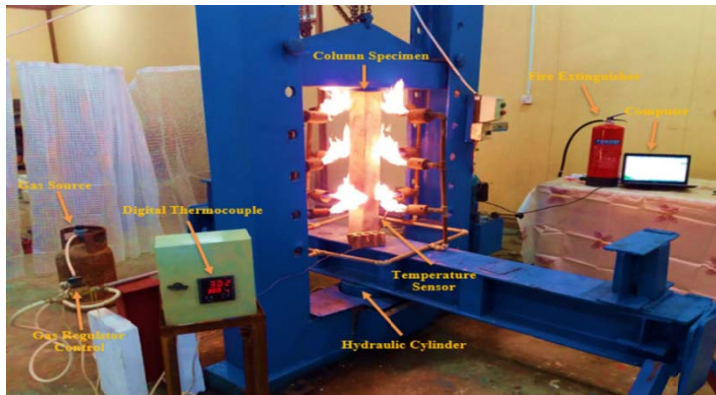
FIGURE 2. Experimental set-up

The slab specimens were tested under increasing concentric load up to failure at the age of 60 days utilizing a frame of 200 t capacity. For each of the three groups, one specimen was used as a reference, which was tested up to the failure, without any fire exposure, while the other six specimens were initially loaded to 25% of the ultimate load; subsequently, they were subjected to fire temperature under 25% constant loading, assuming three different temperatures (300, 400 and 500°C) and two durations (30 and 60 min) for fire exposure, and finally were tested until failure after the exposure to fire is finished. For the columns, which were subjected

to fire under loading, the target heating temperature was reached utilizing a sliding arm to control the fire distance to the surface of the columns and by monitoring the fire intensity thru controlling the liquefied petroleum gas pressure in the burners by utilizing an electric gas regulator control. A gas regulator control is an electronic valve used to supply a very fast and straight gas flow. The target temperatures were 300, 400, and 500°C for the exposed columns, while the reference columns were not exposed to fire (at room temperature). The duration of the temperature loading was either 30 or 60 min, which was enough to warm up the sample to a uniform temperature (Abdulraheem, 2018; Abdulraheem & Kadhum, 2018). The structural behavior of the RPC columns exposed to fire results from loading each column to 25% of the ultimate load before heating, utilizing load control at a loading rate of 1 kN·s<sup>-1</sup>, and then heating these columns with keeping the 25% loading constant after that is loading them until failure. For columns that have not been heated, the results come solely from the applied load (Fig. 2). The vertical and lateral deformations were measured using two dial gauges with an accuracy of 0.001 mm per deviation to measure the deformations for each load increment.

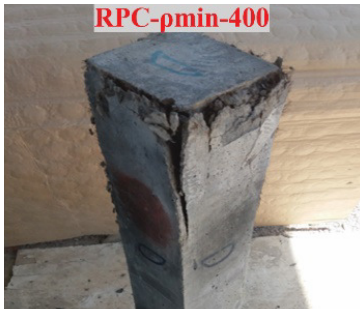
FIGURE 6. Typical crack pattern of pure axial concentric load columns

**Pure axial concentric load.** In this study, one column from each group was tested at room temperature in order to be the reference for the other columns. The columns failed by compression mode (crushing) and the cracks appeared in a conical pattern like the failure of the cylinder in a compression test, as shown in Figure 6.
