### **Crack Initiation and Growth in PV Module Interconnection**

Alireza Eslami Majd<sup>a\*</sup> and Nduka Nnamdi Ekere<sup>a</sup> aSchool of Engineering, Faculty of Science and Engineering, University of Wolverhampton, UK

(Solar Energy)

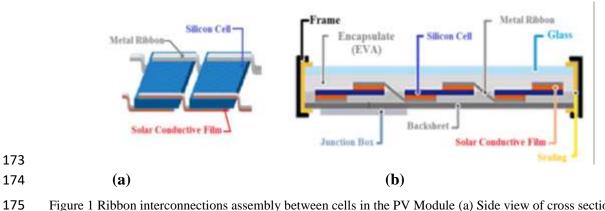
Figure 1 Ribbon interconnections assembly between cells in the PV Module (a) Side view of cross section of PV modules included Materials (b)

Figure 1 shows the schematic view of the assembly of the ribbon interconnections between solar cells in the PV module assembled by back to front connection method. The PV solar module is typically built up of different materials, including: silicon as the semiconductor material, EVA (ethyl vinyl acetate) which serves as encapsulate materials to protect solar cells, aluminium sheet to envelop the backside of the silicon, the pasted silver pads and fingers to receive the electrical current, Tedlar (Polyvinyl Fluoride) as a back sheet to cover the bottom, glass as front cover and the copper wire coated by solder materials to collect the electrical current from the individual cell.

In this study the thickness of aluminium, silicon cell, EVA, glass and Tedlar layers used for the FE models are assumed to be  $25\mu m$ ,  $200\mu m$ ,  $460\mu m$ , 3mm and  $190\mu m$ , respectively. The thickness of other component parts such as silver pad, copper, solder used and the ribbon interconnection width have been varied to investigate the effect of ribbon interconnection geometry and design on the crack initiation and propagation parameters.

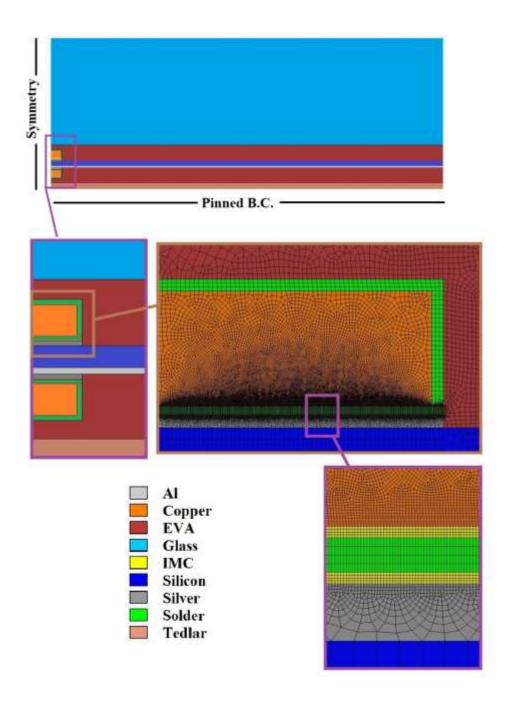
Figure 2 Schematic view of 2D simulation of ribbon interconnection with showing boundary conditions, mesh styles and arrangement of materials

Also, in this study to take account of the high ratio of the ribbon interconnection length to the other dimensions of model, the 2D plane-strain elements (CPE3² and CPE4³) have been used to increase the computational solution speed. The symmetry boundary condition is applied to the mid-point of the ribbon interconnection section and bottom-end of the Tedlar material is closed. Figure 2, presents the schematic view of ribbon interconnection FE model; showing the boundary conditions, the arrangement of component materials and the meshing style (**Note**: the fine meshing technique is used for crack area in the solder joint material).

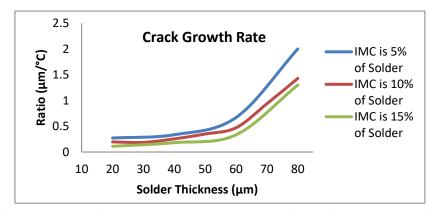
Figure 4 Effect of solder and IMC thickness on the crack growth rate (Silver thickness, copper thickness and ribbon breadth are considered as  $50\mu m$ ,  $200\mu m$  and 1mm, respectively)

Figure 4 presents a plot of the effect of solder coating and IMC thickness on the crack growth rate. The results show that the crack growth rate is almost constant for the solder coating thickness under 50µm, but further increases in solder coating thickness beyond the 50µm limit leads to a big jump in the crack growth rate. Figure 4 also show that the crack growth rate is much lower in the thicker IMC layers compared to thinner IMC layers.

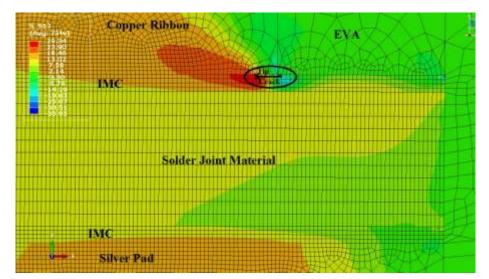
Figure 5 Crack's location and propagation direction in the IMC layer interface with the copper ribbon (Shear stress distribution contour is displayed)

As can be seen in Figure 5, for all the simulation results presented in Figure 3, the location for the crack nucleation is at the edge of IMC layer interface with the copper ribbon and the propagation is in the shear direction; as the shear strength of the IMC layer material is lower than its tensile strength.

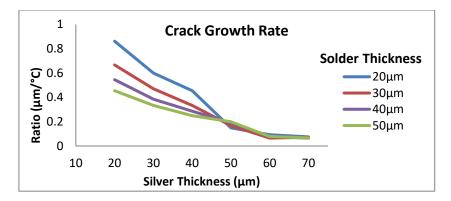
Figure 9 Effect of silver thickness on the crack growth rate for different solder thicknesses (Copper thickness, ribbon breadth and IMC thickness are considered as 200µm, 1mm and 4µm, respectively)

The results of our study presented in Figure 8 and Figure 9 show effect of silver pad thickness on crack initiation temperature and the crack growth rate for the PV ribbon interconnection geometries investigated. The results show that crack initiation temperature and the crack growth rate decreases with increasing the silver pad thickness. However, Figure 8 suggests that the of crack initiation temperature for 20µm and 30µm solder coating thickness peaks at the silver pad thickness in range of 30µm to 50µm before decreasing. The results presented in Figure 9 shows that there is a significant change in the crack growth rate for silver pad thicknesses less than 50µm; as the crack nucleation is located in the IMC-Silver pad. Based on the results of the ribbon interconnection geometries investigated in our study, the recommended solder coating thickness will be 20µm, and we recommend silver pad thickness of between 40µm and 50µm which will help to achieve a higher ribbon interconnection reliability and lower material and manufacturing costs.

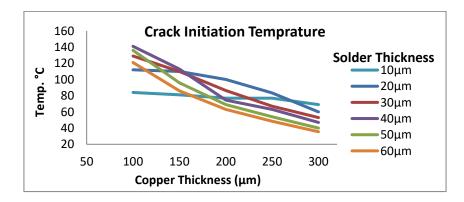
Figure 10 Effect of copper thickness on the crack initiation temperature for different solder thicknesses (Silver thickness, ribbon breadth and IMC thickness are considered as 50µm, 1mm and 4µm, respectively)

The results of our study presented in Figure 10 and Figure 11 show the effect of copper thickness on the crack initiation temperature and the crack growth rate for the PV ribbon interconnection geometries investigated. The results in Figure 10 show that increasing the copper thickness leads to a decrease in the crack initiation temperature; and that reduction in the crack initiation temperature is more pronounced for the thicker solder coatings. The results in Figure 11 also show that the lowest crack growth rate occurs at the 200µm copper thickness (the lowest point for all solder coating thicknesses). The results also show that the PV ribbon interconnection experiences high crack growth rates for the copper thickness below 200µm, due to crack location in the IMC Layer-Silver pad. The results also show that the PV ribbon interconnection experiences high crack growth rates for the copper thickness below 200µm, due to crack location in the IMC Layer-Silver pad. Hence, the 200µm copper thickness is recommended for PV ribbon interconnections as this gives the lowest crack propagation rate and better reliability.

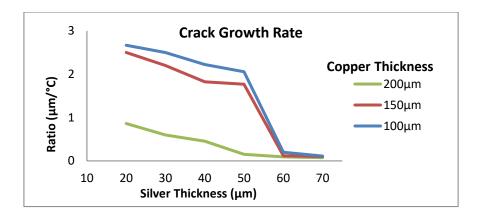
Figure 13 Effect of silver thickness on the crack growth rate for different copper thicknesses (Solder thickness,

ribbon breadth and IMC thickness are considered as 20μm, 1mm and 4μm, respectively)
