Failure patterns of solder joints identified through lifetime vibration tests

A method for non-destructively tracking the integrity of flip chip solder joints through life is investigated in this paper. An industry standard double-sided PCB was designed and manufactured with 14 flip chips to assess the failure patterns of each flip chip and each solder joint in lifetime vibration tests. Two configurations of PCB finish were tested, Electro Nickel Immersion Gold (ENIG) and Hot Air Surface Levelled lead (Pb HASL) using automotive industry manufacturing processes and quality standards. A random vibration test over a frequency range 10 Hz to 1000 Hz was specified by automotive engineers to replicate vibrations typically found on road vehicles. This vibration profile was applied to test circuit board assemblies (CBA) for 4-minute intervals until failure of all chips. At each interval test boards were extensively scanned by an acoustic micro-imaging (AMI) microscope to non-destructively measure parameters of solder joints. This enabled tracking of mechanical joint connection through-life. Methods were developed to process the large number of acoustic images of each solder joint and form

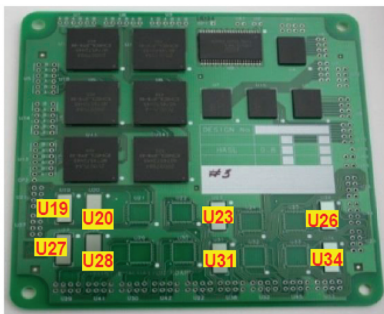
(a) Top Side of the PCB with the labelled flip chips under test

(b) Bottom Side of the PCB with the labelled flip chips under test

Figure 1. Test circuit board assembly layout with flip chip reference numbers [19]. Two images showing flip chip placement on printed circuit board with individual reference numbers. Figure 1(a) shows top side reflow, Figure 1(b) bottom side reflow.

Figure 1 shows the top and bottom view of the printed circuit board (PCB) with various area array packages custom designed at Delphi, Liverpool. The PCB is double layer FR4 laminate of 0.8 mm thickness. The board was available in two surface finishes: Electro Nickel Immersion Gold (ENIG) and Hot Air Surface Levelled lead (Pb HASL) to examine the impact of surface finish choice on solder interconnect reliability. The top side of each PCB has 8 flip chips while the bottom side has 6, making a total of 14 flip chips all of which are numbered as shown in Figure 1. Each flip chip has an area of $8898 \times 3948 \mu\text{m}$ and thickness $725 \mu\text{m}$, and under bump metallization (UBM) structure consisting of an Al/Ni/Cu stack with $102 \mu\text{m}$ pad size. Flip chips were mounted without any underfill

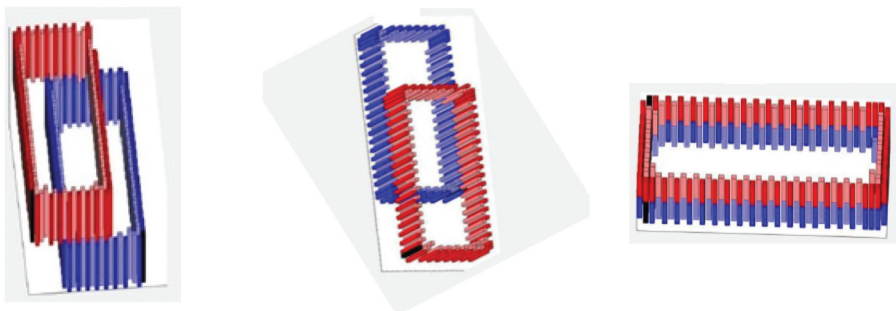
(a) Back to back placed flip chip orientation with offset along the breadth.

(b) Back to back placed flip chip orientation with offset along the length.

(c) Back to back placed flip chip orientation with no offset (mirrored).

Figure 2. Flip chip top (red) and bottom (blue) reflow side configurations to study individual bump behavioural response to applied test environment [20]. Three separate images illustrating rectangular flip chip orientation when placed over top of one another with printed circuit board between. Figure 2(a) offset along shortest edge. Figure 2(b) offset along longest edge. Figure 2(c) no offset, mirrored placement.
