# Water quality impacts and river system recovery following the 2014 Mount Polley mine tailings dam spill, British Columbia, Canada

## ABSTRACT

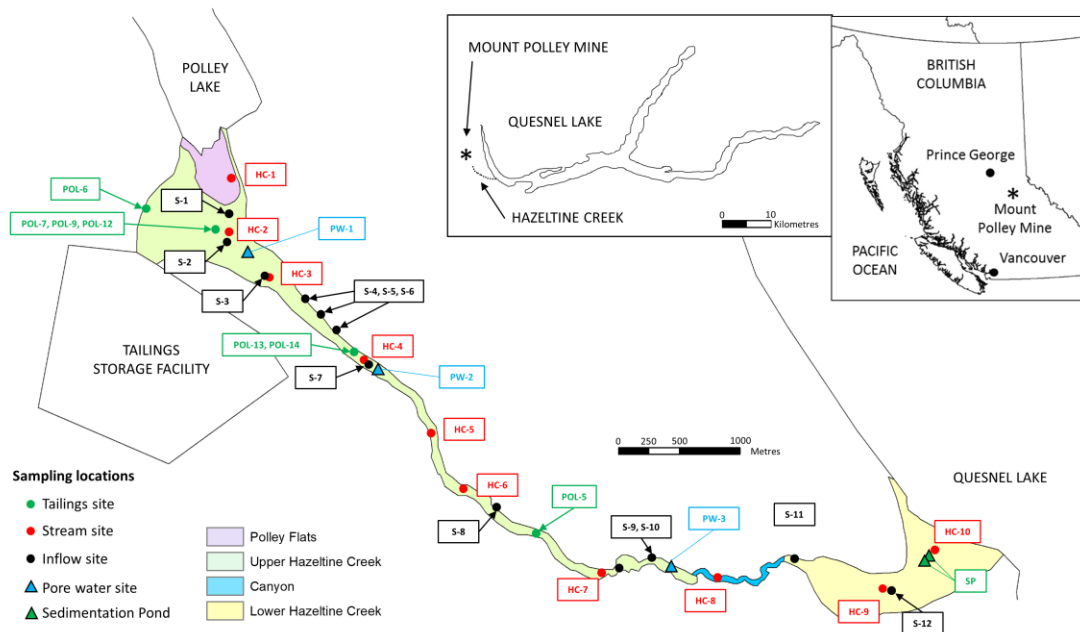
**Figure 1.** Location of study area showing tailings, stream (streamflow and water quality) and inflow (water quality only) sample sites.

Following the embankment breach, tailings material initially discharged north into Polley Lake before forming a ‘plug’ (area known as Polley Flats in Fig.1) that blocked water flowing from Polley Lake. The tailings material subsequently flowed south-east into Hazelton Creek and then discharged into the West Basin of Quesnel Lake. The tailings material initially eroded the existing valley, both vertically and laterally (SNC-Lavalin Inc, 2015). Subsequently, thick deposits of tailings (up to 3.5 m thick) occurred primarily near Polley Lake and in Lower Hazelton Creek with thinner layers occurring in other parts of the creek. Tailings were deposited within the riparian zone up to 100 m from Hazelton Creek.

Mount Polley Cu and Au mine is located approximately 275 km south-east of Prince George, British Columbia, Canada (Fig. 1). Hazeltine Creek is the main outlet of Polley Lake, draining an area of  $112 \text{ km}^2$ , and flowing approximately 9.5 km into Quesnel Lake. Bedrock geology in the catchment is dominated by Mesozoic (252 – 66 Ma) basaltic and andesitic volcanic assemblages. The upper watershed sits partially within Late Triassic (235 – 201 Ma) alkalic intrusions that host the porphyry mineralization (McMillan, 1996).

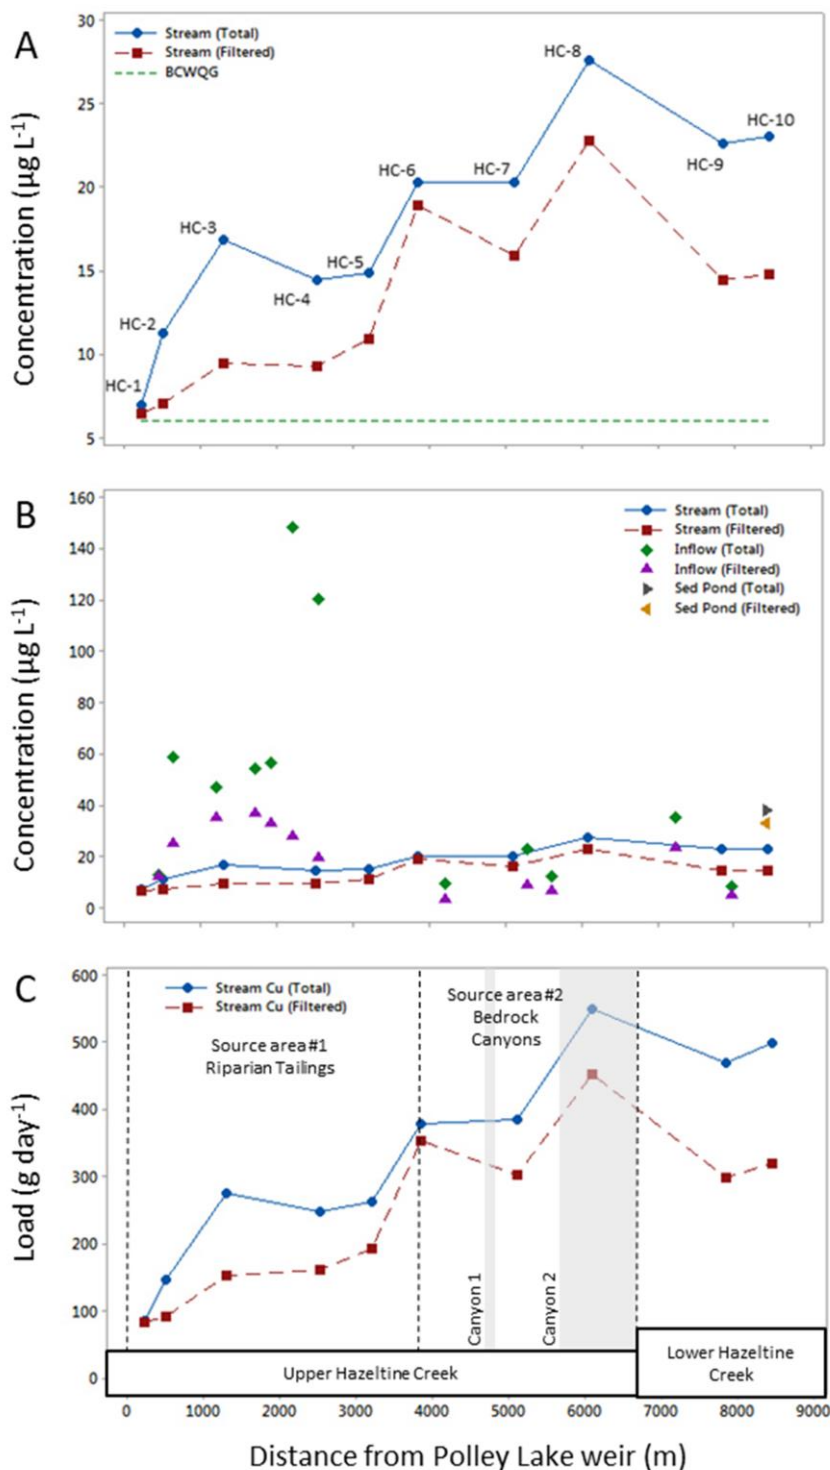
**Figure 2.** (A) Spatial profiles of stream total and filtered Cu concentrations with British Columbia Water Quality Guideline (BCWQG). (B) Spatial profile of stream filtered Cu concentration and inflow (total and filtered) Cu concentrations. (C) Spatial profiles of total and filtered Cu loads. Samples were collected in August 2015.

(Supplementary Table S1 and Fig. 2a). In Upper Hazeltine Creek, around the area known as the Polley Flats (0 – 3000 m below Polley Lake weir), Cu was higher in inflows than in the stream water (Fig. 2b). This result suggests that the inflows were receiving Cu from residual tailings and caused an increase in stream Cu in this part of the watershed. However, inflow Cu concentrations farther downstream (3000 – 8500 m below Polley Lake weir) were more similar to, or lower than, stream water concentrations in Lower Hazeltine Creek, suggesting surface inflow waters were not the only source of Cu in the watershed.

Synoptic sampling of streamflow and stream Cu concentrations is used here to identify and quantify sources of Cu to Hazeltine Creek under low flow conditions. Flow measurements are presented in Supplementary Fig. S2. Spatial profiles of filtered and total Cu loading show a general increase downstream of the Polley Lake weir (Fig. 2c); the maximum filtered (453 g day<sup>-1</sup>) and total (549 g day<sup>-1</sup>) loads were recorded at HC-8. The primary source of total (67%) and filtered (68%) Cu loading in Hazeltine Creek was the reach from HC-1 to HC-6 (0 – 4000 m) which comprised residual tailings in Upper Hazeltine Creek (Fig. 2c; source area #1). In this reach, filtered Cu loads increased consistently and there was no difference between cumulative (the sum of all loadings in the reaches where a positive change in loading was measured) and measured filtered Cu loads (Supplementary Fig. S3), suggesting there was no chemical attenuation (precipitation or adsorption) of Cu here. Total loads exhibit a similar profile to filtered loads in this reach aside from a slight decrease in load between HC-3 and HC-4. The general increase in Cu loading through this reach is most likely due to inflow waters with elevated filtered and particulate Cu concentrations that are draining the residual tailings (Fig. 2b). The increase in filtered and total loads between HC-5 and HC-6 was probably due to surface and/or subsurface inflows that were not sampled. The secondary source of total (33%) and filtered (32%) Cu loading was the reach from HC-6 to HC-10 which comprised the two bedrock canyons and Upper Hazeltine Creek (Fig. 2c; source area #2). Copper loading through this reach was more variable than further upstream but a notable increase in total and filtered loads occurred through Canyon 2 (HC-8) followed by similar magnitude decreases downstream of the canyon in Lower Hazeltine Creek (HC-9). A slight increase in loads downstream of the sedimentation pond (HC-10) prior to

discharge into Quesnel Lake was probably due to elevated Cu concentrations in the sedimentation pond (Fig. 2b). Considering stream Cu loading in the entire watershed, the differences between cumulative and measured Cu loads suggests 18% and 39% of the total and filtered Cu, respectively, added to Hazeltine Creek along its course was attenuated prior to discharge into Quesnel Lake (Supplementary Fig. S3). The alkaline stream water and high calcite and low sulfur content of the Mount Polley tailings undoubtedly limits mobilization and transport of Cu and other trace metals in Hazeltine Creek (Nordstrom, 2011). Nevertheless, the gradual increase in Cu concentrations and loads in the stream suggests aqueous and total Cu phases were influencing stream chemistry (Fig. 2). The following sections present results and discussion aimed at elucidating the mechanisms that may be responsible for the observed spatial pattern of Cu loading.

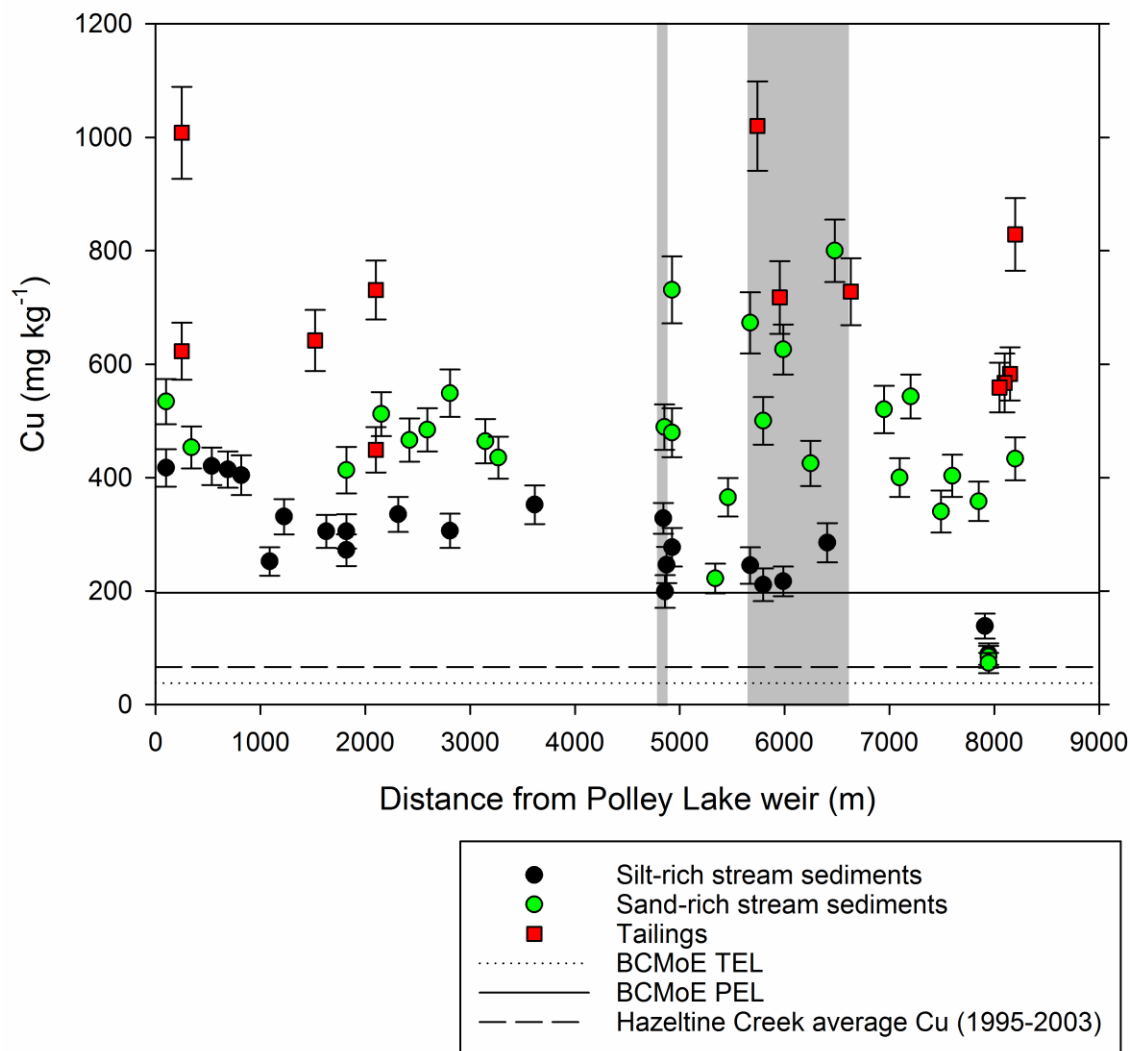
**Figure 3.** pXRF-derived Cu concentrations of sediments in Hazeltine Creek sampled on August 1<sup>st</sup> 2014. Dotted line and solid line represent British Columbia Ministry of Environment (BCMoE) Threshold Effect Limits (TEL) and Predicted Effect Limits (PEL), respectively (British Columbia Ministry of Environment (BCMoE), 2015). The dashed line represents the Hazeltine Creek average Cu concentration from 1995 – 2003 (Golder Associates Ltd, 2015). Grey vertical bars represent the locations of two bedrock canyons at 4800 – 4900 m and 5600 – 6600 m below Polley Lake weir.

pXRF survey of within channel sediments along the entire length of Hazeltine Creek revealed elevated Cu concentrations throughout the river corridor at the time of our sampling in 2015 (Fig. 3). Copper concentrations in material present on the floodplain surface up to 50 m distance from the channel ranged from 88 to 1020 mg kg<sup>-1</sup>. These values exceeded both the threshold effect level (TEL: 37.5 mg kg<sup>-1</sup>) and predicted effect level (PEL: 197 mg kg<sup>-1</sup>) for Cu (British Columbia Ministry of Environment (BCMoE), 2015), and also the mean Cu concentrations of Hazeltine Creek sediments before the breach (Minnow Environmental Inc, 2015). The Cu concentrations reported were comparable to other rivers affected by tailings spills (Bird et al., 2008; Hudson-Edwards et al., 2003; Kossoff et al., 2014) and historical mining operations (Gilchrist et al., 2009; Macklin et al., 2006). Cu concentrations were elevated in both silt-sized material, believed to reflect tailings-dominated material (range 89 – 419 mg kg<sup>-1</sup>) and sand-sized material, believed to reflect magnetite-rich sands (range 72 – 800 mg kg<sup>-1</sup>). The highest concentrations occurred in the magnetite sands in the second canyon between 5700 and 6700 m (Fig. 3).

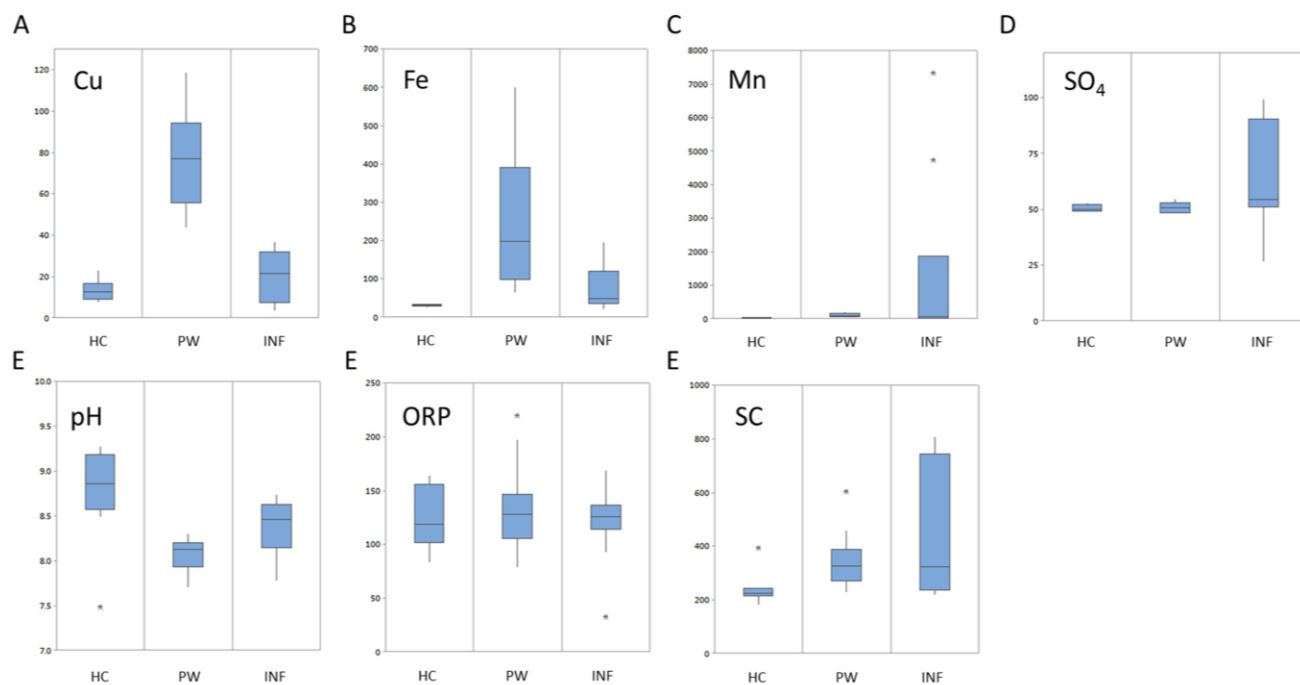
**Figure 4.** Summary of (A – C) filtered Cu, Fe, and Mn concentrations ( $\mu\text{g L}^{-1}$ ), (D) sulfate ( $\text{mg L}^{-1}$ ), (E) pH, (F) ORP (mV) and (G) specific conductivity ( $\mu\text{S cm}^{-1}$ ) in Hazeltine Creek stream water (HC), streambed pore waters (PW) and watershed inflows (INF).

Although positive ORP values were recorded in pore waters in this study (Fig. 4f), potentially suggesting an oxic system, in the absence of low pH (acidic) streambed pore waters, the only mechanism capable of producing the high filtered Fe and Mn concentrations found in Hazeltine Creek pore waters was reductive dissolution (Kimball et al., 2016). The highest pore water Cu and Fe concentrations were generally recorded at 10 cm depth but then declined at 0 cm depth (surface water) suggesting that diffusion of the released Cu to stream water was mediated by (co)precipitation and / or sorption reactions (Fig. 6). Cuprite was saturated at the sediment-water interface (0 – 10 cm) (Supplementary Table S3), however ferrihydrite was supersaturated and sorption of Cu(II) to Fe oxides is well documented in neutral and alkaline systems (Kimball et al., 2016; Koski et al., 2008). Furthermore, evidence from SEM-MLA analysis indicates the presence of Cu-bearing Fe oxides in the stream sediments (Fig. 5c, d; Supplementary Figure S4). Oxidation of the tailings chalcopyrite to Cu-bearing Fe oxide could have occurred either before (in the TSF) or after the 2014 tailings spill (in Hazeltine Creek). However, textural evidence strongly suggests that some of the Cu-bearing Fe oxides formed as discrete phases following deposition in Hazeltine Creek; this pattern is particularly evident in the Fe ochre sample collected from a seep mid-way down Hazeltine Creek (Fig. 5c, d). Also, the chalcopyrite: Cu-bearing Fe oxide ratio decreases from 0.36 – 0.57 in the 2014 deposited tailings, to 0.19 – 0.24 in the upper part of the Polley Flats, and to 0.00 – 0.06 in the lower part of the Polley Flats and further down Hazeltine Creek (Supplementary Table S4). This suggests that chalcopyrite oxidation and/or formation of discrete Cu-bearing Fe oxides increased in Hazeltine Creek between 2014 and 2016 and with distance downstream of the TSF.

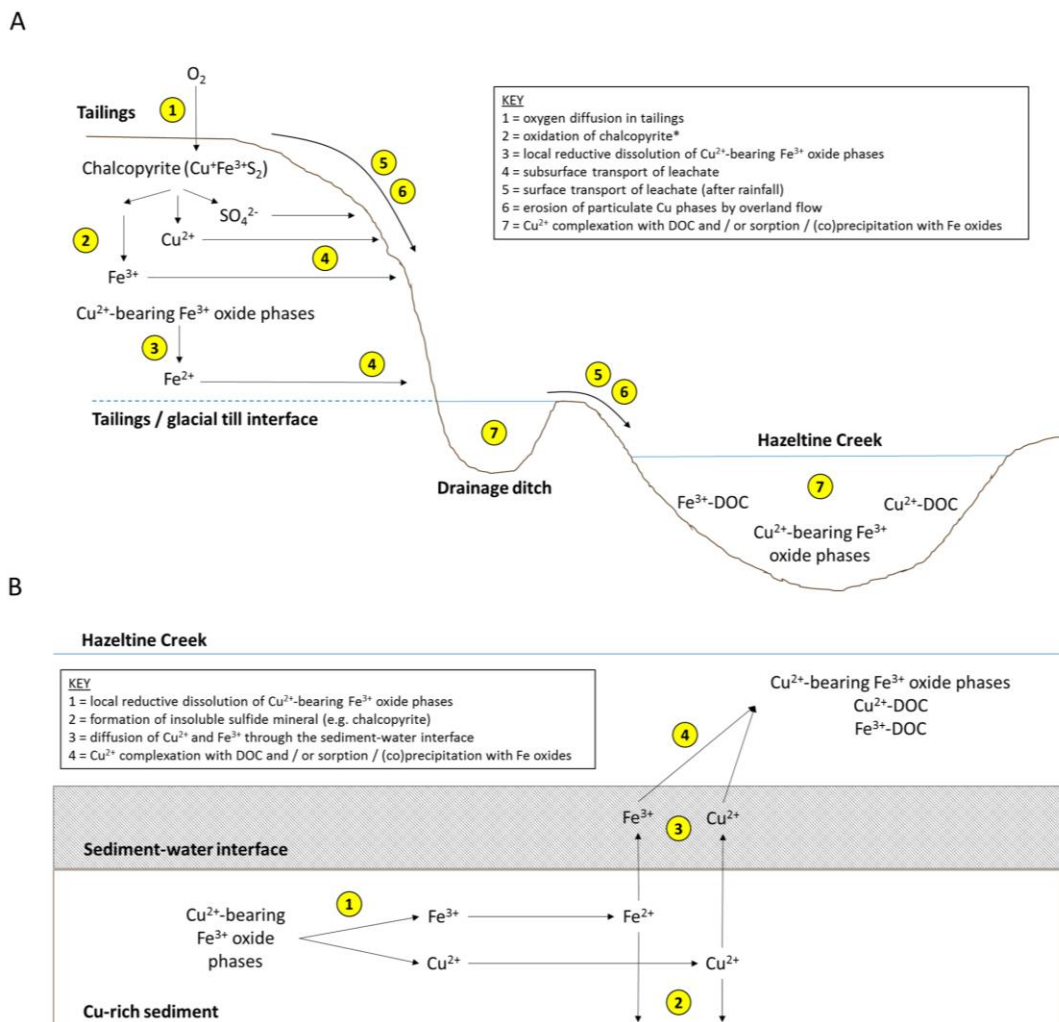
**Figure 7.** Conceptual model of Cu transport and cycling in the Hazeltine Creek watershed following the mine tailings spill. A = Polley Flats; B = streambed sediments. \*Recent evidence suggests oxidation of chalcopyrite may directly yield  $\text{Fe}^{3+}$  (Pearce et al., 2006).

Consideration of the evidence presented in this study allows us to derive a conceptual model of Cu cycling in the Hazeltine Creek watershed (Fig. 7). Oxygen diffusion in streamside tailings in Upper Hazeltine Creek could drive oxidation of chalcopyrite in near-surface tailings with reductive dissolution of Cu-bearing Fe oxides potentially occurring in deeper, anoxic tailings (Fig. 7a). Rainfall and infiltration in the tailings could dissolve the oxidation by-products which could be transported to drainage ditches and Hazeltine Creek water through surface runoff and / or subsurface flow. Any free ionic Cu present would probably form aqueous organic complexes and / or sorb to particulate Fe oxides. Copper mobilization in stream sediments could occur by reductive dissolution of Cu-bearing Fe oxides (Fig. 7b). The released Cu could form insoluble Cu sulfides in the stream sediment or diffuse through the sediment-water interface where it would be

complexed with organic matter and / or sorb to particulate Fe oxides. Finally, physical mobilization of particulate Cu through Canyon 2 could occur through erosion / suspension of Cu-rich sediments and streamside tailings in this high-gradient, turbulent and constrained reach.

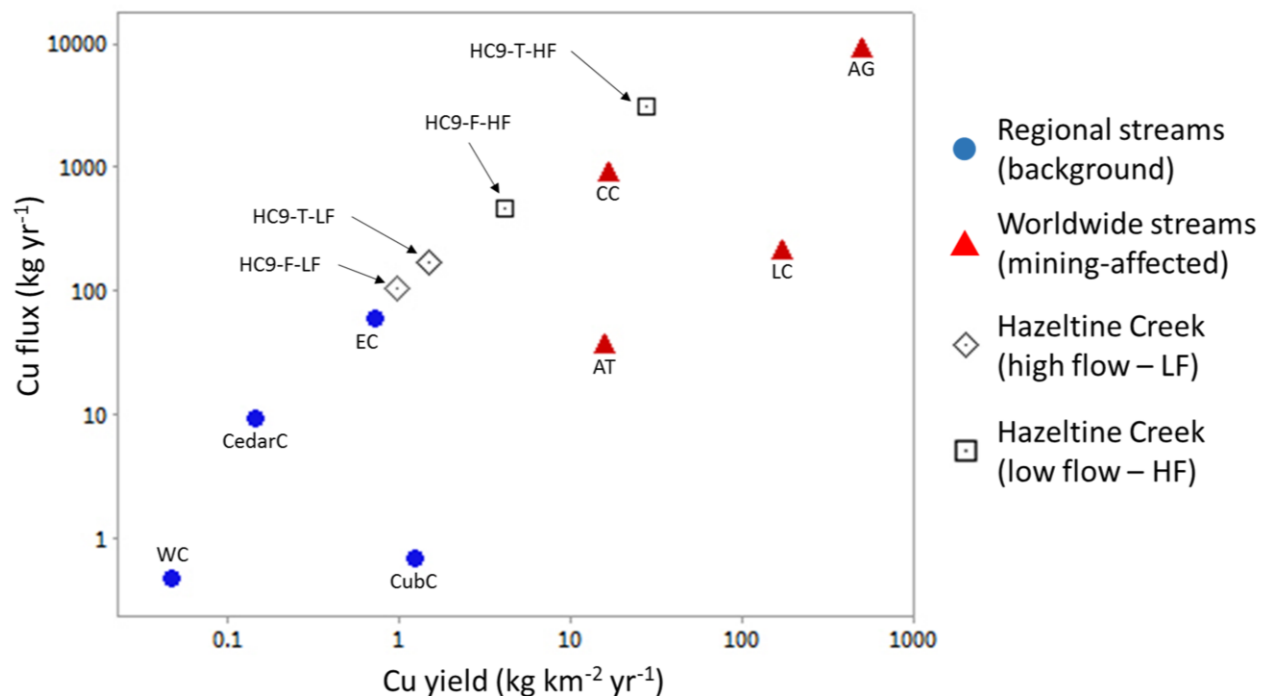
**Figure 8.** Cu flux and yield for Hazeltine Creek, regional streams (background) and worldwide streams (mining-affected). Note the logarithmic axes. Hazeltine Creek: HF = high flow; LF = low flow; T = total load; F = filtered load. Regional streams: WC = Winkley Creek; CedarC = Cedar Creek; CubC = Cub Creek; EC = Edney Creek. Worldwide streams: AT = Afon Twymyn (Wales) (Byrne et al., 2013); LC = Lion Creek (USA) (Byrne et al., in press); CC = Cement Creek (USA) (Runkel et al., 2016); AG = Afon Goch (Wales) (Mayes et al., 2010).

operate in the long-term. Considering the low flow data, watershed Cu flux is elevated when compared with the regional background values. However, the Cu yield (volume of Cu weighted by watershed area) in Hazeltine Creek is only slightly higher than values from Edney Creek (unaffected tributary of Hazeltine Creek) and similar to Cub Creek (unaffected smaller regional watershed) which suggests a relatively minor departure from background Cu yield. Comparison of low flow data with some mining-affected watersheds around the world reveals Cu loads and yields are generally several orders of magnitude greater than in Hazeltine Creek.
