Article

## A low cost way for assessing bird risk hazards in power lines: Fixed-wing small unmanned aircraft systems

Margarita Mulero-Pázmány, Juan José Negro, and Miguel Ferrer

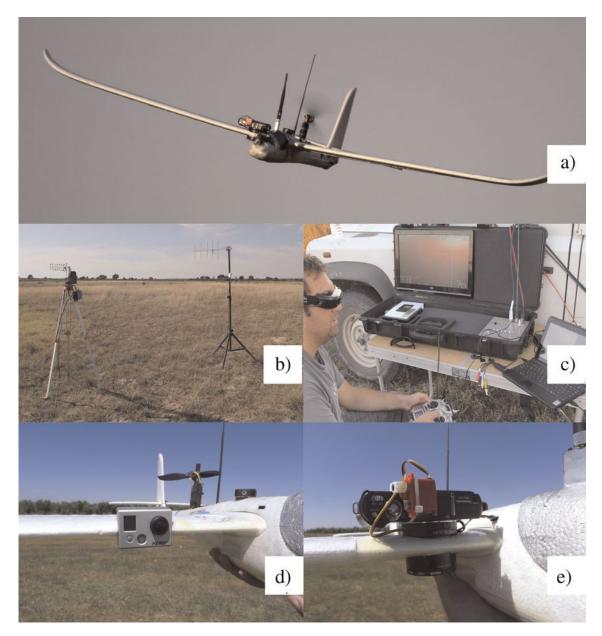
Fig. 1. Description of our small unmanned aerial system: (a) aerial platform, (b) antennas, (c) ground control station, (d) wing-mounted forward-pointing camera, and (e) wing-mounted nadir-pointing camera.

The ground station includes: a flight case, a video tracking system, and a long-range radio control transmitter (Fig. 1c). The flight case contains the equipment needed to visualize the real time video from the plane: a TV monitor, virtual reality goggles, a DVD video recorder, and a laptop that uses the data received with the video to track the UAS on a Microsoft (Redmond, Wash.) map.

The video tracking system integrates a high gain antenna, a motorized tracking system and a 1.2 GHz video receiver (Fig. 1b). Plane control signals are generated by a commercial radio control transmitter (WFT09, WFly, Shenzhen, China). The long range radio control system transmits this signal in

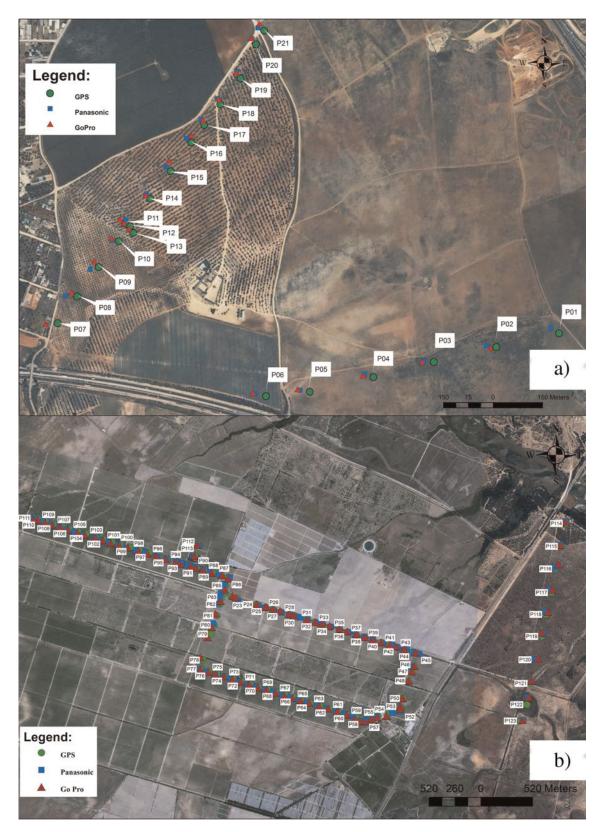
Fig. 2. Surveyed power lines with pylons geo-referenced by three different methods: (a) Dos Hermanas area, (b) Doñana area. Circle, from GPS at the base of the pylon; square, from sUAS using nadir-pointing camera; triangle, from sUAS using forward-pointing camera.

A total of 17 different pylon designs were identified among the 122 pylons that we surveyed (see Fig. 2; see also Fig. 3 for examples obtained by the two airborne cameras, and supplementary material

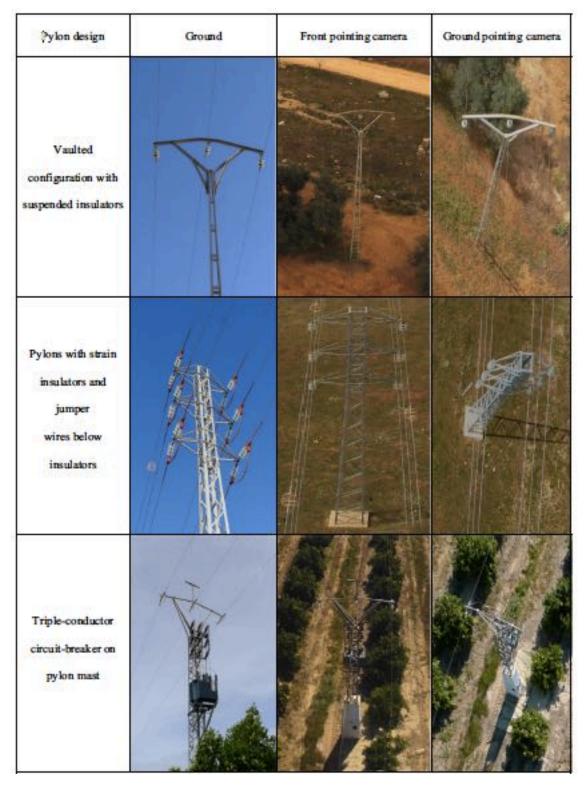
Fig. 3. Example of pylon designs recorded from the UAS (pylon designs classified following Clave 1992).

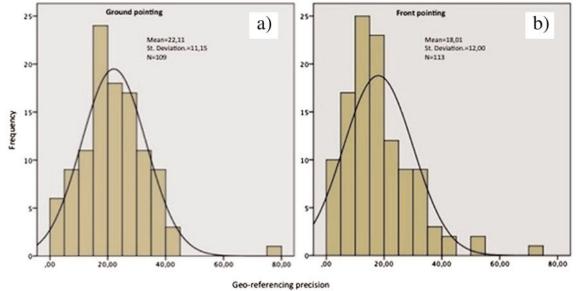
Fig. 4. Geo-referencing precision of the two types of cameras: (a) nadir-pointing; and (b) front-pointing.

Geo-referencing precision was significantly higher using the forward-pointing camera (mean = 18.01 m, sd = 12.00 m, n = 113) compared to the nadir-pointing camera (mean = 22.11 m, sd = 11.15 m,

n = 109; Student's t-test for paired samples = 3.70, p < 0.05; Fig. 4). In both cases, the mean error was lower than the interpylon distances (50 m for distribution lines and 100 m for transmission lines). In addition, as the observer knew the direction of the flights, it was not possible to confound one pylon with the adjacent one.

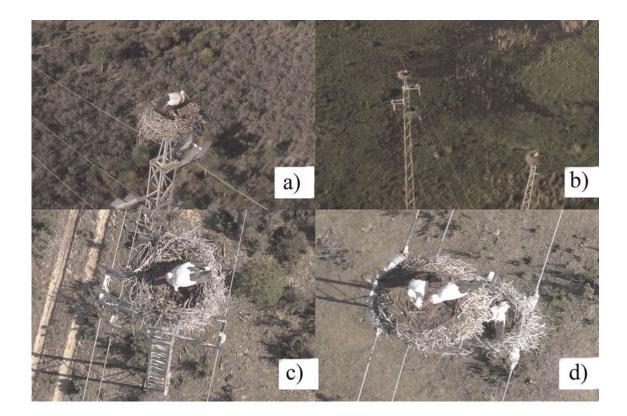
Fig. 5. White stork nests on the pylons: (a) and (b) recorded by forward-pointing camera; (c) and (d) recorded by nadir-pointing camera.

The images obtained with both cameras clearly visualized white storks (Ciconia ciconia) both adults and nestlings, and 10 nests on the pylons (Fig. 5). The size and position of the nests revealed high electrocution risk for the birds and for the power line to be damaged by fallen branches. Discussion
